**SUBJECT: ERRATA – WESTINGHOUSE ELECTRIC COMPANY – NUCLEAR
REGULATORY COMMISSION INTEGRATED INSPECTION REPORT NUMBER
70-1151/2018-004 AND NOTICE OF VIOLATION**

Report No.: 70-1151/2018-004

Facility: Columbia Fuel Fabrication Facility

Westinghouse Electric Company
Columbia Fuel Fabrication Facility
Nuclear Regulatory Commission Integrated Inspection Report 70-1151/2018-004
September 18 through September 21, 2018

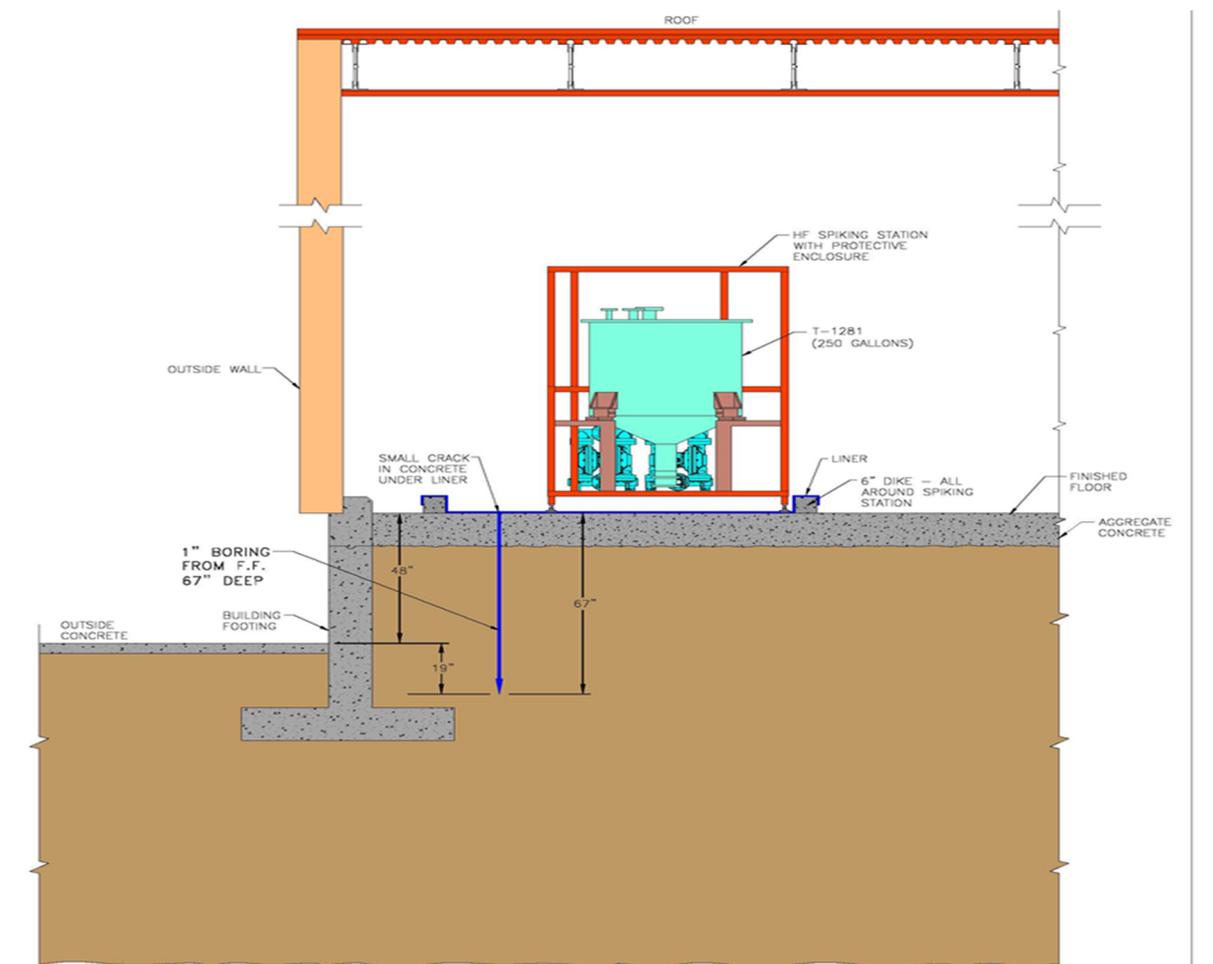
Cross-sectional View of HF Spiking Station

- The liner was removed so the diked area could be cleaned and inspected. Upon removal of the liner, maintenance noticed a small hole about the size of a quarter in the epoxy coating over the concrete. Prodding to investigate further resulted in a ~3 inch hole in the concrete surface.
- Maintenance was able to insert a wire down to ~30 inches into the building backfill before meeting resistance. They also noticed that the concrete was degraded around the immediate area. It should be noted that the building sits ~4 feet above the natural ground level.

The inspectors reviewed the 60-day event (EN 53504) follow-up report (ML18255A276) and the licensee's Apparent Cause Analysis (ACA) report (2018-12123) and noted that the stated apparent cause was a gap in plant standards regarding design, design changes, operations (including system leaks), and maintenance of the spiking station liner that provide a safety barrier to the environment. The licensee determined that prolonged contact with hydrated uranyl nitrate (UNH) process fluid deteriorated the concrete as it was known that UNH solution is highly corrosive to typical concrete mixtures. Acceptance of frequent system leaks and liner degradation from foot traffic, operations, and maintenance activities allowed process fluid to contact the liner resulting in the trapping of moisture between the liner and the diked area concrete surface.

Description: On June 16, 2018, approximately 30 gallons of UNH solution leaked into the diked area surrounding the HF spiking station. A flanged piping connection was the source of the leaking solution. After the system was shutdown, a worker identified a small amount of solution that appeared to have migrated to the outside of the dike wall. CAP 2018-11205 was written to track the issue and Spiking Station #2 was shut down. The dike liner was removed as part of corrective measures. While the polypropylene liner was removed for repair work, a small crack was noticed in the epoxy floor covering. The plan was to repair the crack but as the loose epoxy was chipped away, a hole of approximately 3 inch diameter was revealed.

ADUHFS-902 was considered degraded as indicated by cracks and degradation of the concrete dike wall. The inspectors noted that here was no policy or procedure in place to periodically inspect the area below the liner for indications of degradation of the concrete floor due to liner leaks.

- OM81215 was updated to 1) clarify the steps needed to perform the liner leak check, 2) require notification to Environmental Health and Safety (EH&S) of any degradation, and 3) change the frequency of the inspection from annual to quarterly and following any repair.
- The Spiking Station was barricaded and posted with instructions to put down walking pads prior to stepping on the liner to prevent liner damage.
- Hourly inspections of the liner have been commenced while the spiking station is in operation.

- Develop and implement an improved design for the spiking station system and dike area including a design review to prevent UNH solution from impacting the environment.
- Assess similar design configurations of a liner/environmental barrier relied on for secondary containment for proper post-maintenance and time-based PMs.
- Conduct an extent of condition for similar couplings used throughout the facility to verify PMs have been established.
- Additional long term corrective actions are detailed in ACA 2018-12123.
