U.S. NUCLEAR REGULATORY COMMISSION
REGION IV

NRC Inspection Report: 50-602/90-02

Facility Name: Nuclear Engineering Teaching Laboratory (NETL) (Triga Mark II)

Inspection Conducted April 17-27, 1990 (Report 50-602/90-02)

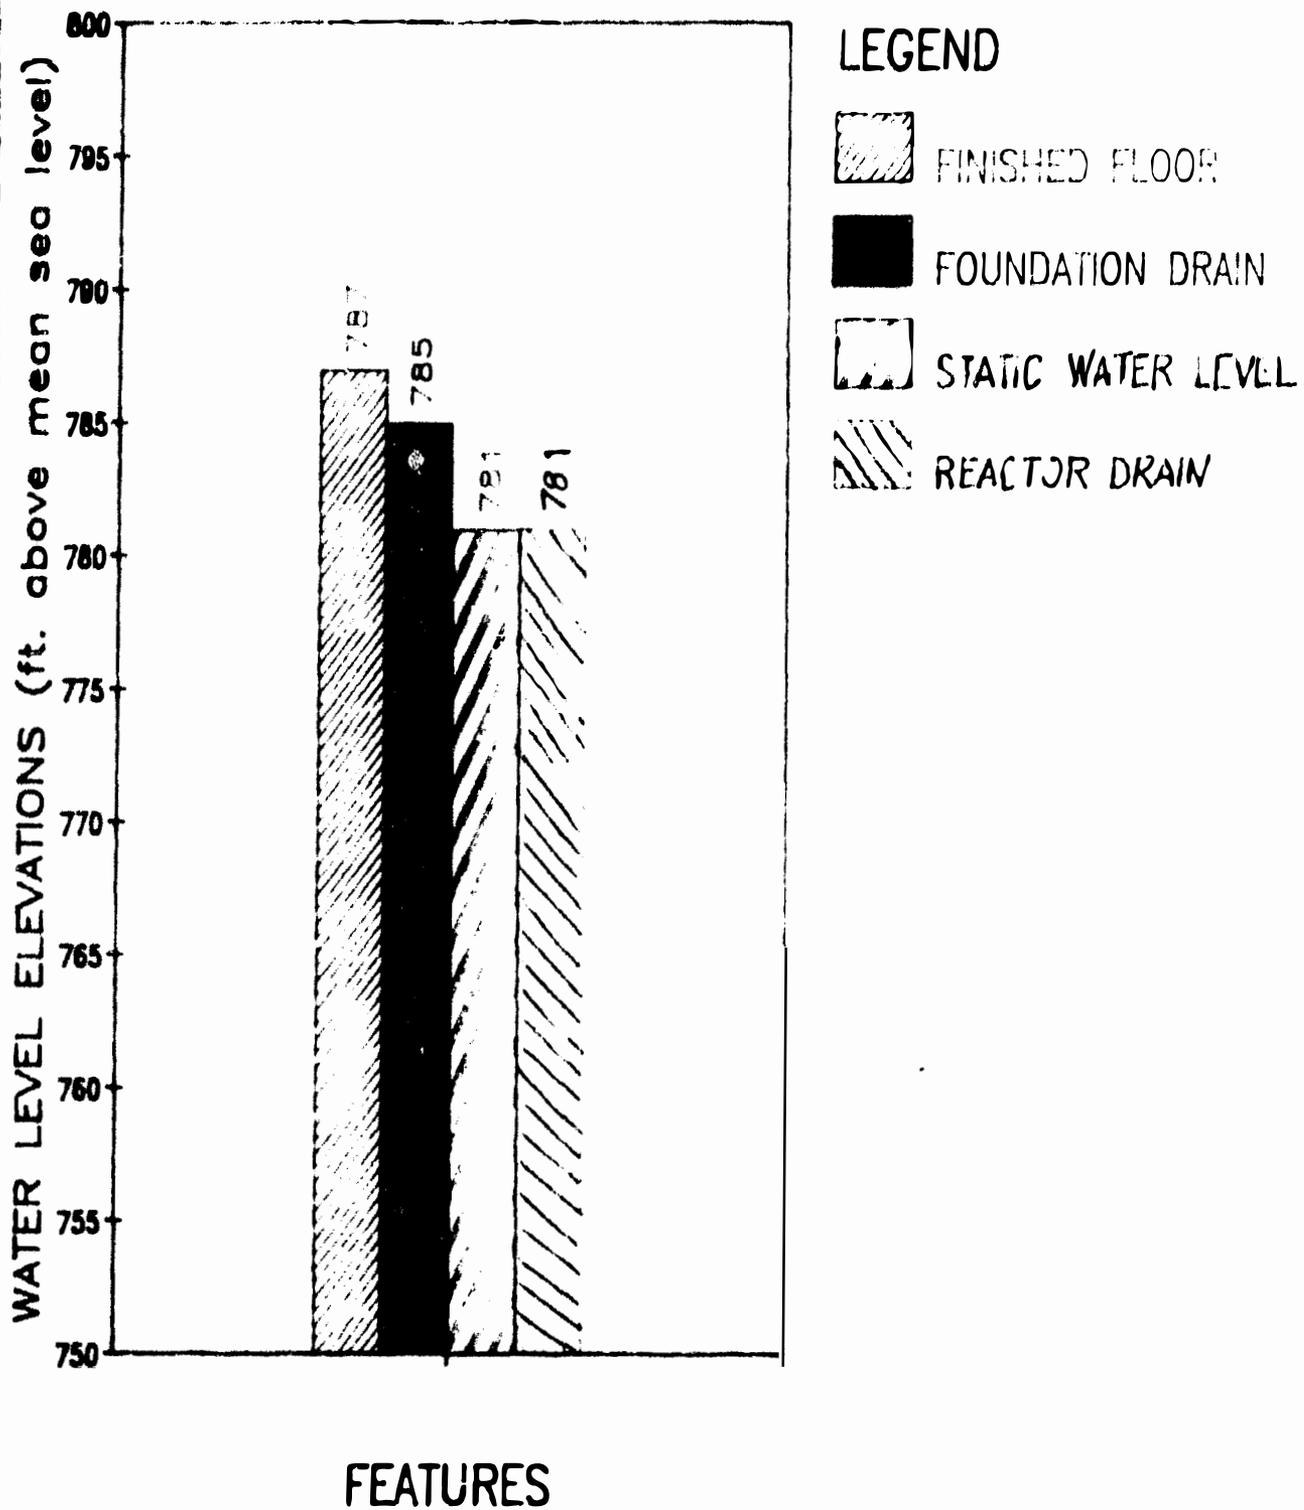
FIGURE ONE VARIOUS ELEVATIONS AT THE BALCONES RESEARCH CENTER

There are several other elevations and water conveyance structures that are important in determining where ground waters at the site will move. Two perimeter drainage systems have been installed at the reactor building. A foundation drain at elevation 785 feet above msl surrounds the perimeter of the building. This system gravity drains to a catch basin where it is pumped to a storm sewer. Additionally, a drain embedded in a gravel pack underlying the reactor vessel at an elevation of 781 feet above msl (the estimated static water level) gravity drains to a sump where any water encountered is pumped to a drain system. The finished floor level of the reactor is at 787 feet above msl. These water levels are graphically shown in Figure 1.

These two systems can be considered as ground-water sinks that have the ability to control water encountered in the underlying strata as well as its weathered surface. Considering the drainage systems that exist at the site, ground water should be consistently drained at a depth of 785 feet above msl at the building's perimeter and 781 feet above msl at the base of the reactor vessel. These depths are 2 feet and 6 feet, respectively, below the floor of the building. Therefore, if the drainage systems perform as designed, then the water surface in the vicinity of the reactor vessel should always be lower than the floor of the structure.

Should the drain system fail, seasonal variations in ground water at this site could cause water to enter the building. This leads to the conclusion that some quality assurance associated with the drain operation should be implemented. Fortunately, such a mechanism exists at the site. Soil boring B-1P was cased and developed as a piezometer located in the reactor room. If additional assurance, as to the functioning of the drains is thought to be necessary, then the piezometer's water level should be monitored. If the drains are functioning as designed, the water level should never rise beyond 781 feet above msl.

After discussions, the licensee agreed to implement periodic monitoring of the water level in piezometer B-1P. Since the cleaning and closure, there has been no water found in the fuel storage tubes. Actions taken during construction to seal the construction joint between the floor and wall of the liquid waste room
