Subject: Interim Notification Report for Potential Part 21.

Curtiss-Wright was notified on August 7th, 2018 by Exelon's Dresden Plant that a Curtiss-Wright Supplied Namco Limit Switch, P/N: EA700-90964 had failed during a planned maintenance test.

To: Danny Srisawasdi, Quad Cities Station, 309-227-3847
From: Devan Wachter, 815-458-7599 devan.wachter@exeloncorp.com
Project: QDC-07067
Subject: Failure Analysis of a NAMCO Limit Switch from Quad Cities Station
Manufacturer: NAMCO Controls Corp
Component ID: 1-5699-MSV1 - ASSY -
U1 TURB MSV #1
AR/CR/WO: 04145668
PO.: FAILURE ANALYSIS
Model: Snap-Lock 700-90964
Quantity Received: 1

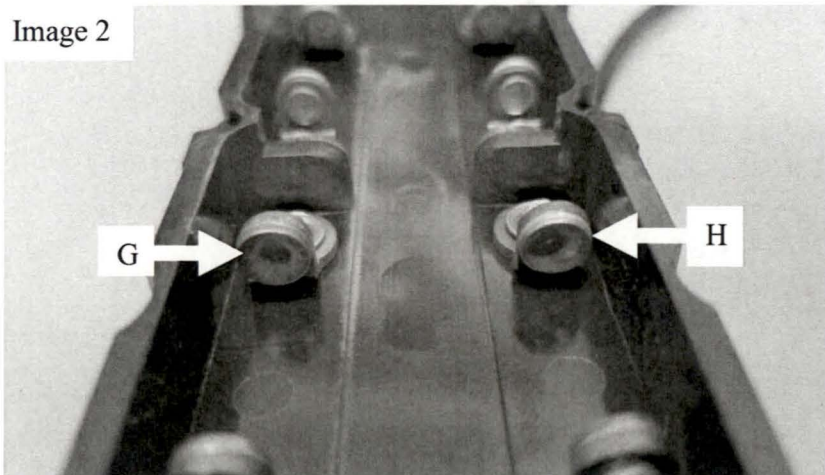
Image 2

Image 2: Contacts G-H show signs of arcing between pads. From the data in table 1, contacts do not show signs of increased resistance.

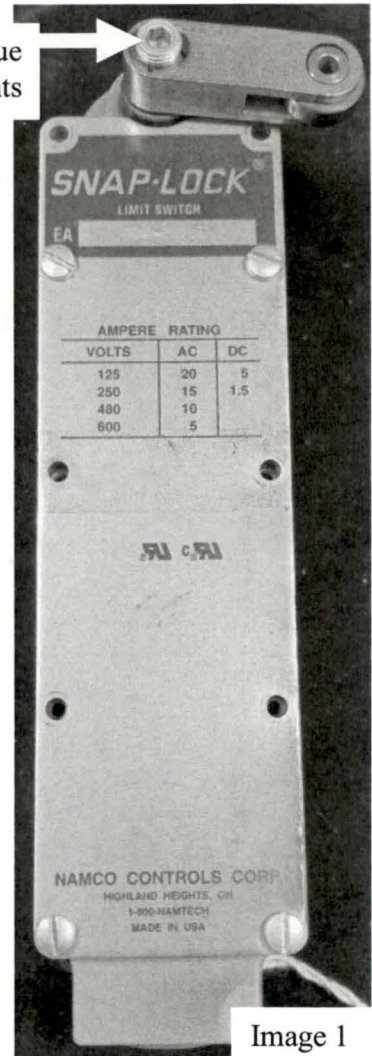
Image 1

Image 1: Namco Controls Limit Switch Nameplate.

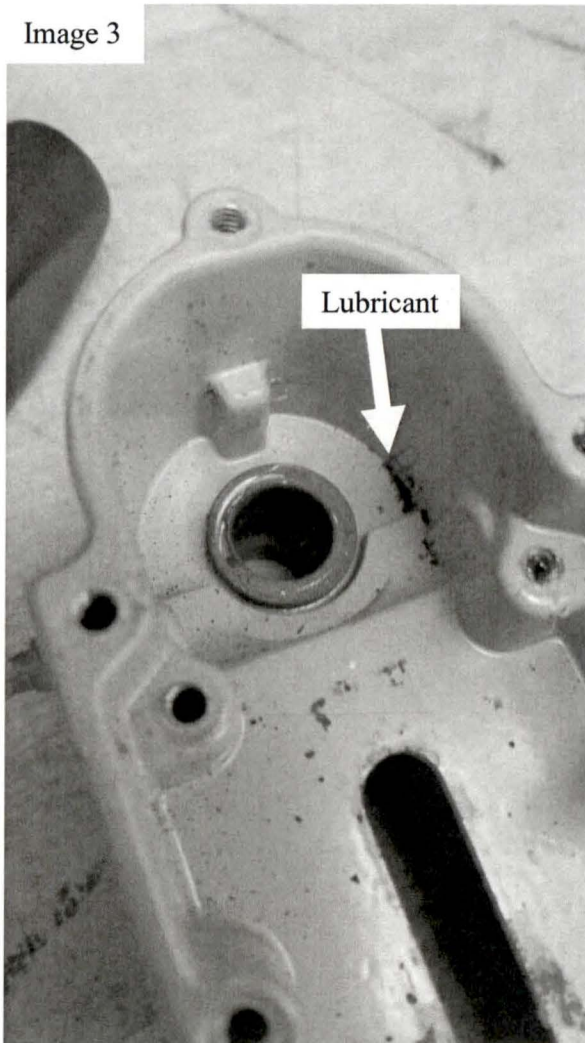
Image 3

The manufacturer uses Nye Lubricant 181 (Technical Data Sheet: Image 7). During examination, dry lubricant residue was found in all of the internal components (Images 3 and 4). The residue is suspected to be dried from the environmental temperatures or insufficient quantity of lubricant.

Image 3: With internals removed from limit switch casing, we can see signs of dried lubricant.

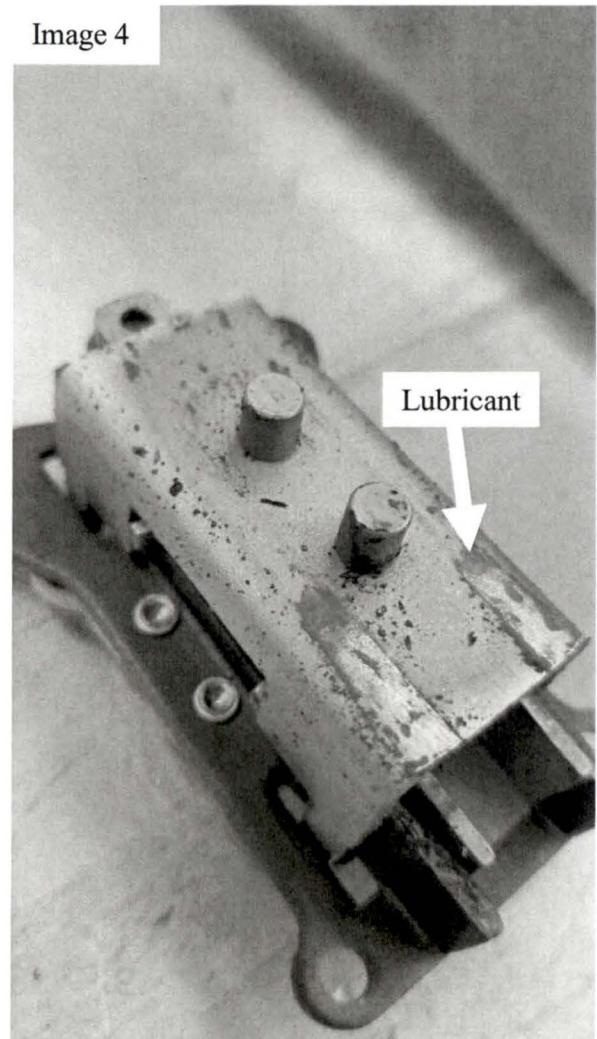
Image 4

Image 4: Latch assembly shows signs of dried lubricant causing binding during operation.

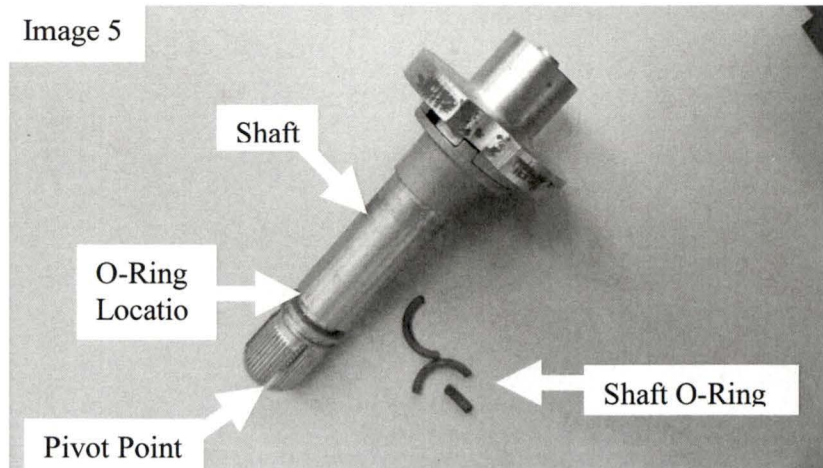
Image 5: The shaft O-Ring was found intact, but fractured into pieces during removal. The O-ring material was severely hardened and embrittled from environment aging. Using fourier-transform infrared spectroscopy (FRIT) techniques, the O-ring was found to be of Buna-N material (Image 8). The combination of dried lubrication and a hardened O-ring would have contributed to binding forces.

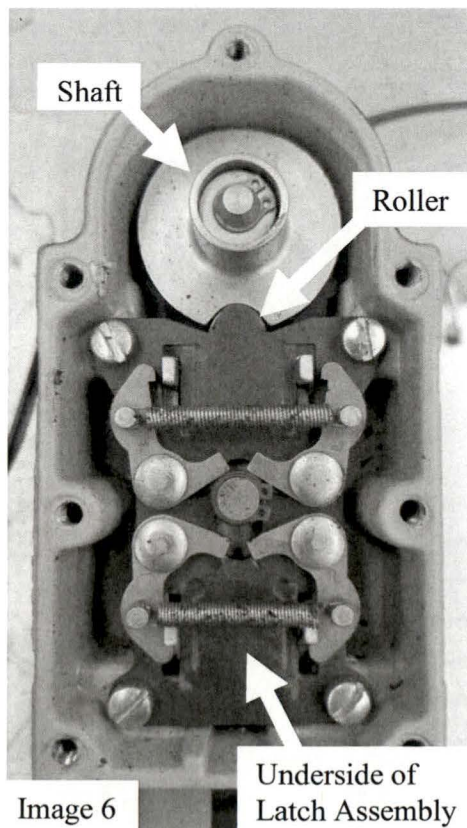
Image 6: Dried lubrication at multiple moving components contributed to the limit switch failure. The dried lubricant at the O-ring would increase the amount of torque required to rotate the shaft. If lubrication was present, the shaft would rotate and the roller on the latch assembly would properly operate to actuate the contacts. When torque on the shaft is released, a spring in the latch assembly pushes the contacts back to shelf state (opening the contacts).

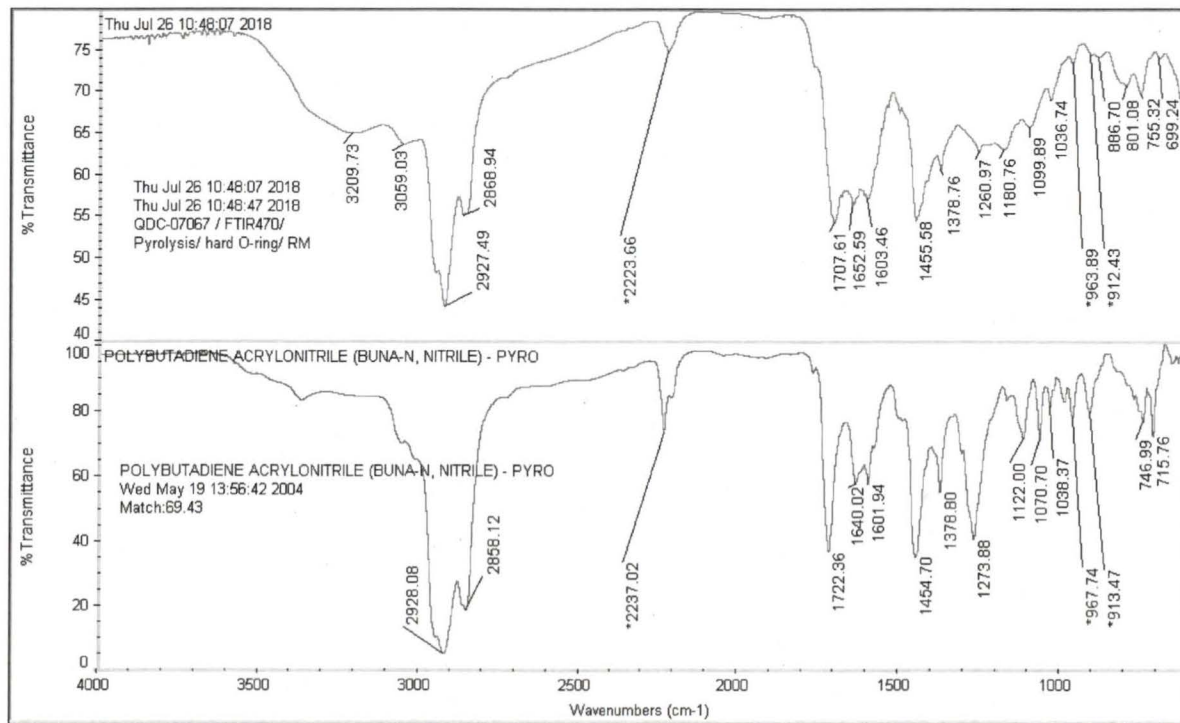
Image 8: FTIR showing the unknown hardened O-ring material to be consistent with Buna-N.
