SUBJECT: CLINTON POWER STATION—NRC INSPECTION REPORT 05000461/2018051  
AND PRELIMINARY WHITE FINDING

Report Number: 05000461/2018051

Facility: Clinton Power Station

Dates: August 3 through September 4, 2018

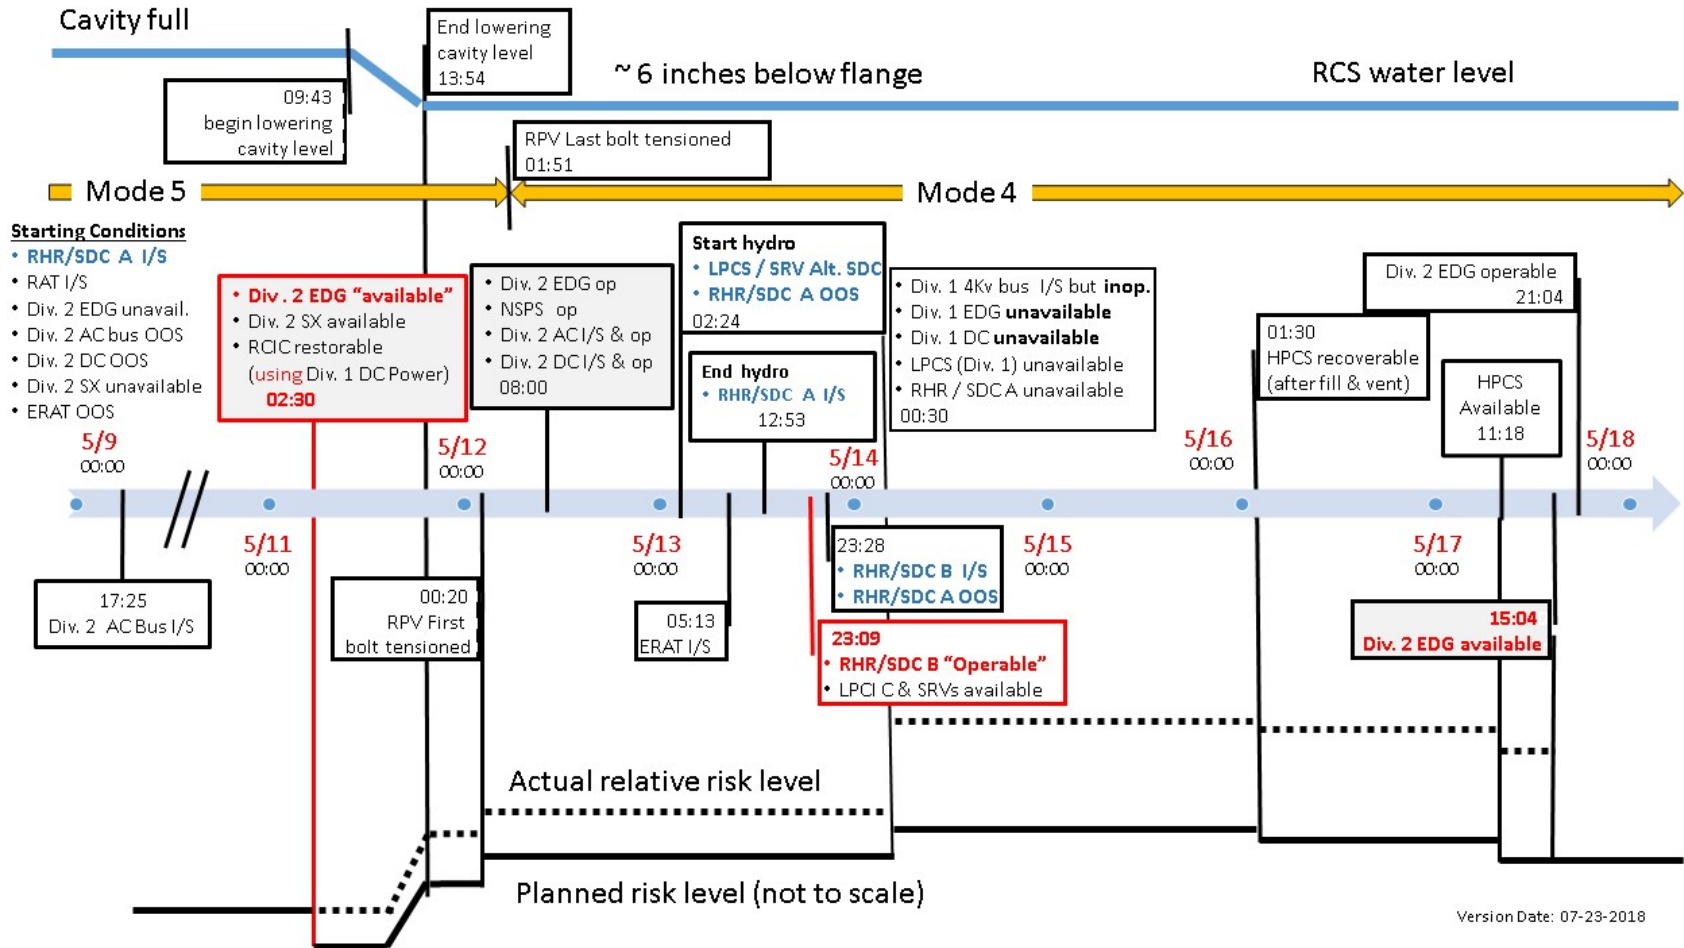
The Division 2 EDG unplanned unavailability started after the reactor had been refueled and the associated reactor cavity was full. That is, there was over 23 feet of water above the reactor core. Early in the unavailability, the licensee installed the reactor pressure vessel (RPV) internals, lowered water level to about six inches below the RPV flange, installed and tensioned the reactor vessel head. The unit entered cold shutdown or Mode 4 when the last reactor head bolt was tensioned. See Figure 1 for a time line of these events.
