UNITED STATES  
NUCLEAR REGULATORY COMMISSION  
REGION III  
2443 WARRENVILLE ROAD, SUITE 210  
LISLE, ILLINOIS 60532-4352

SUBJECT: NRC REACTIVE INSPECTION REPORT NO. 03033539/2018001(DNMS) AND  
NOTICE OF VIOLATION – FLEIS & VANDENBRINK ENGINEERING, INC.

Docket No. 030-33539  
License No. 21-26580-01

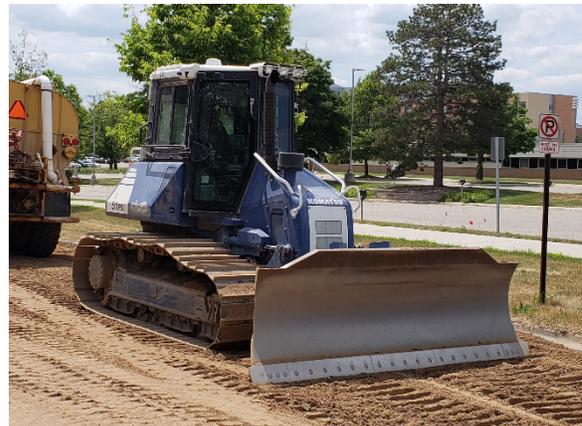
Upon retrieving the clipboard, the technician heard shouting coming from the next block up. The foreman and another employee for McGuirk, standing at the intersection of Ives and Cedar, were yelling at a crawler dozer that had been placing gravel near that intersection, but was now rapidly reversing in the direction of the technician and his gauge. However, the dozer, a Komatsu D51PXi series [see Figure 1], had a fully enclosed cab, and the operator apparently made no attempt to look backwards in the direction of his travel.

The technician, at approximately 15 feet from the gauge, considered making an attempt to retrieve the gauge, upon realizing that the dozer may run it over. However, at the dozer's apparent rate of speed, the technician realized that he may not be able to make it there and retrieve the gauge in time, so decided not to risk his own safety. He too yelled and waved at the operator vigorously, but to no avail. The dozer ran over the gauge with its left tread, then proceeded forward again on Ives towards Cedar, where the foreman finally flagged down the operator and detained the equipment.

*Figure 1: The dozer, still on the Ives Ave job site*

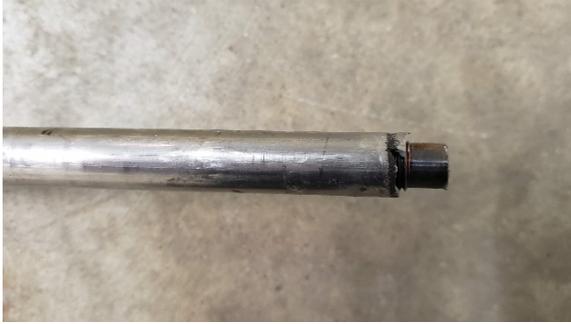
The technicians first attempted to retract the bent source rod by pulling up on its handle, as would be done under normal circumstances. Failing that, the technicians then attempted to bend the rod manually; first using their bare hands to grasp the rod at the base of the gauge (approximately eight inches from the exposed source, for up to two minutes), and then using leverage from a nearby piece of stationary heavy equipment as they held on to the sides of the gauge. Failing that, the office technician took the field technician's hammer from his bucket of density testing equipment, and struck the rod on the end (i.e. where the source was located) in an attempt to overcome the broken locking mechanism and force the rod back into its shielding. On the second hammer strike, the welded cap on the end of the rod shattered [see Figure 2], and the now singly-encapsulated Cs-137 sealed source, a QSA Global, Inc. model CDC.W556, fell out of the cup on the end of the source rod.

*Figure 2: Source rod, post-hammer. Note that the Cs-137 source is no longer present.*

Due to the substantial potential for exposures or releases in excess of regulatory limits, the licensee's inadvertent detachment of the Cs-137 sealed source from the damaged gauge's source rod while attempting to retract it is an apparent violation of this License Condition.

The inspector determined that the root cause of both violations appeared to be a lack of understanding of the scope of authorized activities. The licensee's staff appeared to believe that they could manipulate the source rod in order to retract the source into its shielding, given the circumstances. A contributing factor was the lack of any explicit guidance on how to properly resolve a situation involving a bent source rod.

- Developing and providing annual refresher training to its gauge users to reinforce safety procedures and incident response;
- Developing a case study of this event for presentation to staff, incorporating what went well and what could have been done better;
- Determining the availability of Type A containers which can accommodate a damaged gauge no matter the condition of the gauge;
- Incorporating the availability of such containers into its emergency response plans and training; and,
- Developing an incident response team, comprised of additional staff with RSO training and experience, to provide timely support and coordination and to minimize uncertainty in responding to future events.

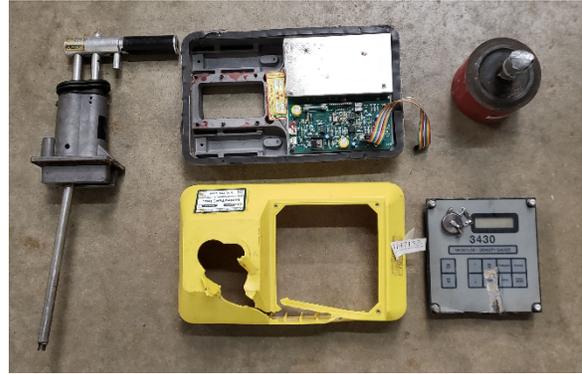
The technician walked back to the gauge to assess the damage. The technician found that the dozer had pressed the gauge into the gravel, cracked and broken the plastic case and electronics panel, and sheared the indexing rod (which stands parallel and adjacent to the retracted source rod and provides latch stops at regular intervals to assist in extending the source rod to the desired depth). He looked underneath the broken electronics panel and found that the Am-241:Be source at the bottom of the case appeared to be undamaged. He also attempted to pull on the handle of the source rod to retract it into its shielded position, but it did not move. He picked up the gauge momentarily, and found that although the source rod appeared to be intact, the dozer's weight had bent it approximately eight degrees from vertical. In this shape, the technician recognized that the rod would not be able to retract into the gauge through the narrow inner diameter of its lead shielding.

The RSO contacted and then visited a different portable gauge manufacturer than the one he spoke to the night before to arrange for transfer of the damaged gauge to their service center, also in Grand Rapids. The manufacturer provided him with leak test collection equipment, a lead pig, and instructions on how to remove the source rod shielding (and by extension, the source rod) from the gauge housing, so that the

Figure 3: Gauge remnants, awaiting disposal at the service center
