SUBJECT: NRC REACTIVE INSPECTION REPORT NO. 03001609/2018002(DNMS) –
INDIANA UNIVERSITY-IUPUI/IU MEDICAL CENTER CAMPUS

Report No. 03001609/2018002(DNMS)

Licensee: Indiana University-IUPUI/IU Medical Center
Campus

Location Inspected: IU Health Methodist Hospital Campus
I-65 and 21st Street
Indianapolis, Indiana

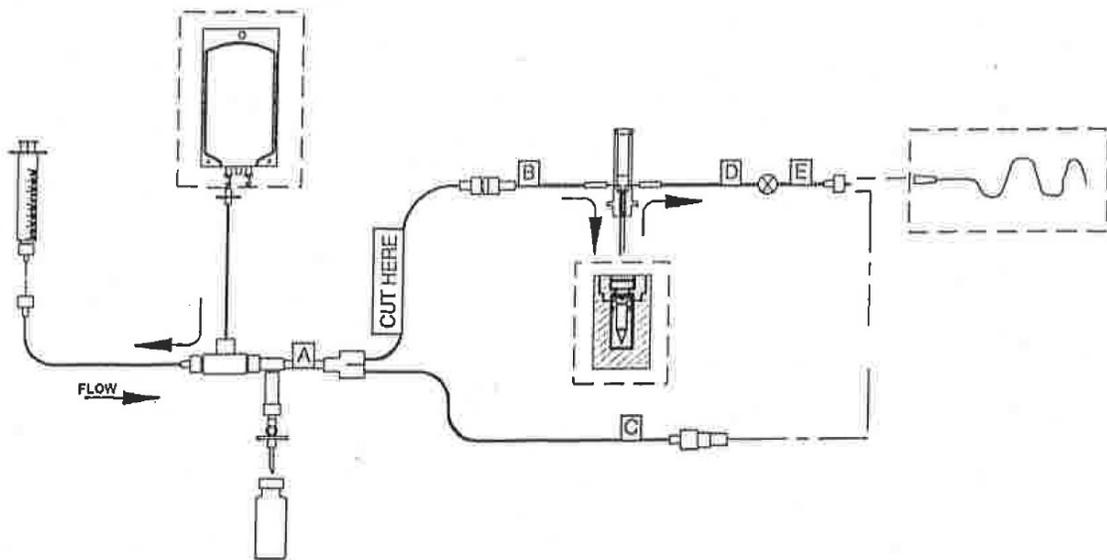
TheraSphere® Administration Set

Administration Set is assembled for patient treatment, tubing after “B” on the diagram depicts the “hot” portion or the radiation component of the set where the Y-90 microspheres would flow to the patient. All components depicted after “B” would be potentially contaminated and contained within the Administration Accessory Kit for shielding and contamination control. The components of the Administration Set depicted to the left of “A” are non-radioactive or “cold.” Upon completion of the treatment, the licensee staff would cut the tubing depicted on the Attachment as “Cut Here.” The “cold” components depicted to the left of “A” would be treated as medical waste; the “hot” components depicted to the right of “B” would be collected as radioactive waste and held for decay.

At the start of the administration of the Y-90 microspheres, the authorized user noted an unusually low pressure within the system. As the authorized user injected saline in the system, he noted that the saline flowed through the system with little resistance, appeared to bypass the v-vial containing the Y-90 microspheres, and collected directly into the “excess” vial. After two attempts to inject saline through the system with the same outcome, the authorized user terminated the treatment.

The device manufacturer, BTG International Canada, Inc., initiated its investigation of the licensee's returned Administration Set on October 12, 2018. The manufacturer's investigation included a visual inspection, radiation exposure rate surveys, digital microscopy and pressure/flow testing. The manufacturer confirmed through visual inspection and surveys that the majority of microspheres remained in the dose vial and were not delivered to the patient during the treatment. The manufacturer noted residual microspheres along the flow path, from the outlet tubing to the microcatheter. Kinks were identified on the microcatheter and radiation surveys at these locations were elevated in comparison to other sections of microcatheter that appeared normal or unkinked. The manufacturer could not confirm whether these kinks in the microcatheter were present during the patient treatment. Pressure/Flow tests determined that Administration Set and tubing appeared functional with no resistance to flow. The manufacturer's tests revealed significant resistance in flow within the microcatheter which was used to deliver to dosage to the patient; this resistance indicated a possible occlusion or kink that could prevent the microspheres from flowing to the treatment site.

Based on the components that were returned, the manufacturer indicated that there may have been a kink obstruction within the treatment catheter. The manufacturer could not perform a complete analysis of the Administration Set, because not all of the components were returned.

The licensee implemented immediate corrective actions to address the suspected cause of the medical event to prevent similar events by taking Administration Sets and microcatheters from the same lot out of its inventory. The licensee also revised its process to include returning the “cold” portion of the Administration Set, along with the “hot” portion, for any future events involving TheraSphere® Y-90 microspheres.
