Legacy
Management

2018 Annual Site Inspection and
Monitoring Report for Uranium Mill Tailings
Radiation Control Act Title II Disposal Sites

December 2018

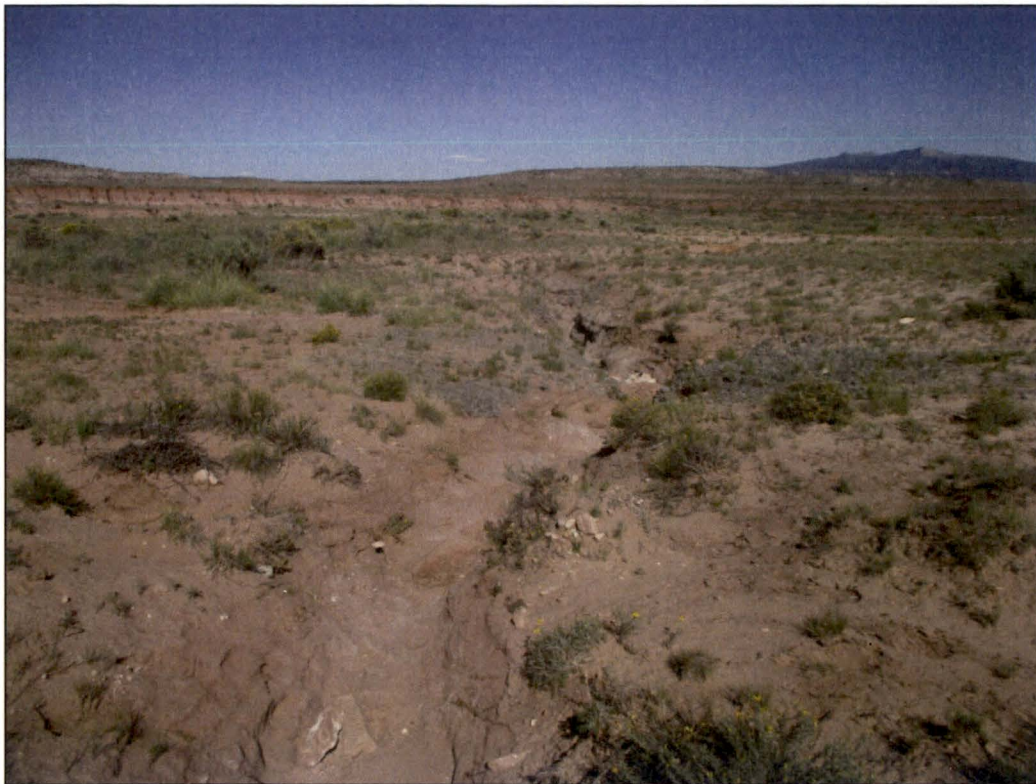
Interior roads used to access LM assets consist of a dirt track covered at places with crushed basalt. The roads are susceptible to erosion and are repaired when they become impassable. Increased erosion was observed on a road northwest of the main tailings disposal cell (PL-1). A gully intersecting the road at this location required maintenance in the past. Riprap previously was added to repair this section of the road; other repair options will be evaluated in 2019. This portion of road is not necessary to maintain access to the disposal cells; it is used to access the northern portion of the site and monitoring well 11(SG), which can be accessed by utility terrain vehicles when necessary. No other maintenance needs were identified.

PL-1. Gully Intercepting Interior Site Road

Additional fence maintenance needs identified during the April 25, 2018 fence inspection will be addressed and repairs made in 2019. Potential options to address erosion impacting the interior site road will be evaluated in 2019. No other maintenance needs were identified.

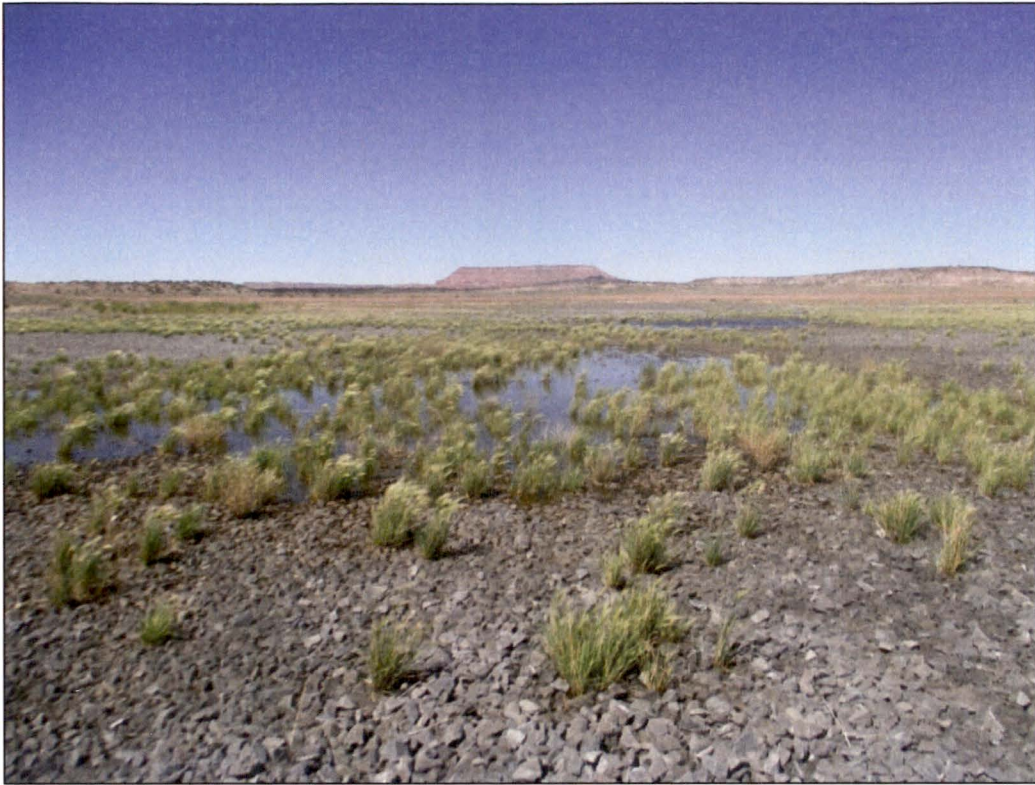
materials if the pond surface reaches an elevation high enough to spill over the north side slope of the disposal cell. Water would start to spill at the lowest point along the north edge of the top slope, and that could initiate erosion at that location. In 2018 LM developed a conceptual design to repair the depressions, regrade the north portion of the top slope, and construct a spillway on the north side slope to ensure positive drainage. In 2019, LM will continue to work on the design and coordinate with NRC regarding its concurrence.

PL-7. Ponded Water on Main Tailings Disposal Cell Top Slope

- **Bluewater, New Mexico:** In 2018 LM developed a conceptual design to repair depressions on the main tailings disposal cell, regrade the north portion of the top slope, and construct a spillway on the north side slope to ensure positive drainage. In 2019, LM will continue to work on the design and coordinate with NRC regarding its concurrence.

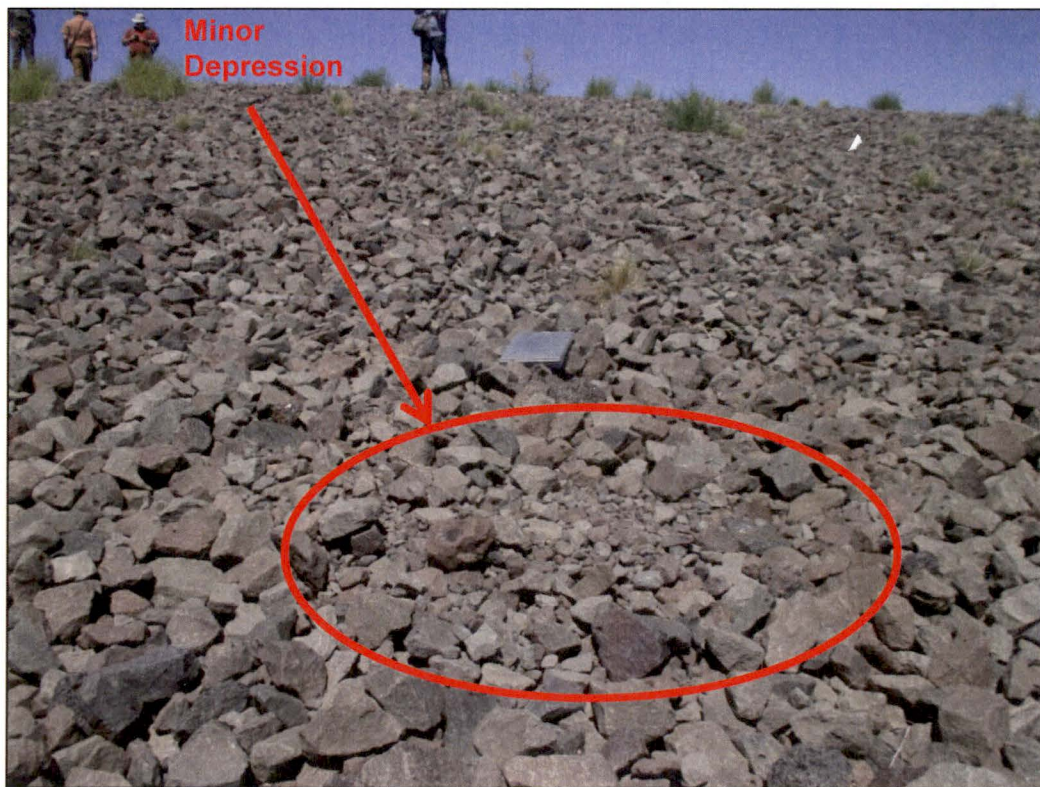
The side slopes and toe of the main tailings disposal cell were inspected for signs of erosion or sediment deposition. An area of minor depression was observed on the southern side slope of the main tailings disposal cell (PL-10). The area was approximately 3 feet wide and 3 inches lower than the surrounding areas. The depression area consisted of smaller sized riprap than that found on the surrounding side slope and is believed to be a construction artifact. This depression will continue to be inspected and will be evaluated using periodic LIDAR survey results. No other

PL-10. Minor Depression on Main Tailings Disposal Cell South Side Slope

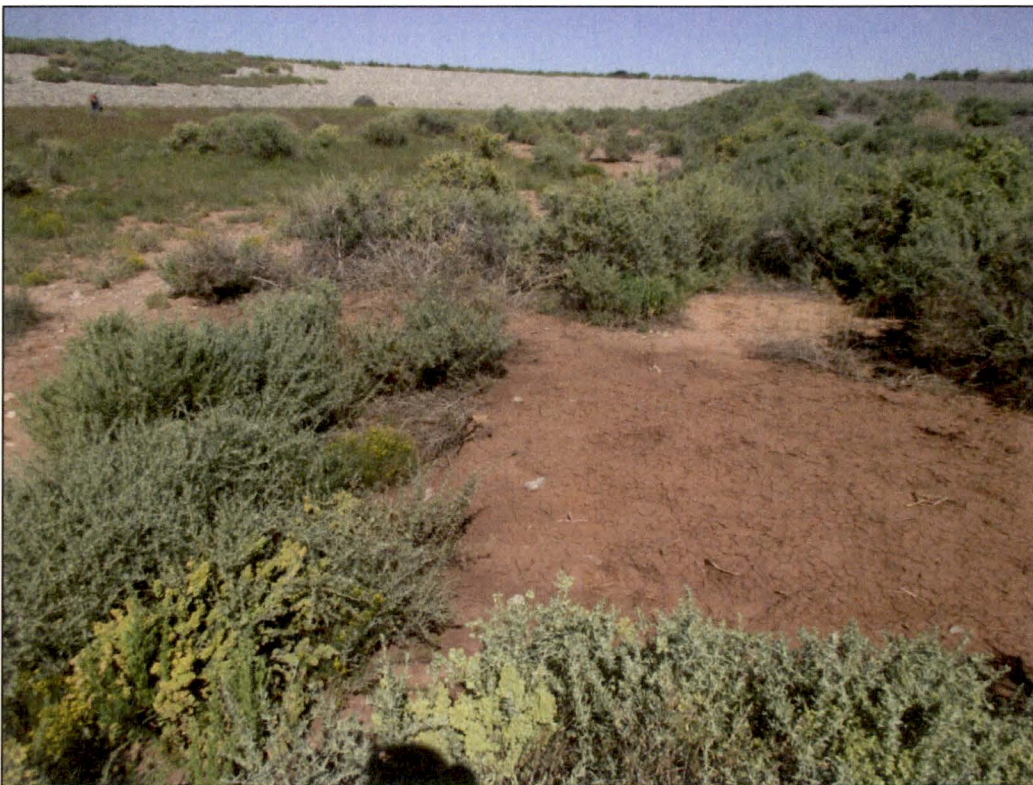
The 2-acre asbestos disposal area is a bowl-like feature just south of the carbonate tailings disposal cell (PL-13). The north, west, and south side slopes of this feature are covered by limestone riprap; the bottom of the bowl (the asbestos cell cover) is grass covered. Several small depressions were identified during the 2017 annual site inspection around the perimeter of the disposal area where relocated clean soil (placed for slope grading) and small-diameter riprap has filtered down through basalt joints and fractures. These depressions were repaired on May 22, 2018, by filling the depressions with either rock or soil, depending upon the surrounding material. These areas were inspected during the 2018 annual site inspection, and no negative impacts were observed (PL-14). No maintenance needs were identified.

PL-14. Repair of Depression in Asbestos Disposal Cell

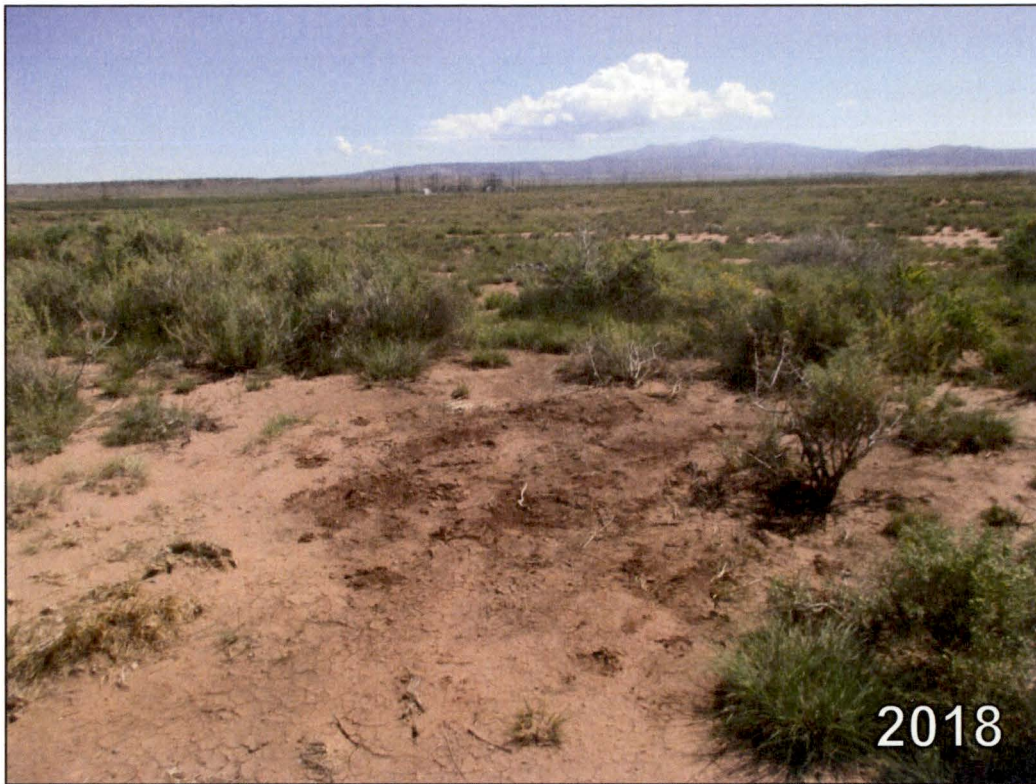
PL-17. (a) Repaired Settlement on Soil Cover of Disposal Area No. 1—September 12, 2018

- The perimeter fence was repaired at multiple locations to eliminate gaps, and a new corner post was replaced.
- Scattered tamarisk shrubs and other noxious weeds were treated with herbicide.
- Small depressions near the perimeter of the asbestos disposal area and a small settlement area on Disposal Area No. 1 were repaired.

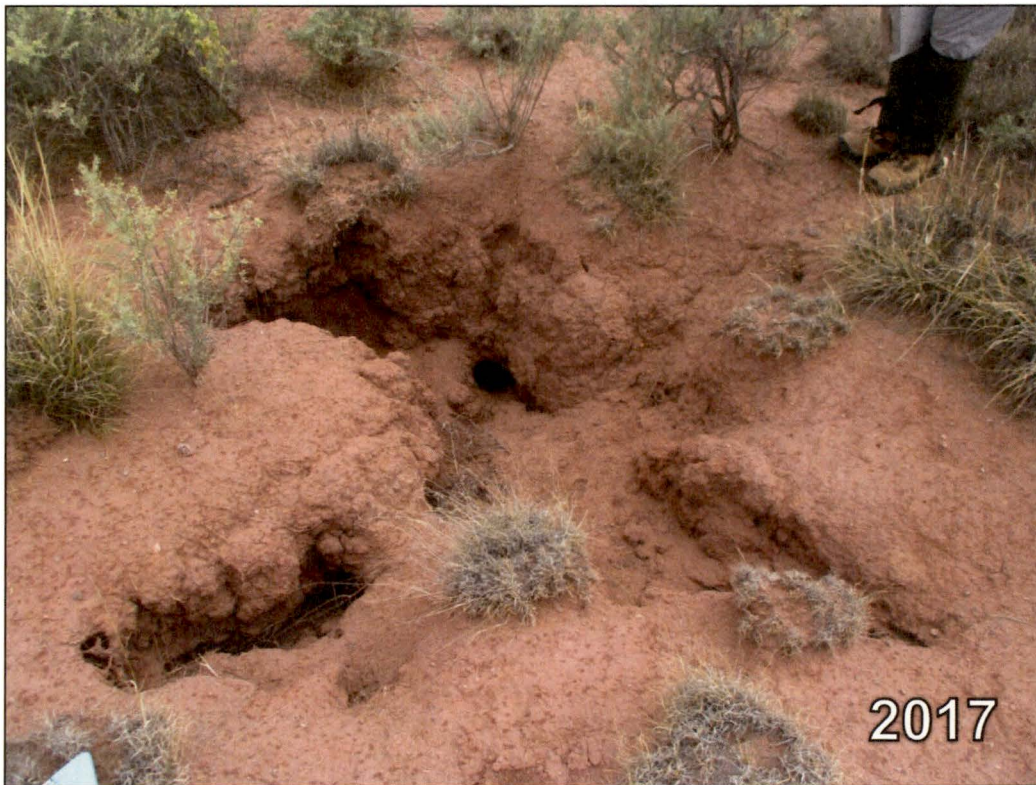
PL-17. (b) Settlement on Soil Cover of Disposal Area No. 1—2017 (Photo for Comparison)

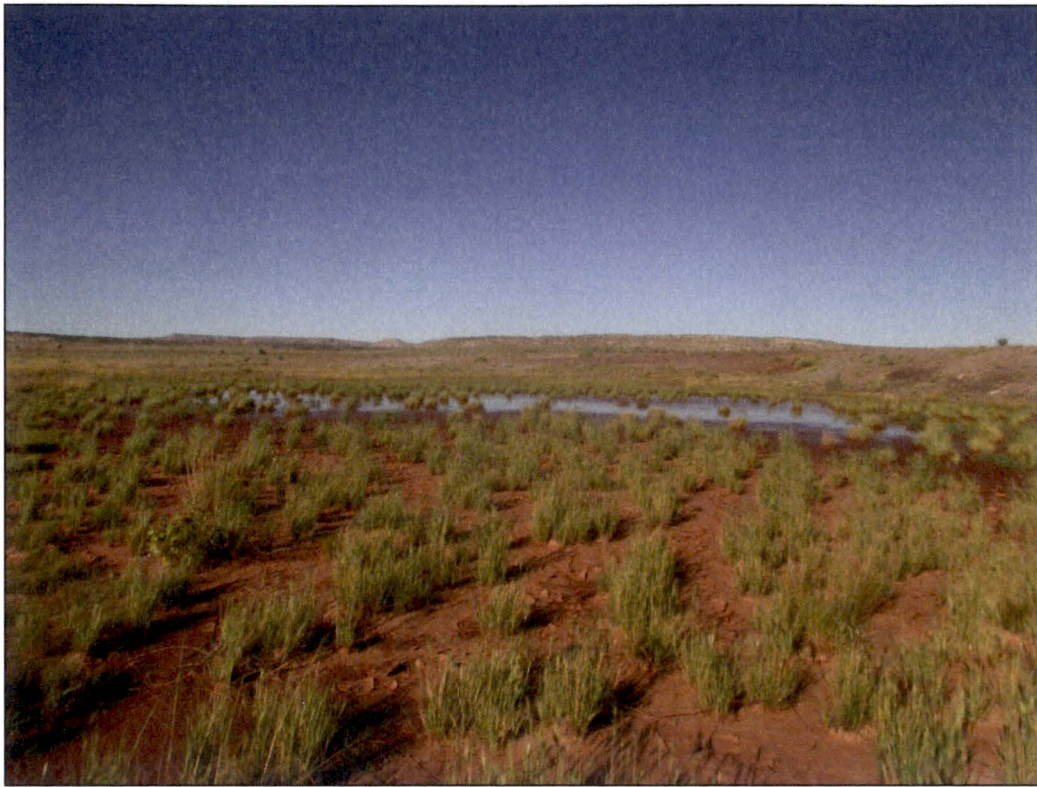
Small ponds often form in an area along the east side of the main tailings disposal cell and in other low spots following storms. The areas of ponding are far enough from the main tailings disposal cell to not impact it. Several ponds were observed in this area during the inspection (PL-18).

PL-18. Ephemeral Pond

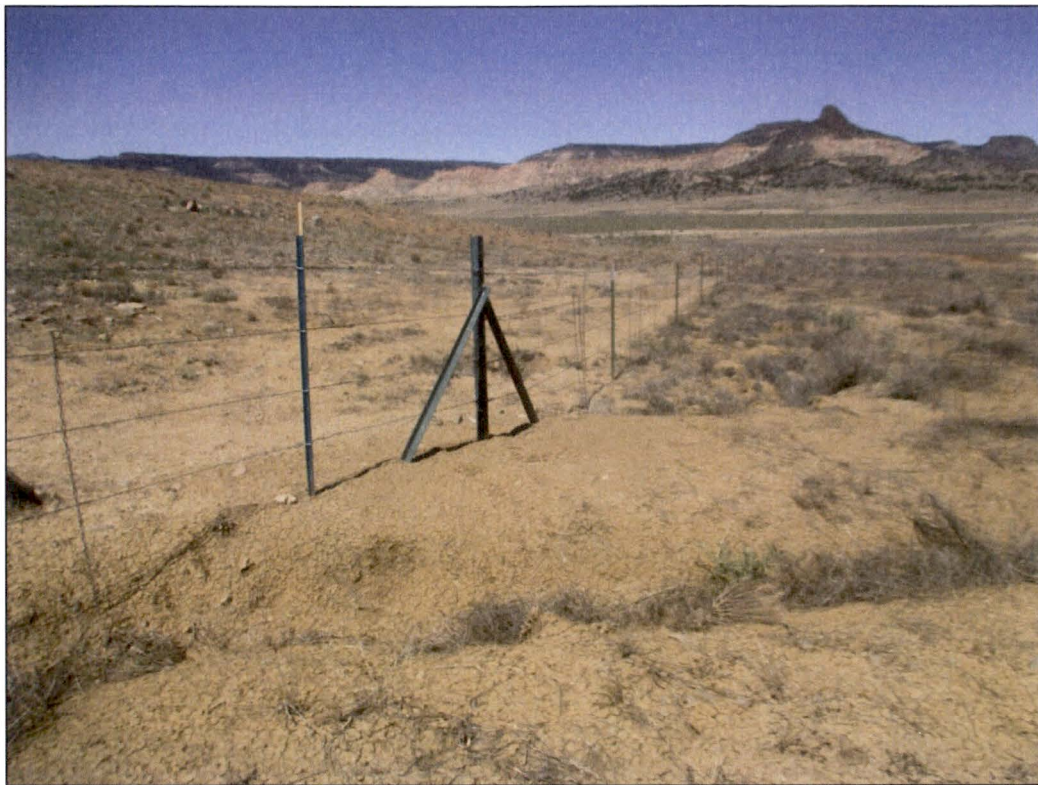
PL-1. Loose Fence Post Repair South of Perimeter Sign P33

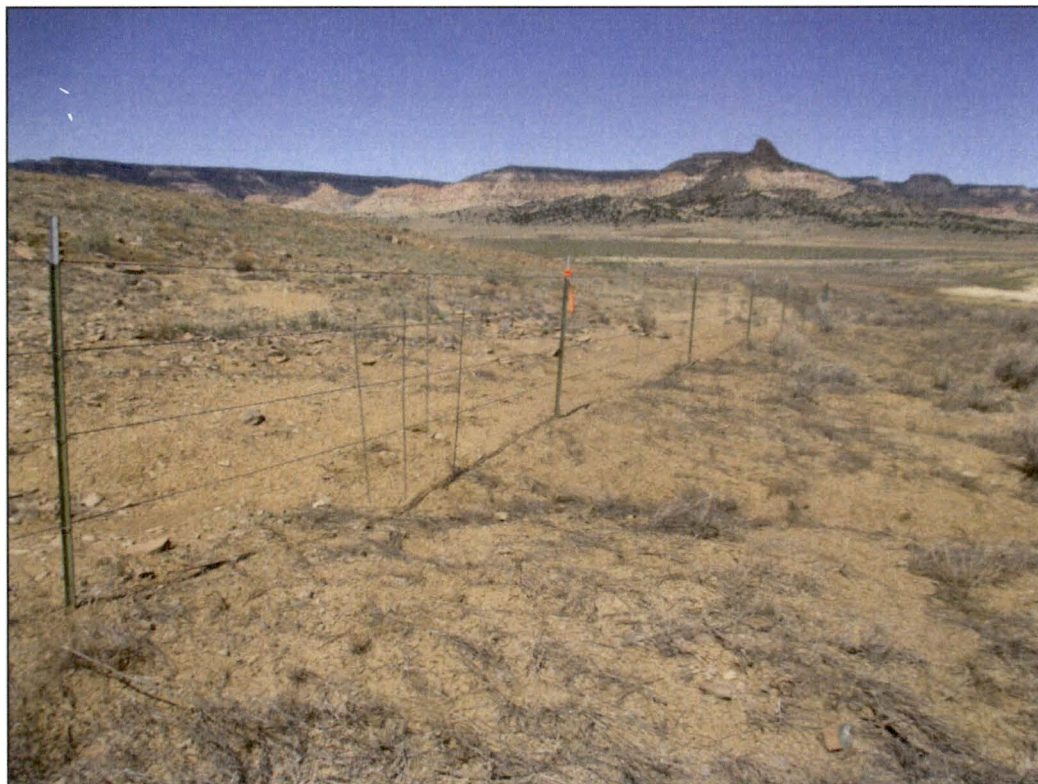
PL-2. Erosion Under Perimeter Fence and Fence Repair

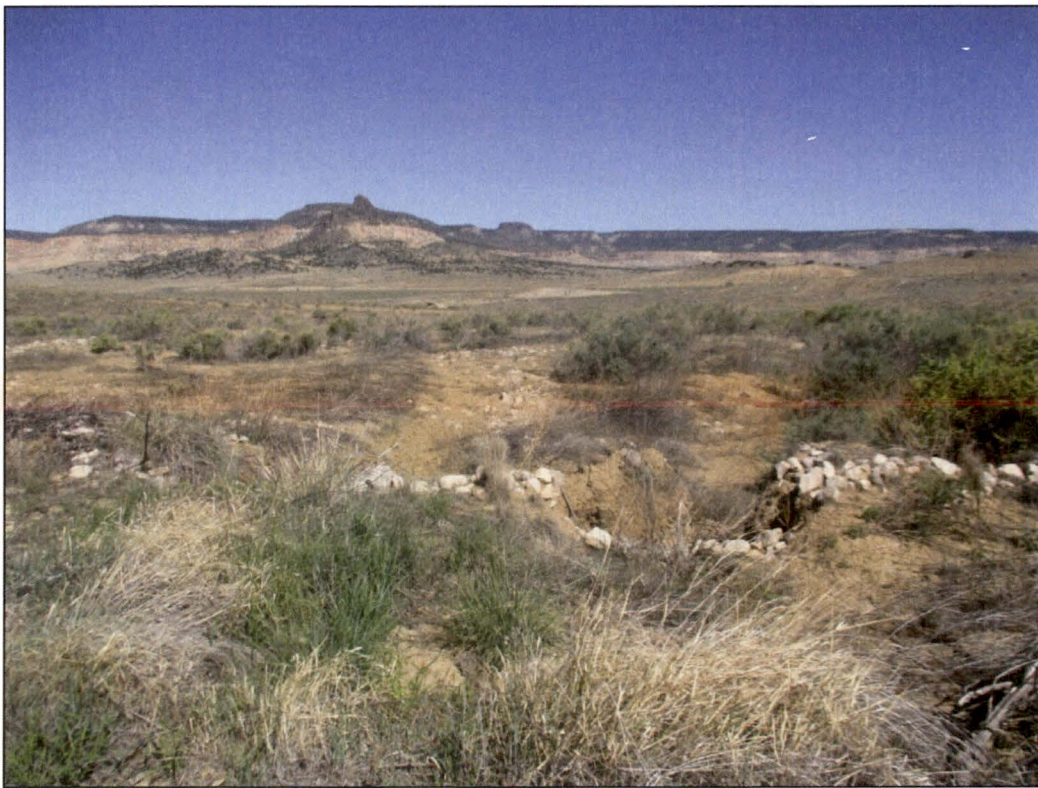
PL-12. Breach of Runoff Control Structure A Berm

- **L-Bar, New Mexico:** In 2018 LM developed conceptual designs to repair damaged erosion control structures that LM had installed in 2009. In 2019, LM will continue to work on the designs and coordinate with NRC, as needed, regarding its concurrence.

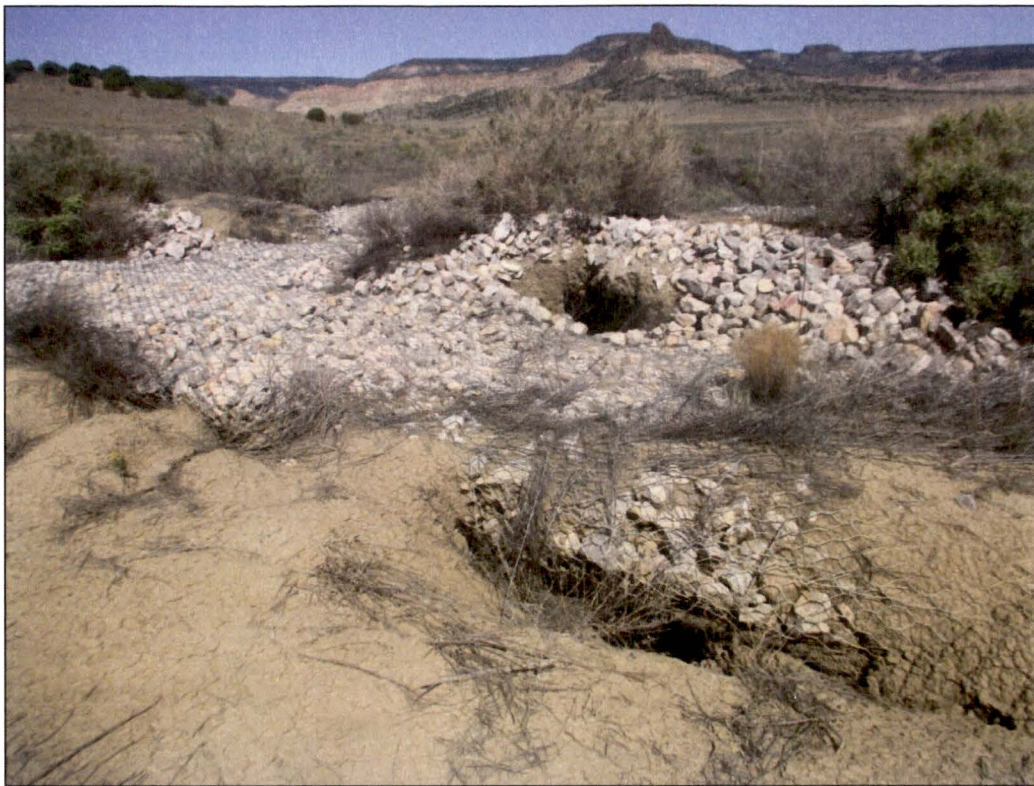
PL-13. Soil Piping Along Inlet of Runoff Control Structure A

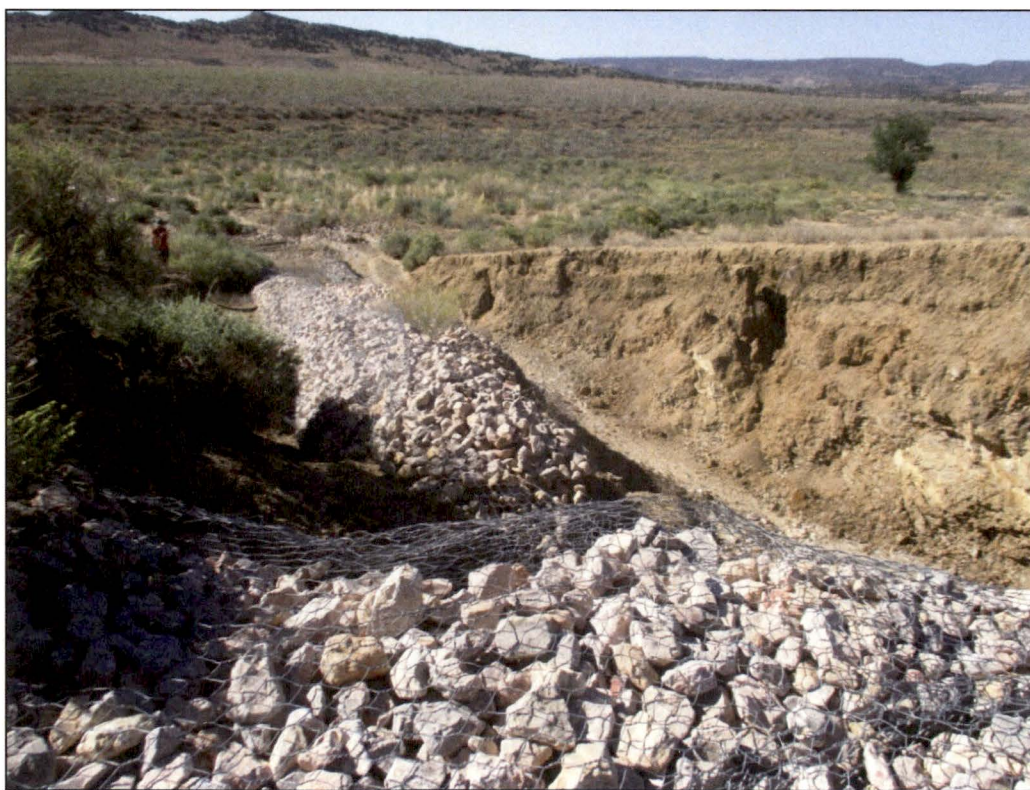
PL-16. Damaged Runoff Control Structure G

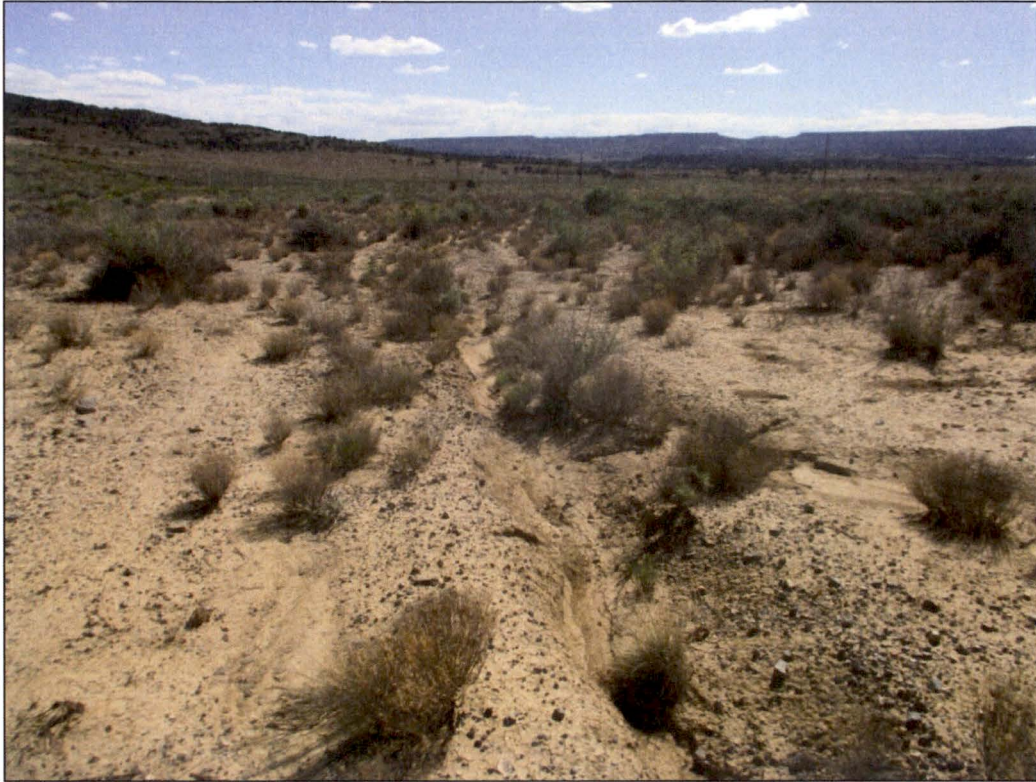
PL-17. Erosion East of Riprap Cutoff Wall at Outlet of North Channel

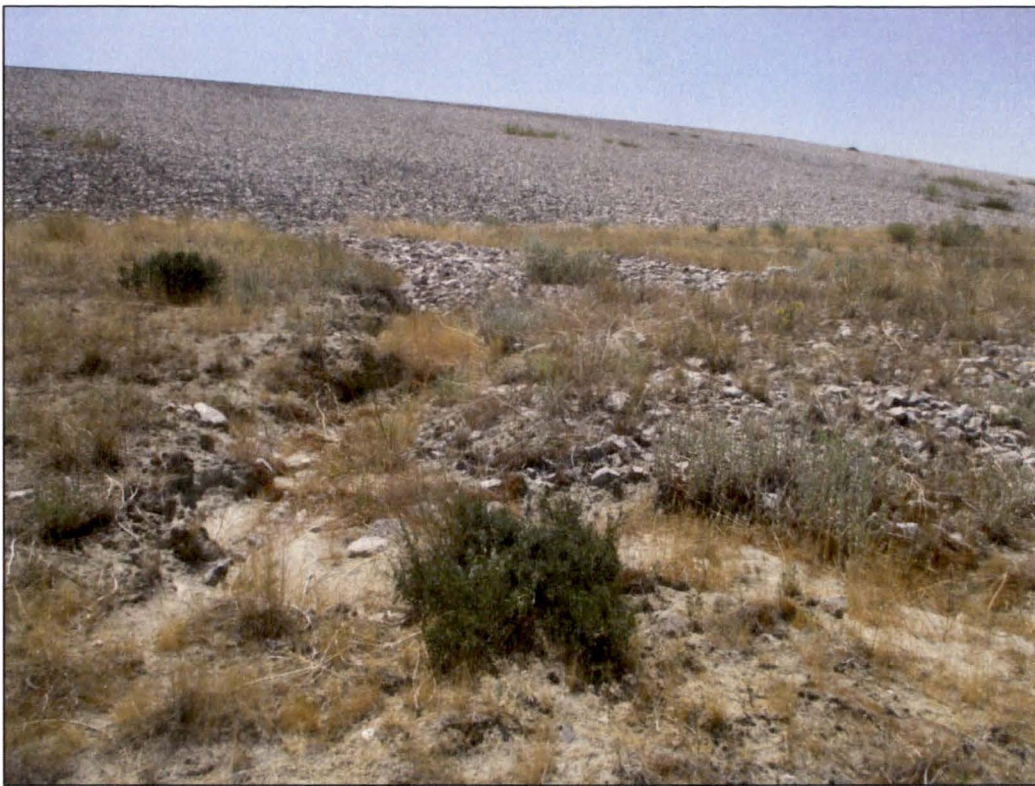
PL-11. Toe Drain on Disposal Cell North Side Slope and Adjacent Erosion

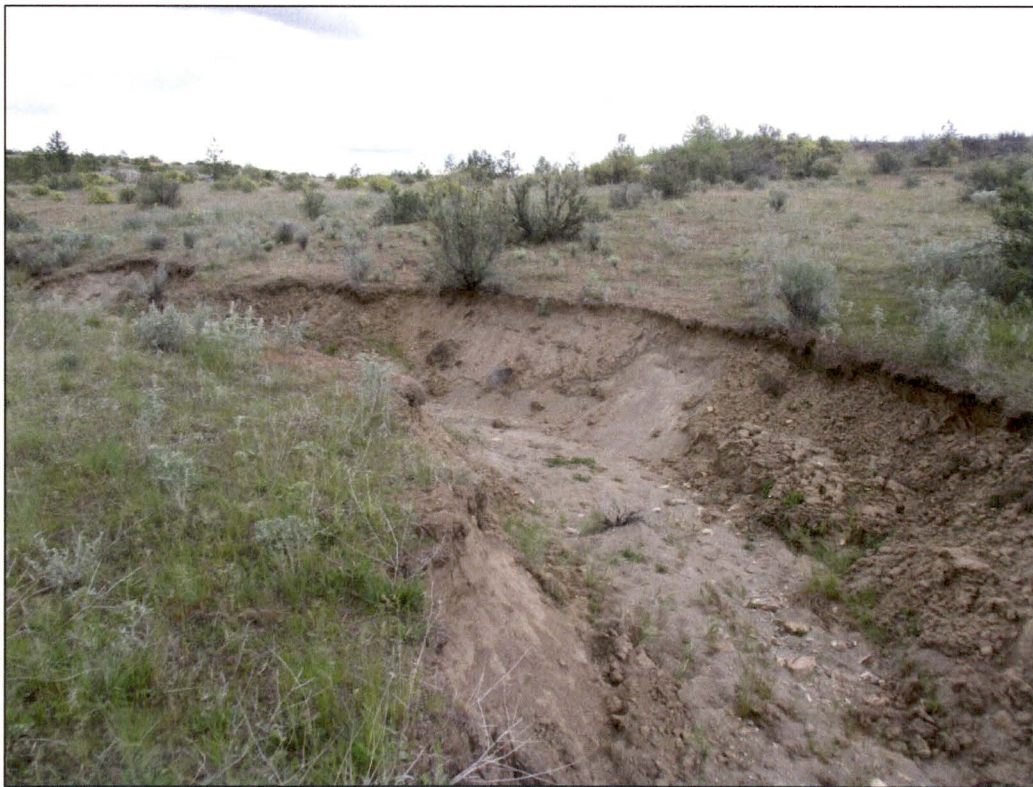
PL-4. Gully Outside Site Boundary near Perimeter Sign P1
