DOCKET 50-255 - LICENSE DPR-20 - PALISADES
PLANT - FEED-WATER LINE WATER HAMMER

EVALUATION OF
AUXILIARY FEEDWATER AND MAIN FEEDWATER
WATER HAMMER POTENTIAL AT
PALISADES PLANT

Prepared for
CONSUMERS POWER COMPANY
by
NUCLEAR SERVICES CORPORATION
Campbell, California

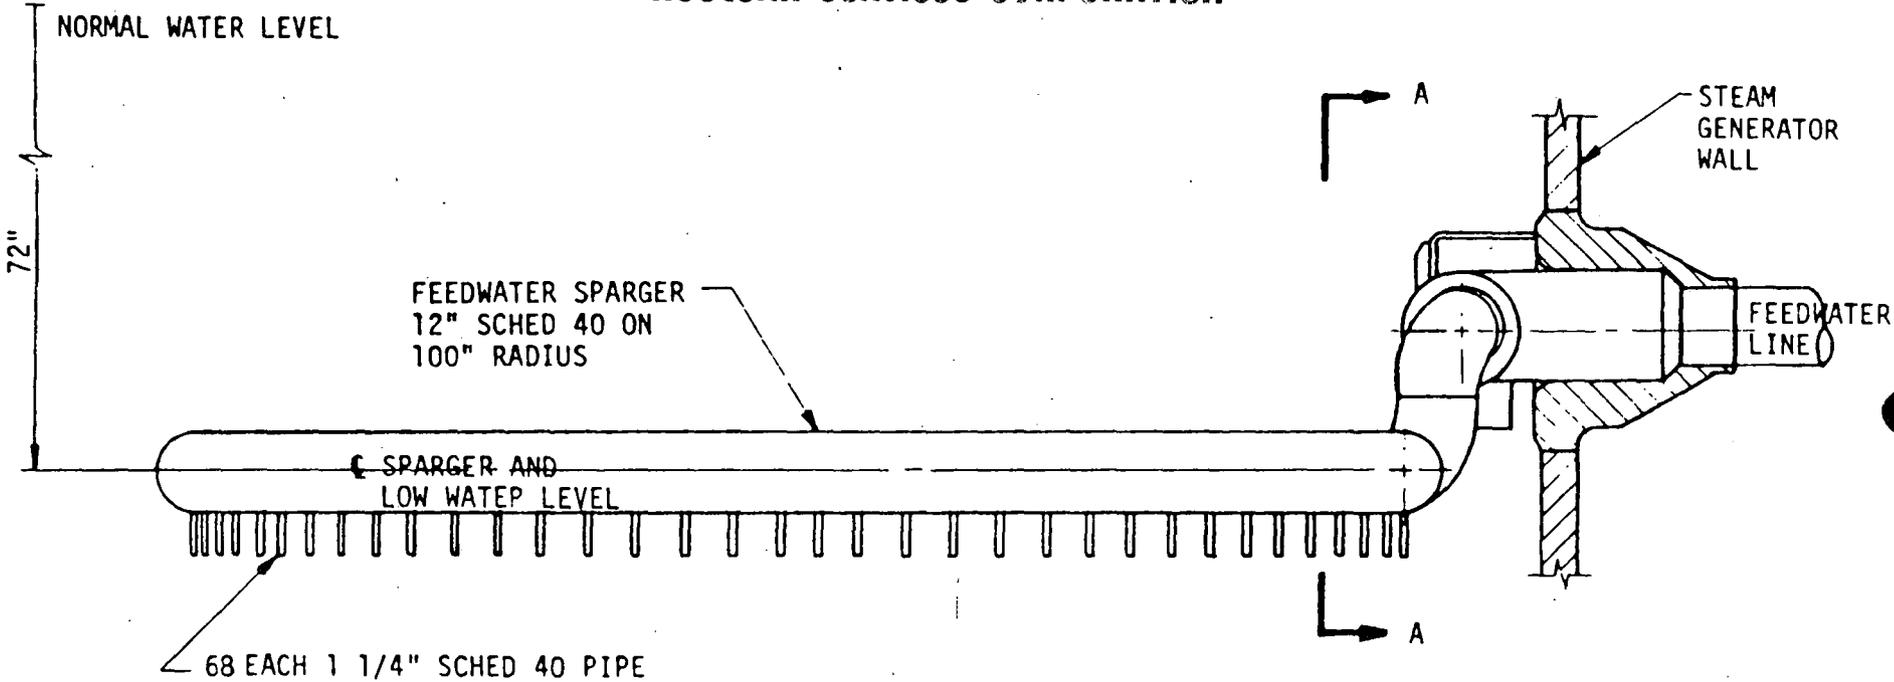
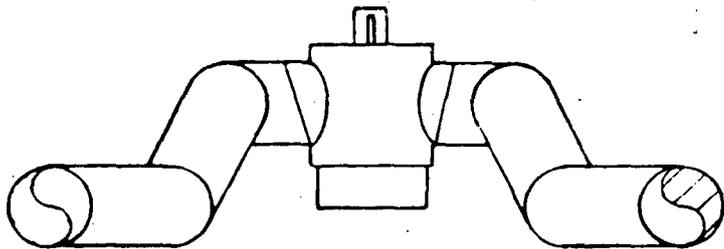
Figure 2-2. Palisades Plant
Feedwater Sparger

Inside each steam generator two 12" piping branches carry flow from the feedwater line to the feedwater sparger which is located two feet below the feedwater nozzle as shown in Figure 2-2.

The design of the Palisades feedwater and auxiliary feedwater system is similar to that of many other pressurized water reactors. The Palisades sparger, however, differs from most plants in its connection to the feedline. In the most common sparger design the sparger centerline is coincident with the feedwater line centerline as shown in Figure 3-3. The Palisades sparger is approximately two feet below the feedline and connected by two branches as shown in Figure 2-2. A study of this design indicates that it contains no unique features that will preclude the water sealing condition conducive to initiation of slugging type water hammers observed in other designs. The remainder of the sparger design is similar to that of other plants examined and should have no unique effects on the probability of water hammer occurrence.

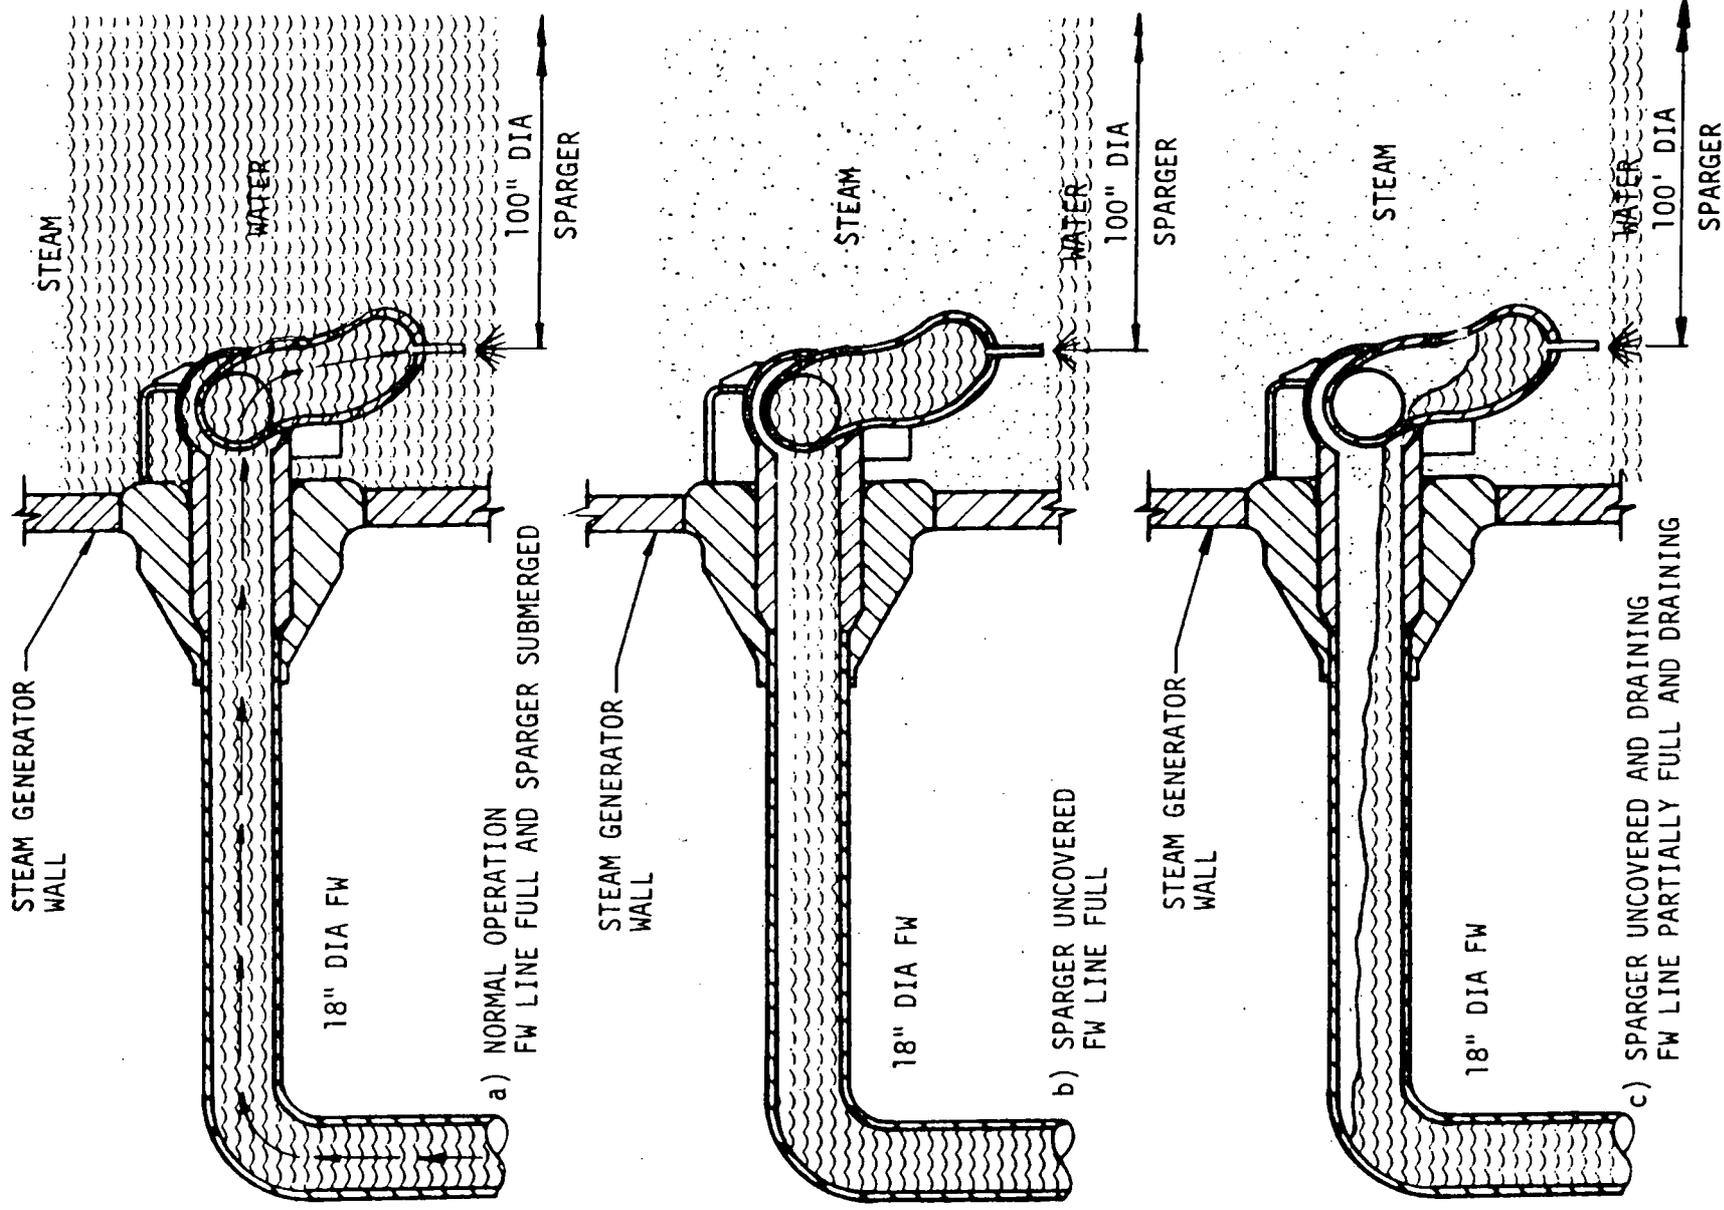
Figure 3-1. Palisades Plant
 Sheet 1 Feedwater Sparger Conditions
 Following Level Drop

Insufficient data is available to quantitatively identify all parameters and mechanisms conducive to the steam-water slugging water hammer occurrence. However, a mechanism as discussed below is generally accepted as the mechanism for water hammer occurrence. Figure 3-1 shows the sequence of events in the vicinity of the sparger which leads to the uncovering of the sparger and subsequent draining of the feedwater line prior to steam generator water level recovery. Figures 3-2a and 3-2b show the feedline conditions prior to and at the start of feedline slug formation, respectively. The slug seals the main feedwater line and prevents the normal flow of steam from the steam generator to replenish the entrapped steam being condensed by the cold water layer. As steam is condensed at the steam-water interface, the pressure of the entrapped steam drops, accelerating the water slug away from the steam generator, as shown in Figure 3-2c and 3-2d. As the

If the level in a steam generator has been below the feedwater sparger center line for more than one minute, new operating procedures will limit flow to the uncovered sparger to less than 100 gpm until the steam generator is above the top of the main feedline.

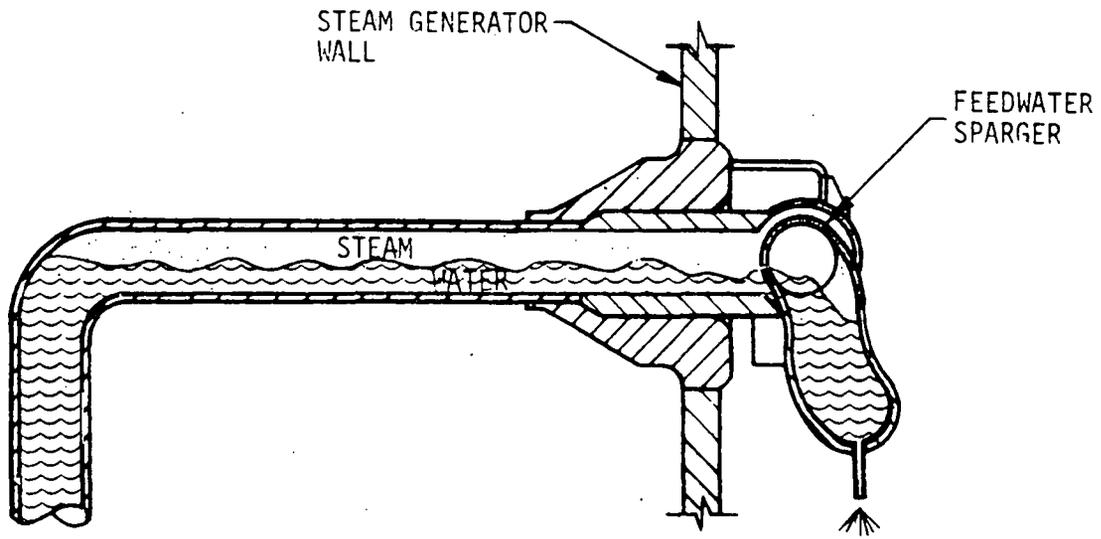
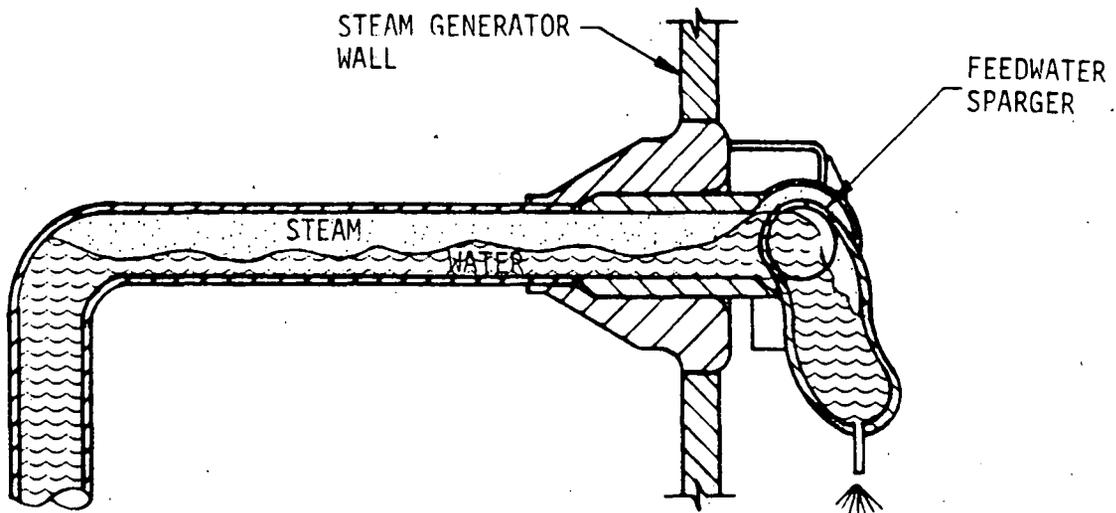
Figure 3-2. Palisades Plant
Sheet 1 Postulated Slug Formation
In Feedwater Line

a) FEEDWATER LINE RUNNING PARTIALLY FULL

b) START OF SLUG FORMATION
PIPE IS SEALED BY SLUG

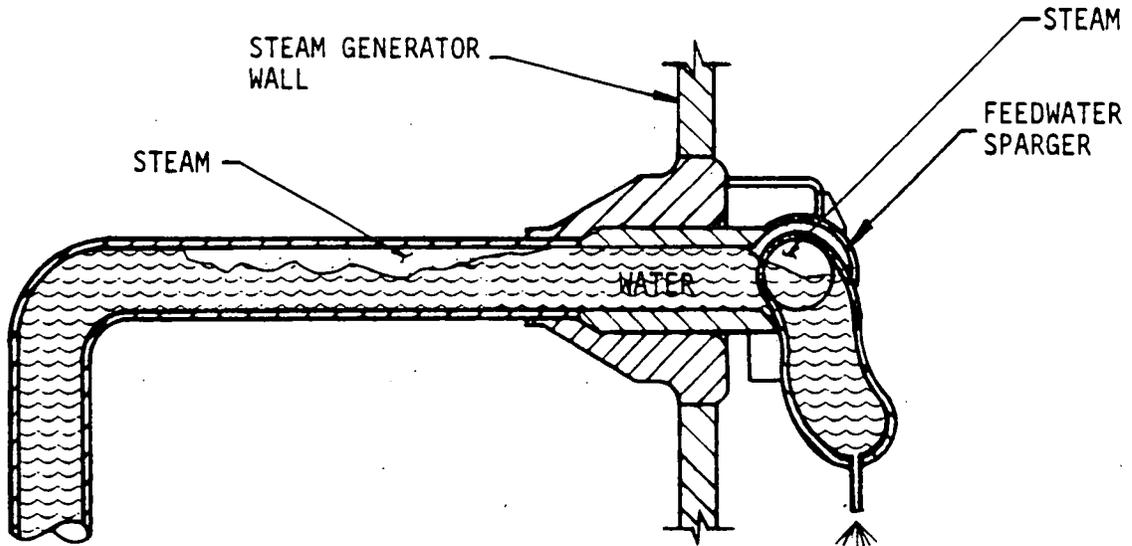
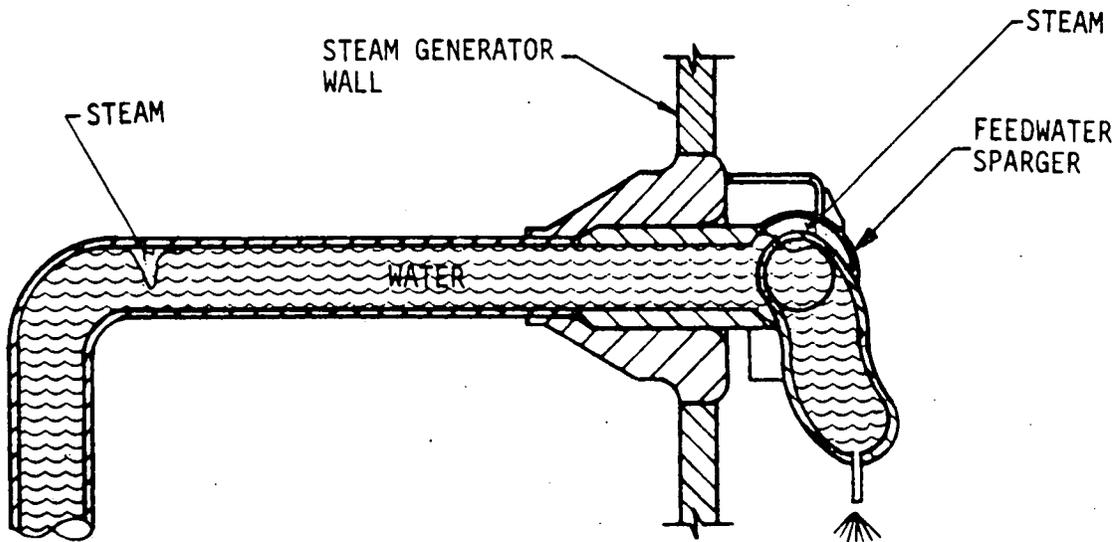
Figure 3-2. Palisades Plant
Sheet 2. Postulated Slug Formation
In Feedwater Line

pressure continues to drop, more feedwater flow is accelerated into the entrapped steam bubble increasing the depressurization process until the bubble eventually reaches zero pressure. The slug continues to travel down the feedline until it impacts the column of feedwater upstream of the bubble as shown in Figure 3-2d. The rapid deceleration of the slug causes an overpressure spike to form. This pressure wave is then propagated down the piping.

c) SLUG BEING ACCELERATED THRU FEEDWATER LINE AS STEAM BUBBLE IS BEING DEPRESSURIZED

d) FEED LINE CONDITIONS PRIOR TO SLUG IMPACT
