**Consumers
Power
Company**

DOCKET 50-255 - LICENSE DPR-20 -
PALISADES PLANT - STEAM GENERATOR -
SUPPORT PLATE CRACKING

INVESTIGATION FOR STEAM GENERATOR
SUPPORT PLATE CRACKING AT PALISADES
DURING FEBRUARY 1978

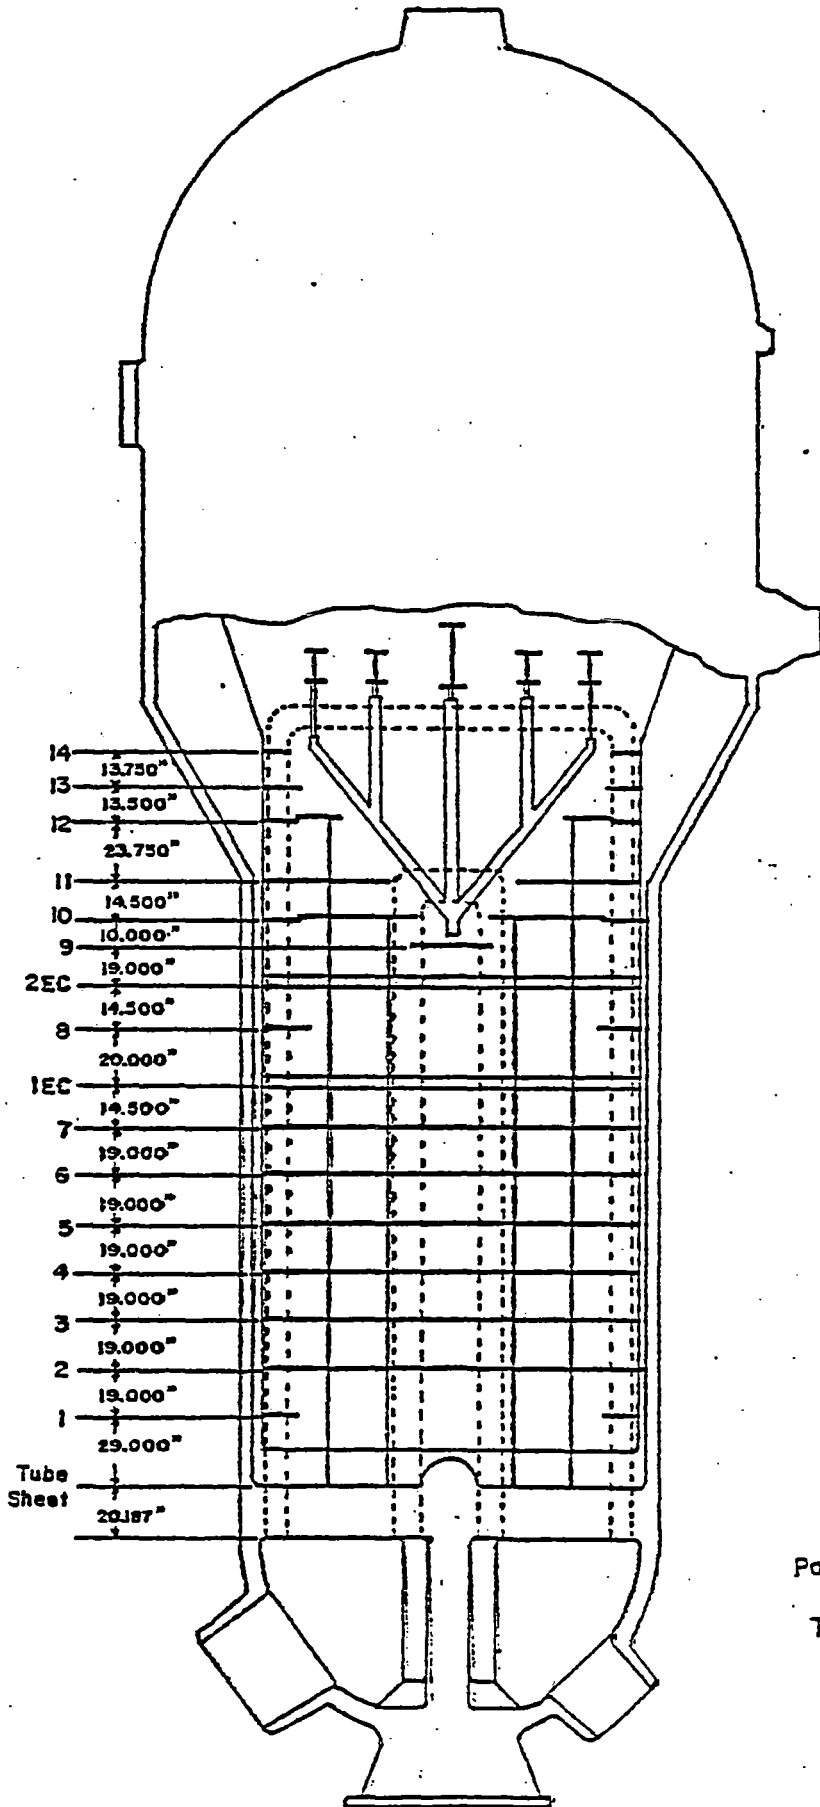
FIGURE 2 -
 STEAM GENERATOR.
 SUPPORT LOCATIONS

Tube blockage was found at only three tube locations - Quad II and III, Line 5, Row 114 and Quad III, Line 14, Row 85. All tubes are located in steam generator A and appear blocked at the eleventh (11) support plate. Figure 2 illustrates the relative location of this support plate in the Palisades steam generator design. A subsequent retest of two tubes using a 0.470 inch probe resulted in the smaller diameter probe passing through tube L14, R85.
