**Summary Report and Analysis of Data from Operating Experience Smart Sample,  
OpESS 2018/01, “Evaluation of Licensee Actions Taken in Response to 10 CFR Part 21  
Notification of the Potential Existence of Defects Related to Control Rod Drive  
Mechanism (CRDM) Thermal Sleeves”**

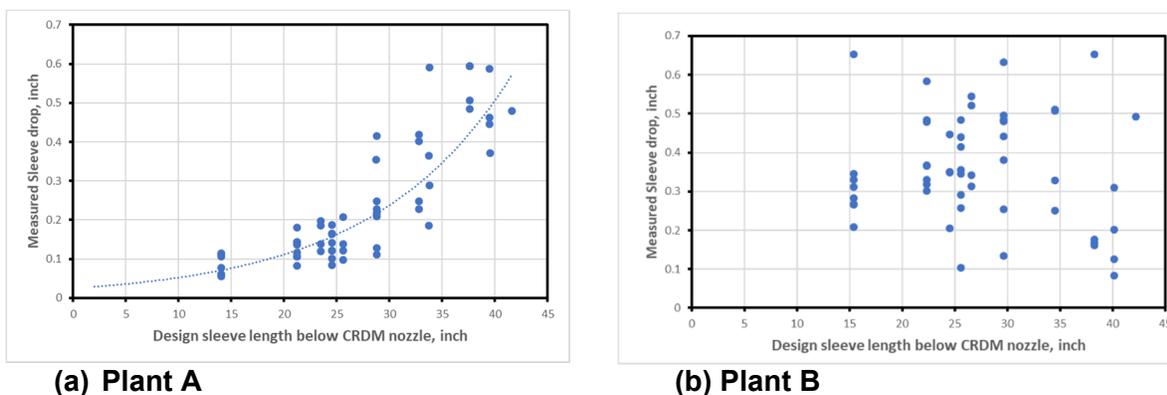
Figure 1 Thermal sleeve wear measurements

Through the smart sample, the staff obtained CRDM thermal sleeve measurement data. This data includes either design or as-built CRDM thermal sleeve elevation measurements and to-date elevation measurements for each CRDM thermal sleeve in the units. The regional inspection team supplied this data to headquarters in tabular form. Using this data, staff investigated the trends of wear relative to the location of the wear. From the sample of 10 Tier 1 plants, the NRC staff recognized two different trends in the data. Figure 1 illustrates these two trends:

Note that the thermal sleeves near the top of the head have a greater portion of the thermal sleeve exposed to cross flow than the thermal sleeves on the periphery of the head. The “design sleeve length,” on the above graphs corresponds to the length of the thermal sleeve that is exposed. In some cases, a clear trend with location is seen—more wear occurred near the center of the head. In other cases, the wear appeared location independent. It is currently unknown why these differences occurred.

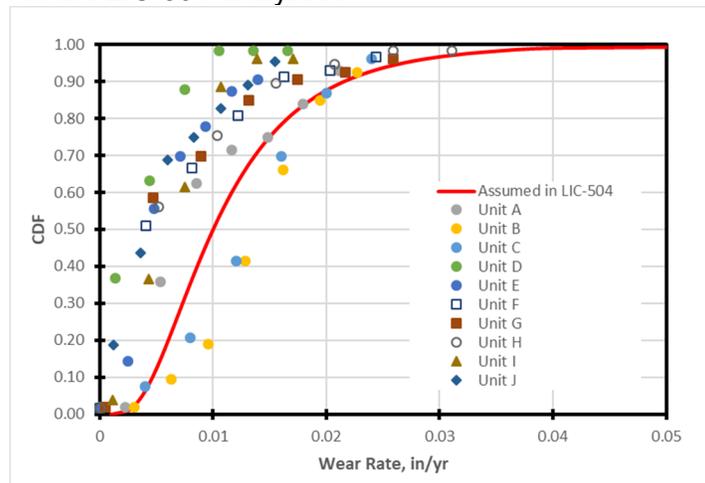
**Figure 2 Comparison of smart sample wear rates and assumption in LIC-504 analysis**

Even though this data only represents one point in time, a wear rate can be estimated from this data and the design or as-built conditions. These wear rates can then be displayed as a cumulative distribution function and compared against what was used in the LIC-504 analyses [2] as shown in Figure 2. In this figure, the different color circles represent the data<sup>1</sup> from the sampled plants, while the solid red line represents the distribution assumed in the LIC-504 analyses [2]. Data that falls above and to the left of the red line is considered conservative and data that falls below and to the right is considered nonconservative. It is suspected that the nonconservative values would produce probabilities of failure that are higher than those calculated in the LIC-504 analyses.

From Figure 2, most of the collected data falls above the assumption used in the LIC-504 analyses. Of the two plants that fall below the curve, the difference is relatively small.

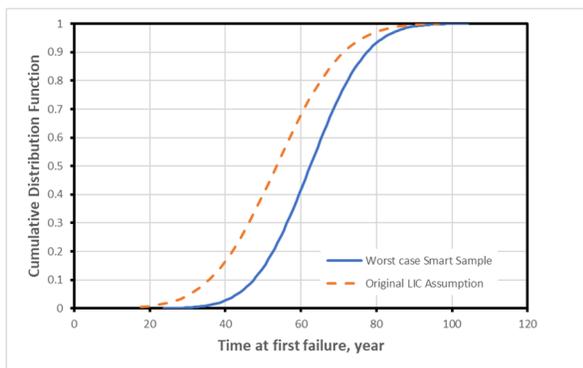
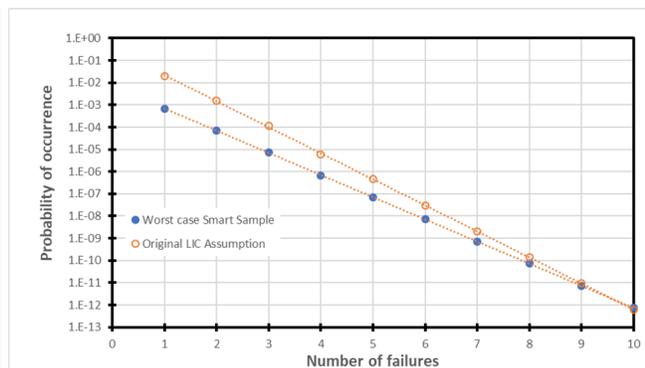
**Figure 3 Probability of failure comparison**

Taking the worst-case wear data, the staff conducted an analysis to compare the probability of failure results with those in the LIC-504 analysis. Using the same analysis procedure as in the LIC-504 [2], staff calculated the probability of failure shown in Figure 3.

In these figures, the orange open circles represent the results presented in the LIC-504 analysis, while the blue solid circles represent the results using the worst-case wear rate in Figure 2. Surprisingly, even though the wear-rate data appears to be nonconservative, the probability of failure numbers are conservative compared to those in the LIC-504 analyses. The reason for this behavior becomes clear when the worst-case data is investigated more closely. See Figure 4.

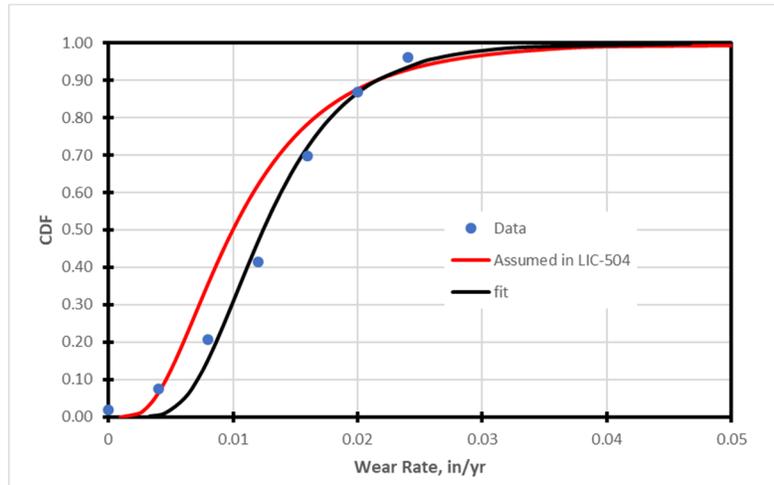
**Figure 4 Comparison of worst case wear rate data with LIC-504 assumption**

Figure 4 shows the worst-case wear data and its fit compared with the assumption used in the LIC-504 analyses. While most of the data is nonconservative with respect to the LIC-504 assumption, the data at the high wear rates are conservative (i.e., the data above 90 percent probability falls above the assumption in the LIC-504 analyses). Since the probability of first thermal sleeve failure is driven by the upper tail of the wear rate distribution, the data and fit shown in Figure 4 would produce probability a first failure greater than that from the LIC-504 analyses. In looking at the data in Figure 2, the maximum measured wear rate was 0.030 inches/year with all of the high wear rate data falling above the assumption made in the LIC-504 analyses.
