**Summary Report and Analysis of Data from Operating Experience Smart Sample,
OpESS 2018/01, “Evaluation of Licensee Actions Taken in Response to 10 CFR Part 21
Notification of the Potential Existence of Defects Related to Control Rod Drive
Mechanism (CRDM) Thermal Sleeves”**

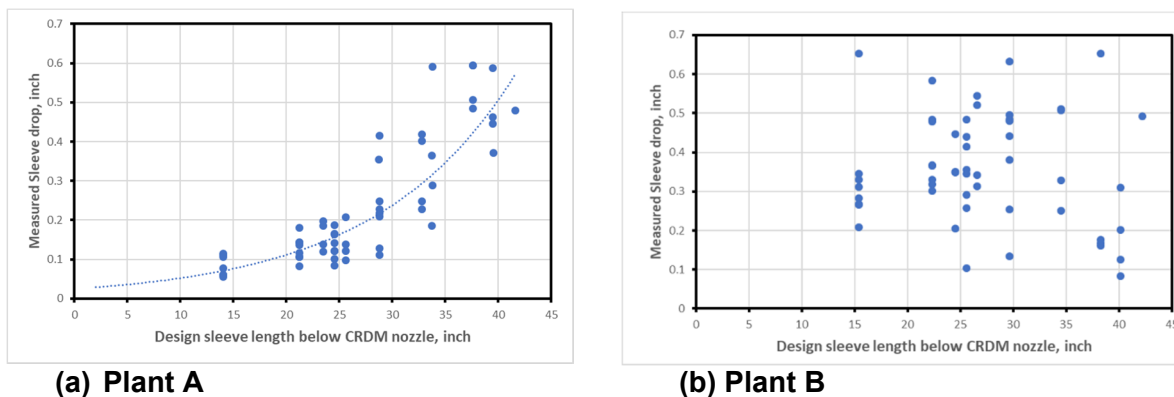
Figure 1 Thermal sleeve wear measurements

Note that the thermal sleeves near the top of the head have a greater portion of the thermal sleeve exposed to cross flow than the thermal sleeves on the periphery of the head. The “design sleeve length,” on the above graphs corresponds to the length of the thermal sleeve that is exposed. In some cases, a clear trend with location is seen—more wear occurred near the center of the head. In other cases, the wear appeared location independent. It is currently unknown why these differences occurred.

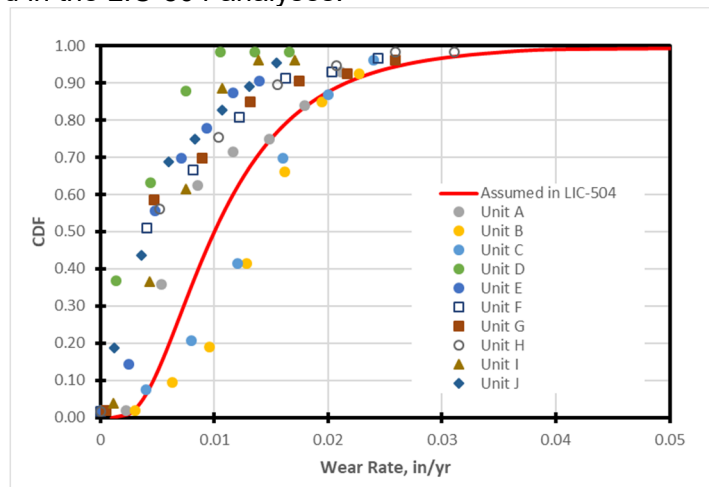
Figure 2 Comparison of smart sample wear rates and assumption in LIC-504 analysis

Even though this data only represents one point in time, a wear rate can be estimated from this data and the design or as-built conditions. These wear rates can then be displayed as a cumulative distribution function and compared against what was used in the LIC-504 analyses [2] as shown in Figure 2. In this figure, the different color circles represent the data¹ from the sampled plants, while the solid red line represents the distribution assumed in the LIC-504 analyses [2]. Data that falls above and to the left of the red line is considered conservative and data that falls below and to the right is considered nonconservative. It is suspected that the nonconservative values would produce probabilities of failure that are higher than those calculated in the LIC-504 analyses.

From Figure 2, most of the collected data falls above the assumption used in the LIC-504 analyses. Of the two plants that fall below the curve, the difference is relatively small.

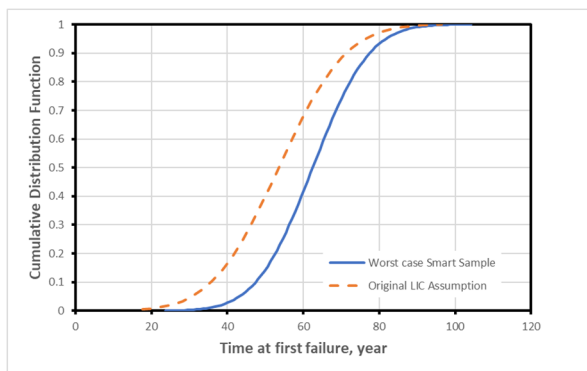
(a) First thermal sleeve failure

In these figures, the orange open circles represent the results presented in the LIC-504 analysis, while the blue solid circles represent the results using the worst-case wear rate in Figure 2. Surprisingly, even though the wear-rate data appears to be nonconservative, the probability of failure numbers are conservative compared to those in the LIC-504 analyses. The reason for this behavior becomes clear when the worst-case data is investigated more closely. See Figure 4.

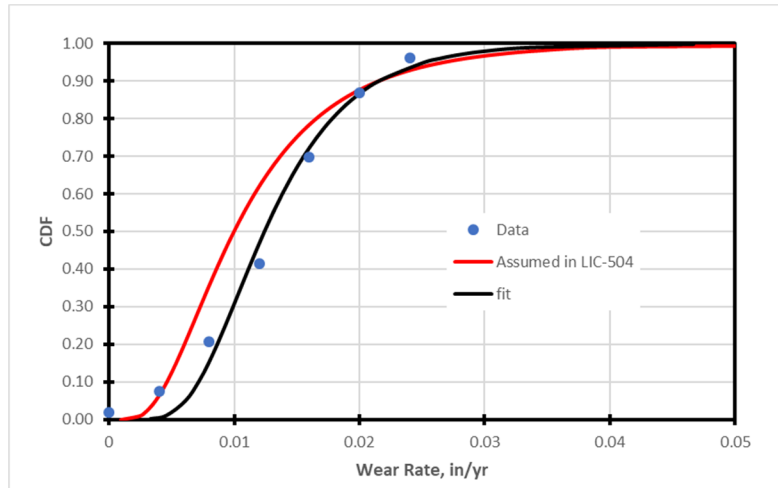
Figure 4 Comparison of worst case wear rate data with LIC-504 assumption

Figure 4 shows the worst-case wear data and its fit compared with the assumption used in the LIC-504 analyses. While most of the data is nonconservative with respect to the LIC-504 assumption, the data at the high wear rates are conservative (i.e., the data above 90 percent probability falls above the assumption in the LIC-504 analyses). Since the probability of first thermal sleeve failure is driven by the upper tail of the wear rate distribution, the data and fit shown in Figure 4 would produce probability a first failure greater than that from the LIC-504 analyses. In looking at the data in Figure 2, the maximum measured wear rate was 0.030 inches/year with all of the high wear rate data falling above the assumption made in the LIC-504 analyses.
