CAMECO RESOURCES
CROW BUTTE OPERATION
86 Crow Butte Road
P.O. Box 169
Crawford, Nebraska 69339-0169

February 12, 2019

Subject: Potential Spill Impacting Surface or Groundwater

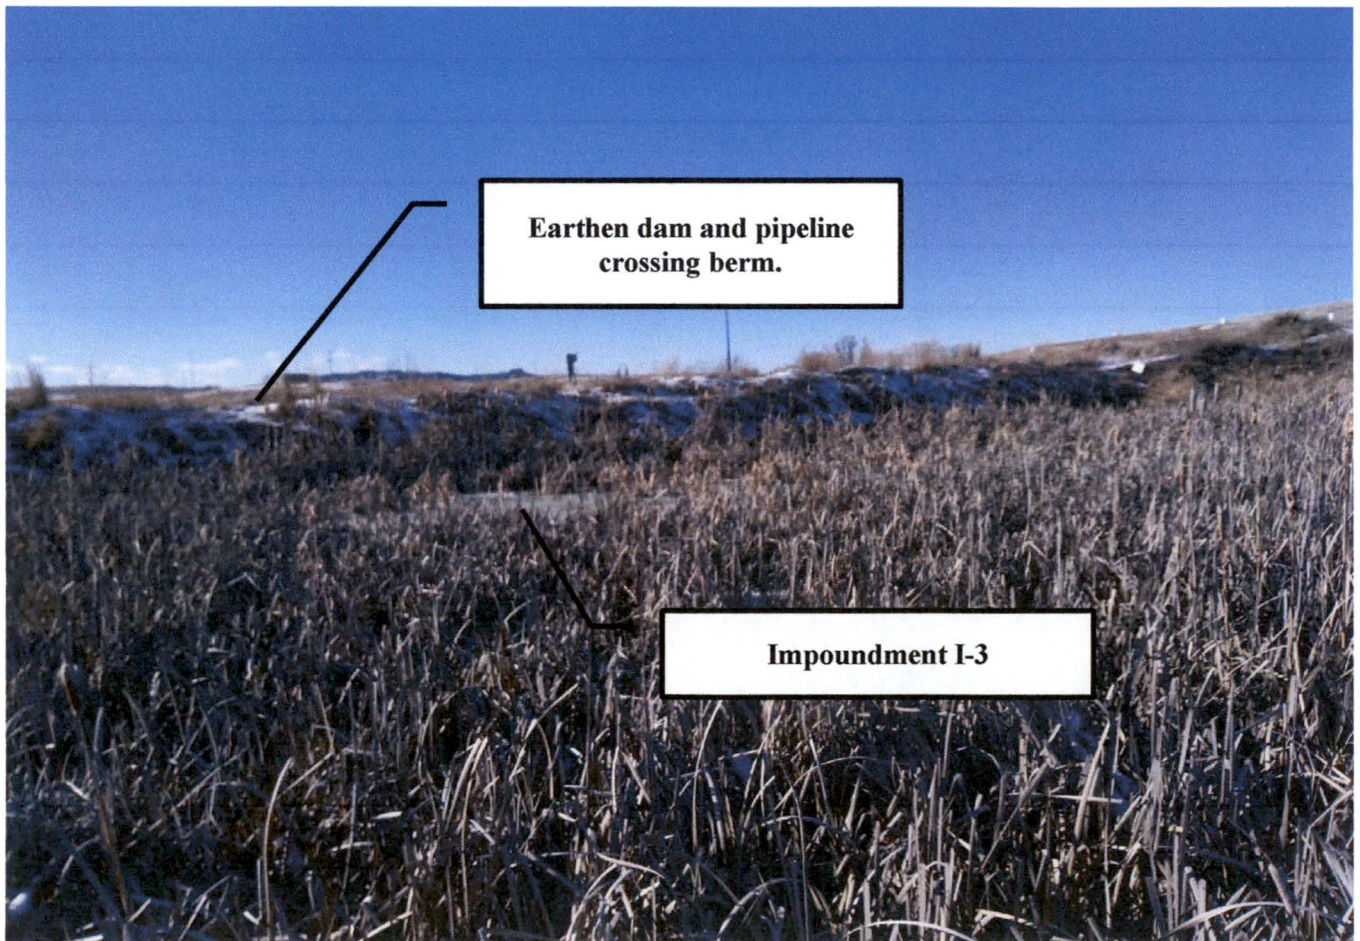
This photo depicts the English Creek crossing from the upstream side.

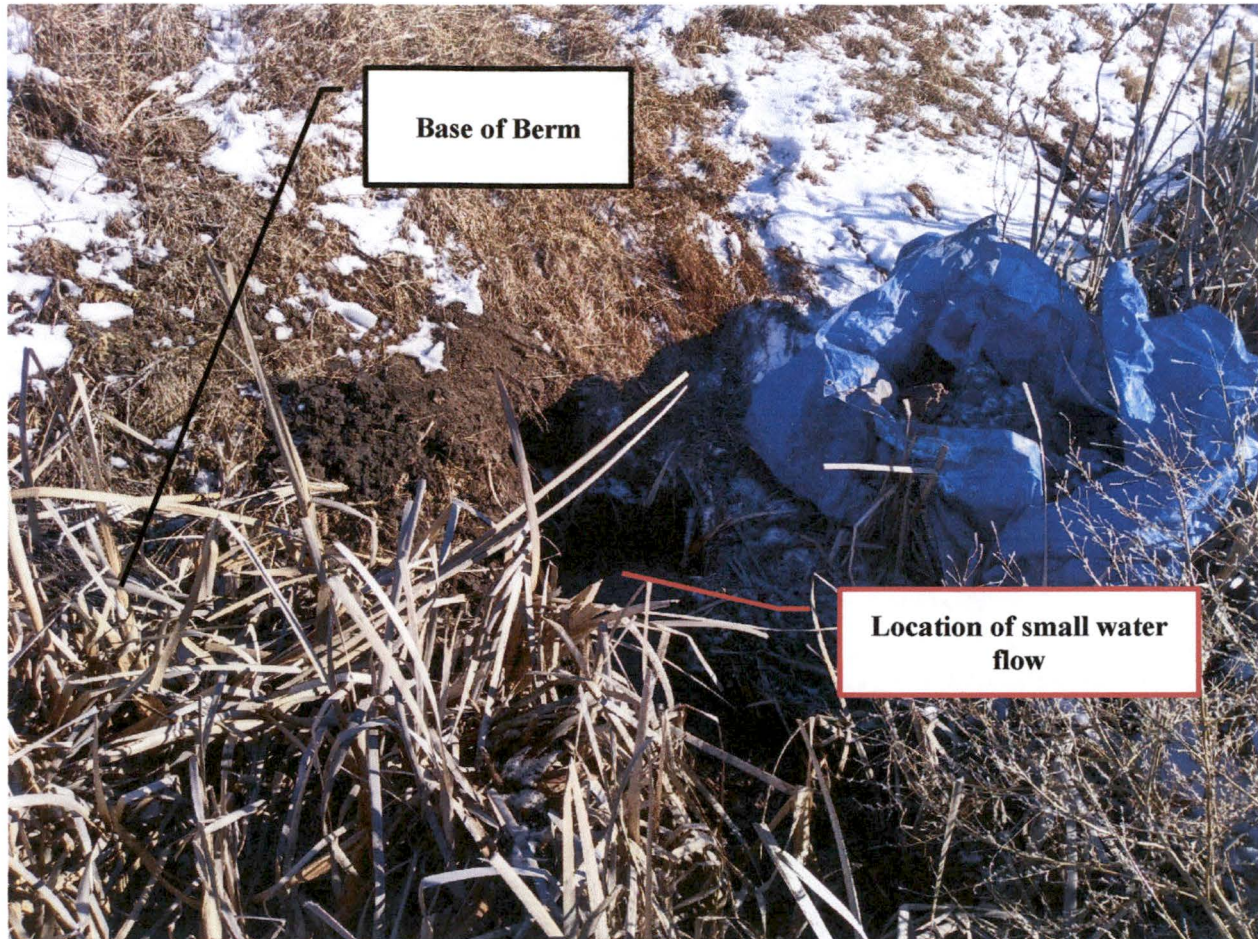
On Monday, February 11, 2019, CBO continued to investigate the cause of the wet crossing alarm and the source of the small flow of water that was identified at the base of the crossing. Even though north wellfield flow was shut off and the crossing pipe was isolated from the main pipeline following the alarm, the small flow continued throughout the weekend, indicating that the source of the flow was not likely to be a pipeline failure. CBO successfully pressure tested the English Creek crossing pipe, demonstrating pipeline integrity. The nearest, downstream shallow monitor well, SM8-15, was sampled and no impact was indicated by the results of the sample. A small amount of fluid was collected from the secondary pipe at the English Creek crossing, and this fluid had a conductivity of 1161 μmhos , consistent with condensation from the primary pipe that was impacted by the bentonite contained in the secondary pipe, and significantly less than the conductivity of the fluid in the primary pipe (~4000 μmhos). A hole was made in the ice on Impoundment I-3, immediately upstream of the crossing, and a sample was collected. The conductivity of this sample was 715 μmhos . Based on this evidence, CBO concluded that the cause of the wet crossing alarm was condensate from the primary pipe in the English Creek crossing, trapped in the secondary containment pipe. The source of the small water flow at the base of the crossing is a small, natural, ephemeral spring, not a pipeline failure as was originally suspected and reported.

This photo depicts the small flow of water located on the downstream side of the berm after some of the soil around the flow had been removed to try to determine its source.
