**Report No. 10CFR21-0124**  
**Rev. 0: 03/21/19**

**10CFR21 REPORTING OF DEFECTS  
AND NON-COMPLIANCE**

**COMPONENT:** Excitation Transformers for Vickers Voltage Regulator System

**SYSTEM:** Emergency Diesel Generator – Voltage Regulator System

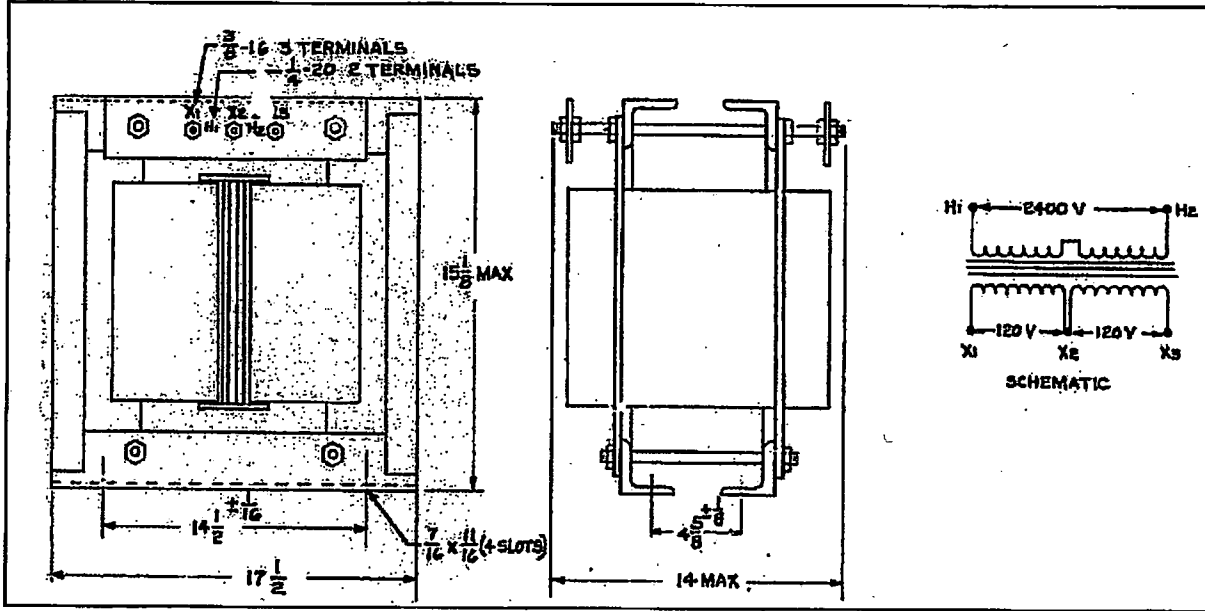
Figure 2: EPT Outline Drawing

<b>Part Number</b>	<b>Device</b>	<b>Description of Defect</b>
<i>8408213-ESI</i>	<i>PCT</i>	<i>Insufficient core gap.</i>
<i>8408218-ESI</i>	<i>Reactor</i>	<i>Differences in coil winding and core lamination from original design.</i>
<i>8411387-ESI</i>	<i>EPT</i>	<i>Incorrect polarity.</i>

Three single-phase EPTs are wye connected on the primary and delta connected on the secondary. Per the system design, EPT primary H1 should have the same polarity of EPT secondary X1. Contrary to this requirement, EPT primary H1 has the same polarity as secondary X3.

*Return to ESI for rework to have EPT primary terminal markings (H1 & H2) re-labeled.*

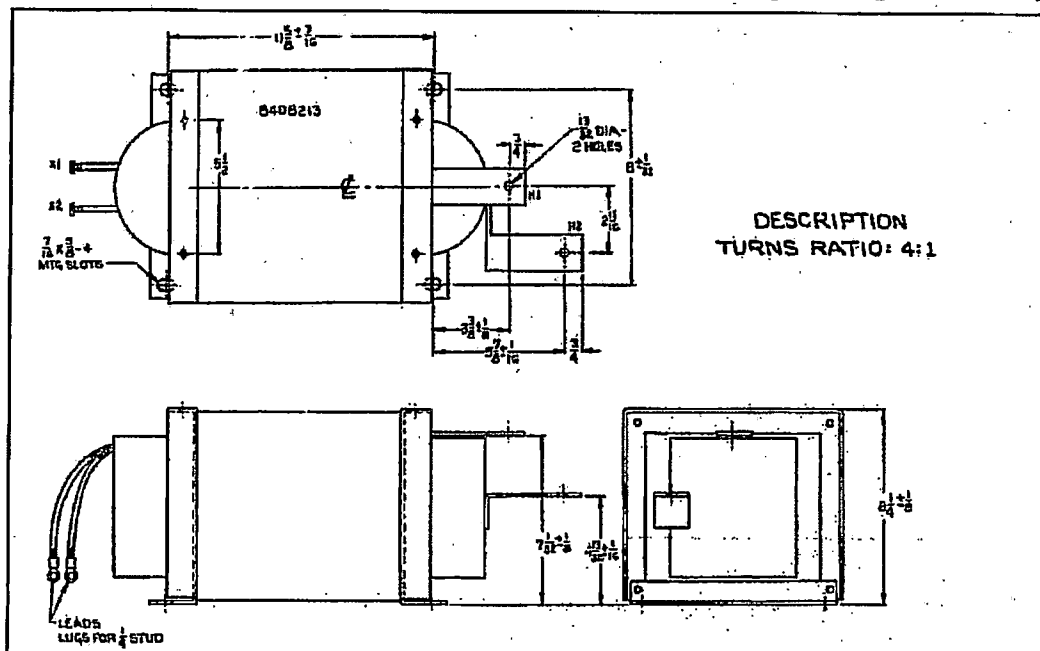
Figure 3: PCT Outline Drawing

Three single-phase PCTs provide a secondary voltage proportional to the primary current. The PCT, in conjunction with the EPT, provide the power to support generator field excitation. Certain characteristics of the PCT secondary voltage are determined by the magnitude of an air gap in the core construction. It has been determined the PCT supplied by ESI has a gap of 0.030" whereas the original design PCT has a gap of 0.080".

*Return to ESI for rework. The PCT requires additional insulating material to increase the core gap.*

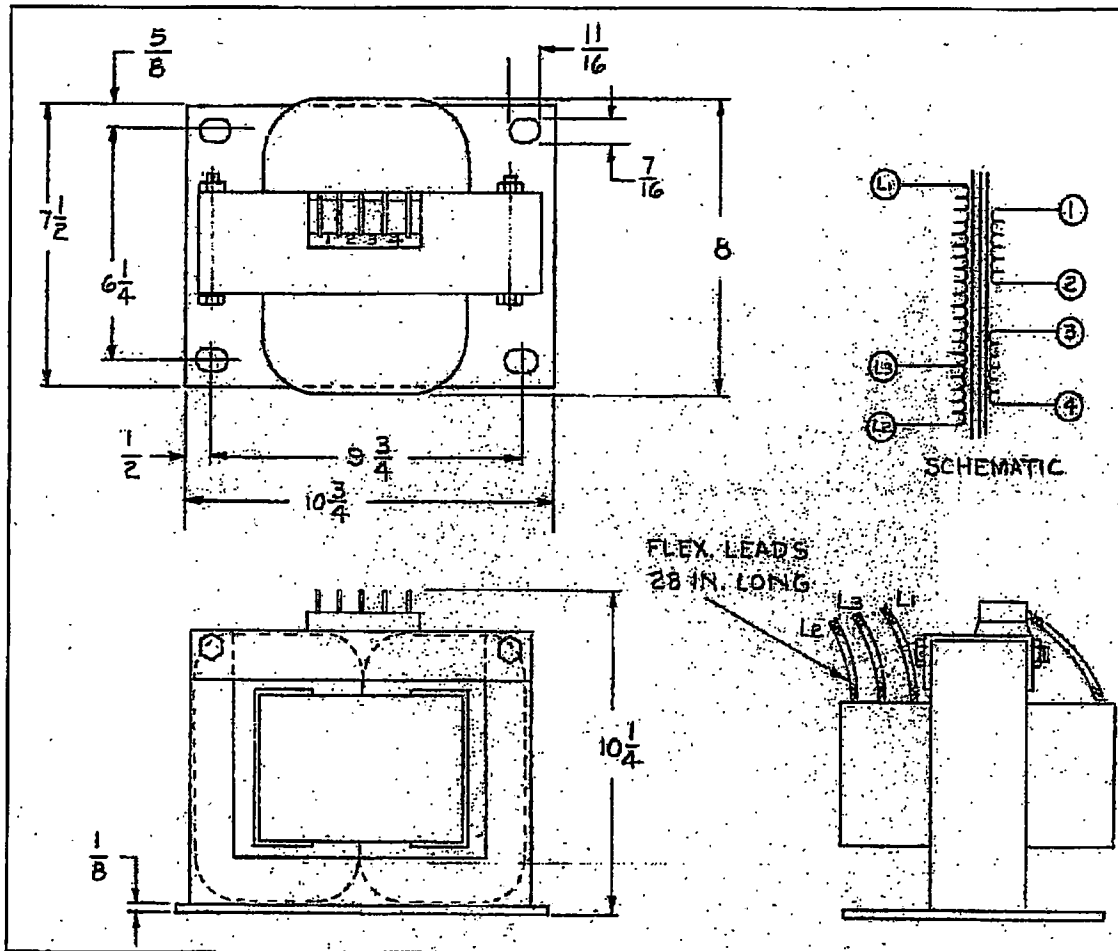
Figure 4: Reactor Outline Drawing

In conjunction with a rectifier diode, the saturable reactor acts as a magnetic amplifier. Six of these magnetic amplifier assemblies are used in the rectifier bridge of the voltage regulator system. The reactor receives a bias and control current from the voltage regulator which varies the level of saturation in the reactor core. As the level of saturation changes, the reactor impedance varies which increases or decreases generator field voltage. It has been determined the saturable reactor supplied by ESI has coil winding and core winding differences from the originally supplied reactor that may cause subtle, but undesired performance differences.

*Return to ESI for replacement.*
