REFERENCE: Docket No. 50-186
University of Missouri-Columbia Research Reactor
Renewed Facility Operating License No. R-103

SUBJECT: Written communication as required by University of Missouri Research
Reactor Technical Specification 6.6.c(3) regarding a deviation from Technical
Specifications 3.2.a and 3.2.f

Licensee Event Report No. 19-03 – April 28, 2019
University of Missouri Research Reactor

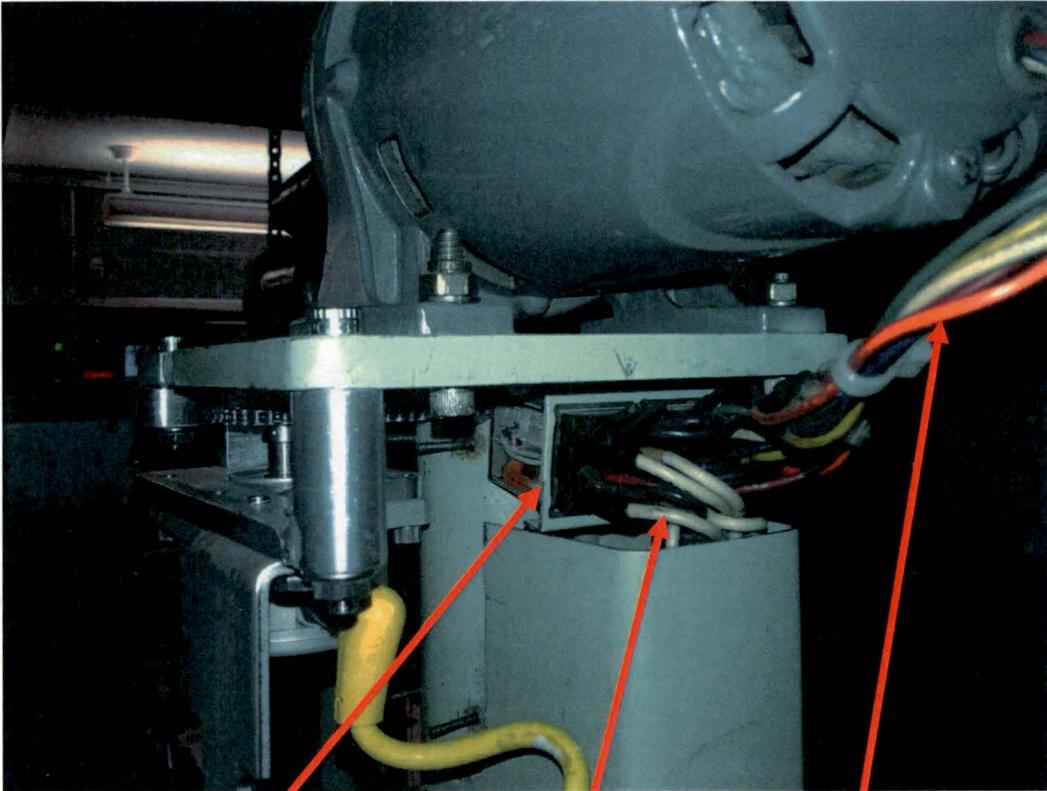
ATTACHMENT 1

After the reactor was secured, the CRDM for shim control blade ‘D’ was removed and transported to the Instrumentation Support shop for troubleshooting. Investigation revealed a broken wire to the inward direction motor winding of shim control blade ‘D’ CRDM. The broken wire prevented the inward direction motor winding from energizing and moving the shim control blade. The wire was repaired, and operability of shim control blade ‘D’ CRDM was tested satisfactorily. Permission from the Reactor Facility Director was obtained prior to reactor startup per TS 6.6.c(4), and the reactor returned to 10 MW operation at 13:19 CDT on April 28, 2019.

Troubleshooting revealed a broken wire to the inward direction motor winding of shim control blade 'D' CRDM. The wire was repaired, and operability of shim control blade 'D' CRDM was tested satisfactorily.

In the past, MURR has occasionally discovered a broken wire or a loose relay on the CRDM motor circuit. A broken wire or loose relay could be caused by either age degradation of components or occasional physical contact with the wiring causing cyclic stress to the wire or movement to the relay. MURR started a shim control blade CRDM refurbishment effort under Modification Record 18-02, "Fabrication of a New Control Rod Drive Mechanism," in which a new, spare CRDM was fabricated and installed in shim control blade 'B' position in October 2018. Installation of a new CRDM is allowing MURR to systematically remove and refurbish the remaining four (4) CRDMs.

Insertion Relay Socket
(where wire was broke)

Overview of Shim Control Blade Drive Mechanism Motor Circuit Wiring

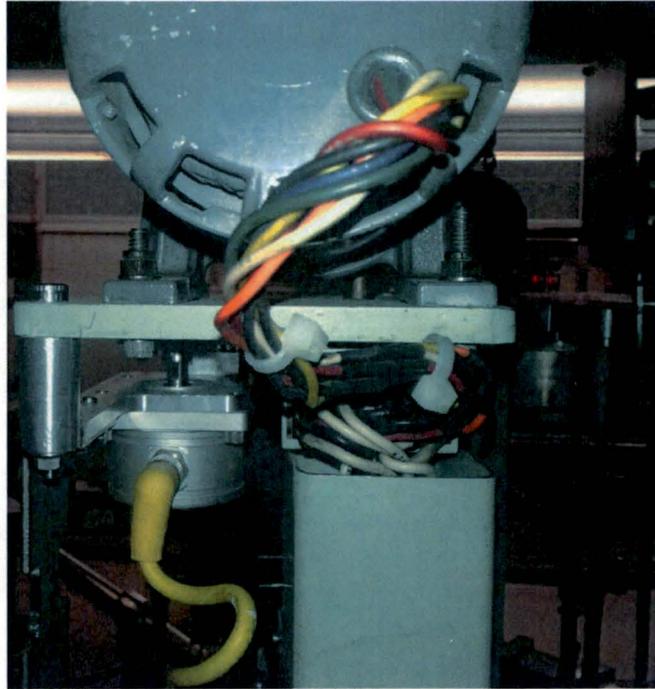
ATTACHMENT 2

**Motor Circuit Prior to Rewiring and Addition of Strain Relief and Wire Protections
(Backside View)**

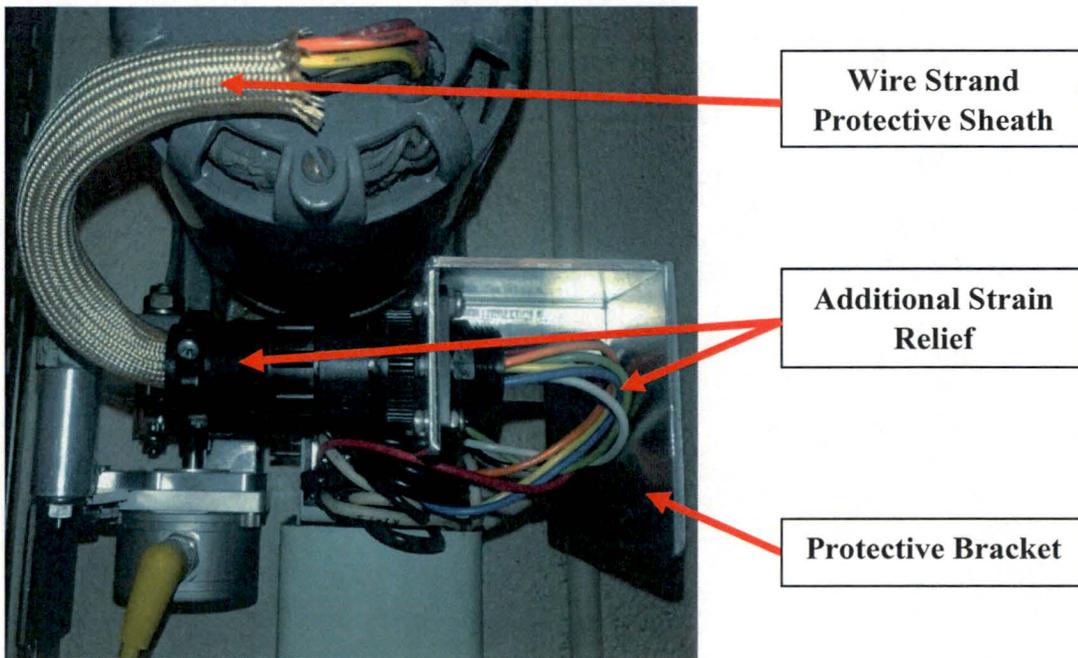
**Motor Circuit After Rewiring and Addition of Strain Relief and Wire Protections
(Backside View)**

Refurbishment includes replacement of the CRDM motor relay sockets and wiring. The installation of a relay retainer bracket and providing more strain relief to the wire bundle is part of the CRDM refurbishment process. MURR will be implementing these wiring and relay bracket changes on an accelerated schedule due to this LER (see Attachments 2, 3, and 4).

In response to this LER, MURR has designed a bracket to help protect the CRDM wiring from physical contact that may occur during CRDM removal and reinstallation or sample handling evolutions in the vicinity of the CRDMs. This bracket will be installed on the same accelerated schedule as the wiring refurbishment (see Attachments 2, 3, and 4).

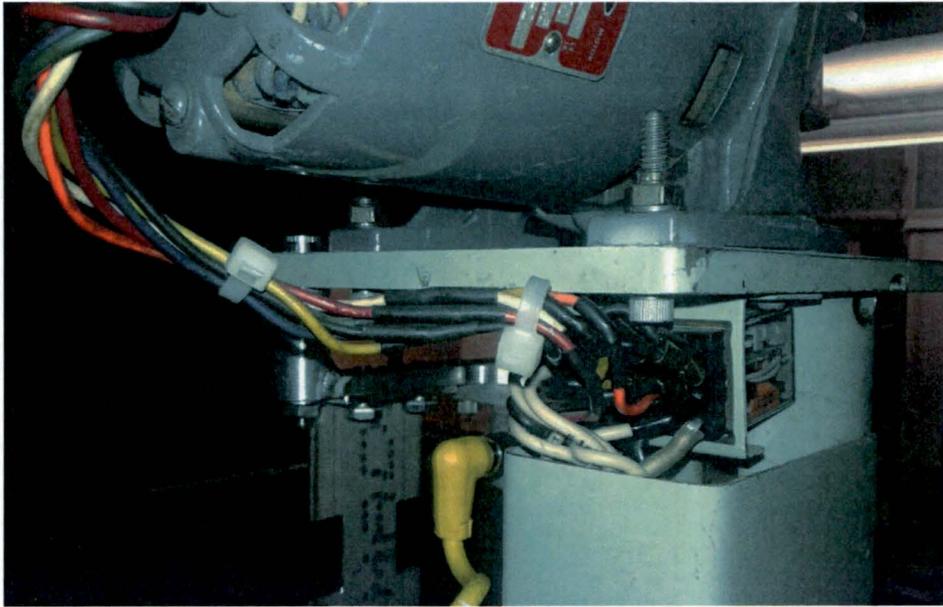
ATTACHMENT 3

**Motor Circuit Prior to Rewiring and Addition of Strain Relief and Wire Protections
(Angle View)**

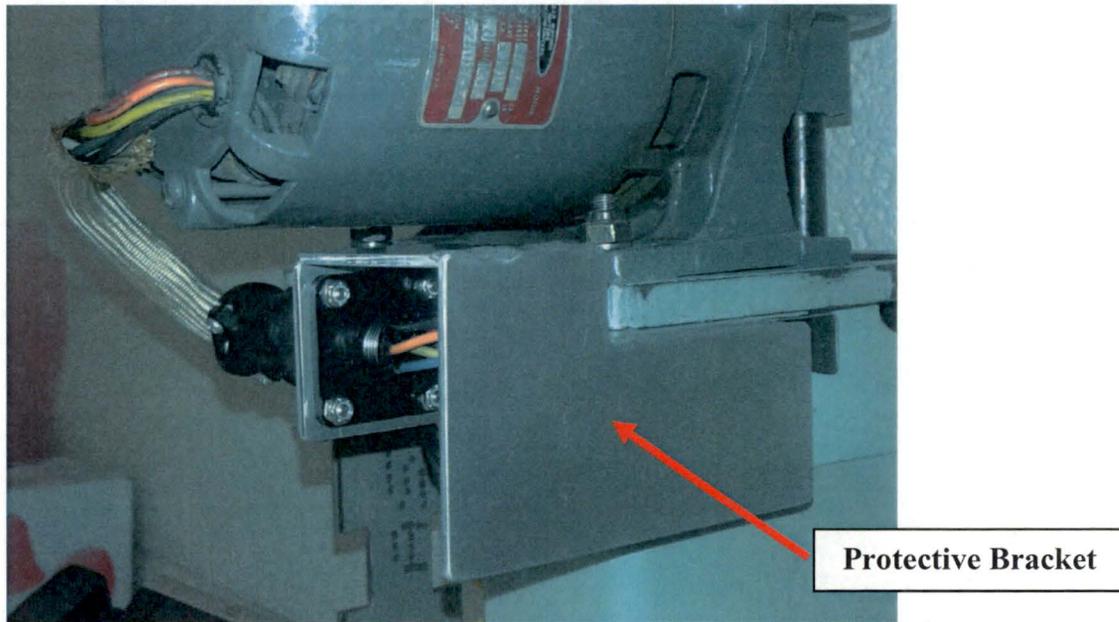
**Motor Circuit After Rewiring and Addition of Strain Relief and Wire Protections
(Angle View)**

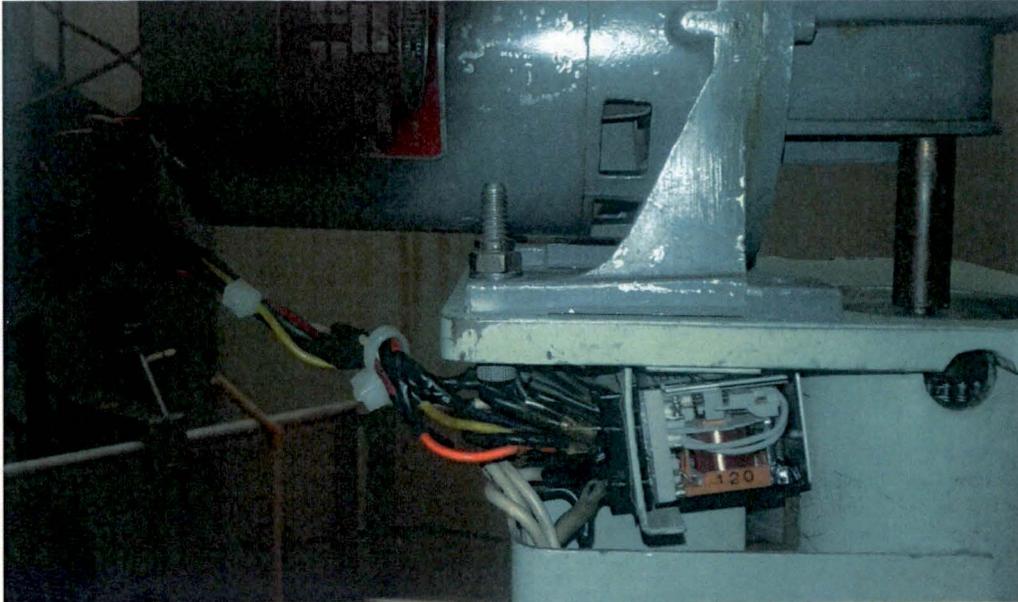
ATTACHMENT 4

**Motor Circuit Prior to Rewiring and Addition of Relay Retainer and Wire Protections
(Side View)**

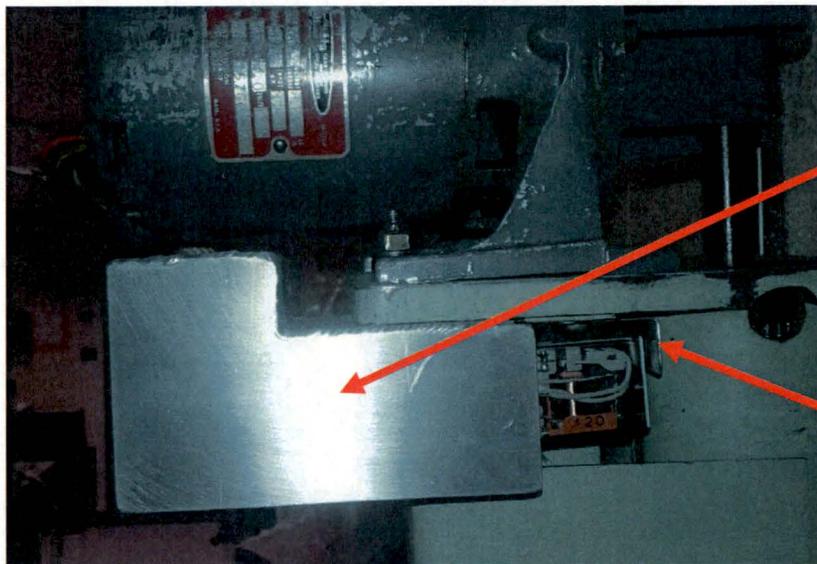
**Wire Protective
Bracket**

**Relay Retainer
Bracket**

**Motor Circuit After Rewiring and Addition of Relay Retainer and Wire Protections
(Side View)**
