Repair of Doel 1 NPP Reactor Vessel Head Penetrations

International Workshop on Age-Related Degradation of Reactor Vessels and Internals, USNRC, Washington, 23-24/5/2019

Repair Reactor Vessel Head penetrations Doel 1

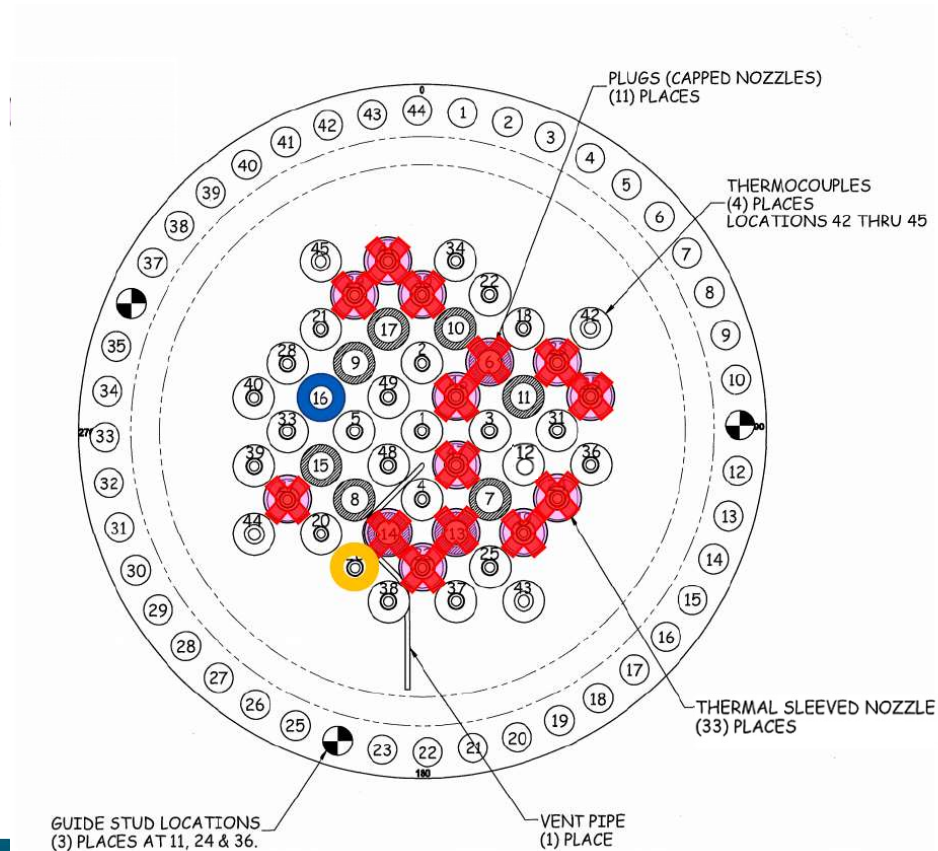
- Doel 1 – 2018: UT + repair by IDTB

- Pre-ISI PWSCC locations

- Originally scheduled (14) repair locations

- Two new indications detected by UT in 2018

- Penetration 26 : seen not reported in 2017

- Penetration 16 : not observed in 2017

- Total of 16 repaired penetrations

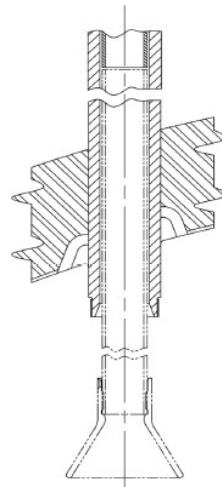
Step 1
Cutting and Removal of
Thermal Sleeve

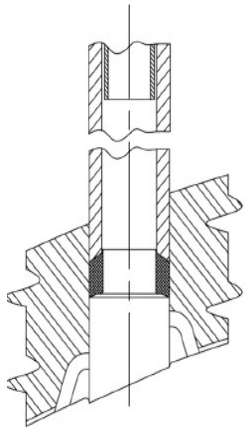
Step 4
Temper Bead
Welding (GTAW)

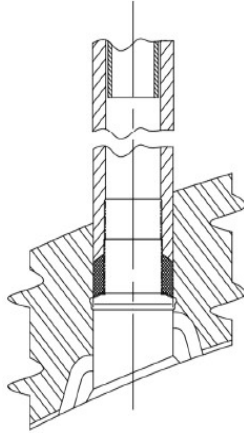
Step 5
Machining, UT,
automated PT, rotary
peening and PT

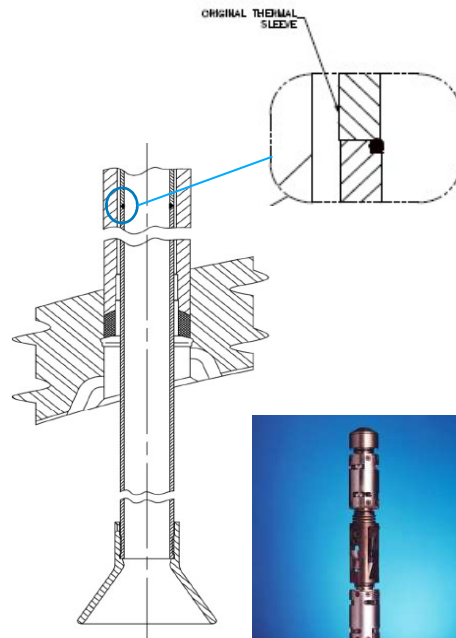
Step 6
Thermal Sleeve
Replacement

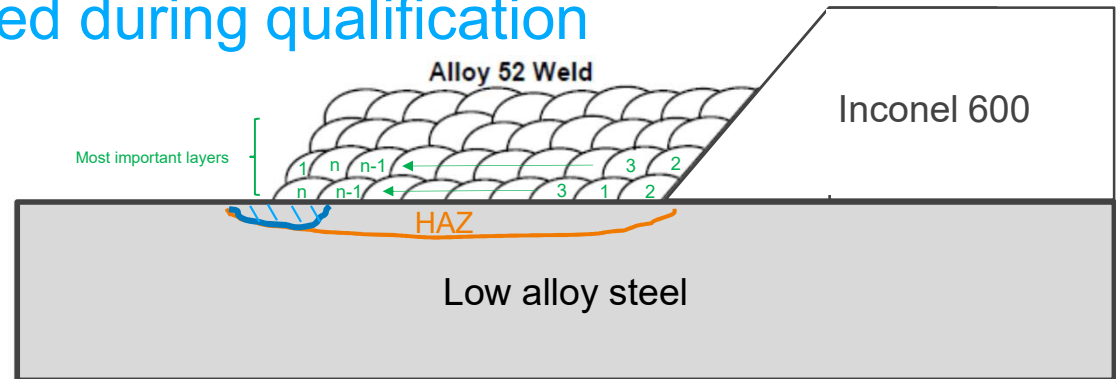
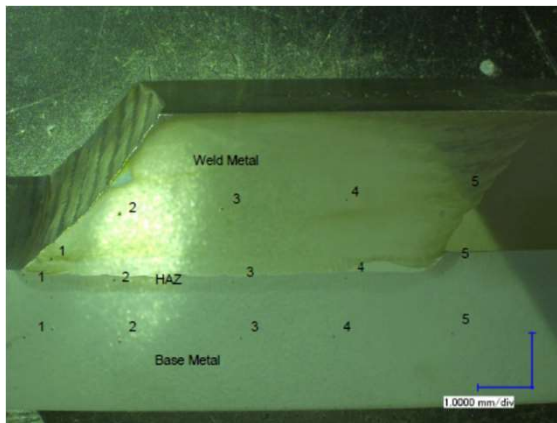
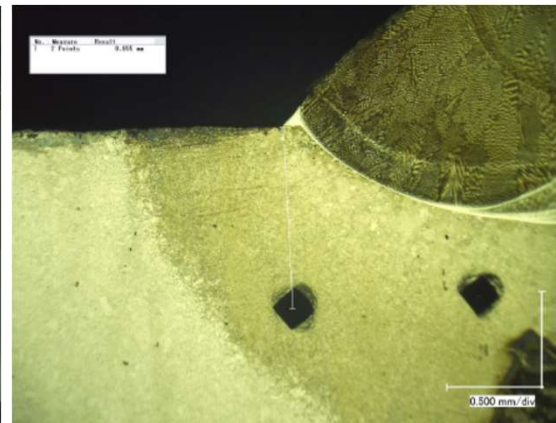
Hardness issue encountered during qualification

- Hardness value in HAZ > 380 HV₁₀

Sample	Vickers Microhardness HV10														
	Weld Metal Location					HAZ Location					Base Metal Location				
	1	2	3	4	5	1	2	3	4	5	1	2	3	4	5
IDTB02-HRD-01	200	205	229	225	228	360	321	318	296	351	271	214	218	208	215
IDTB02-HRD-02	241	221	211	248	238	434	301	298	296	320	280	194	195	195	203
IDTB02-HRD-03	205	189	228	222	239	360	307	312	312	343	242	199	206	201	205
IDTB02-HRD-04	180	187	217	216	208	367	298	354	277	314	191	195	192	203	213
Required	380 Max

- During qualification, welding parameters and sequence had to be optimized in order to have sufficient tempering and acceptable hardness values in HAZ
- During repair, breakdown of cutting tools used to cut and remove thermal sleeves
 - FRAMATOME Inc. never encountered this issue before
 - Issue may have been due to a very slight inclination of the thermal sleeves (approx. 0.5-1°)
 - Solution : tooling adaptations with tests done at Lynchburg and copied at Doel
