Doel 1&2 Upper Plenum Injection line issue

International Workshop on Age-Related Degradation of Reactor Vessels and Internals, USNRC, Washington, 23-24/5/2019

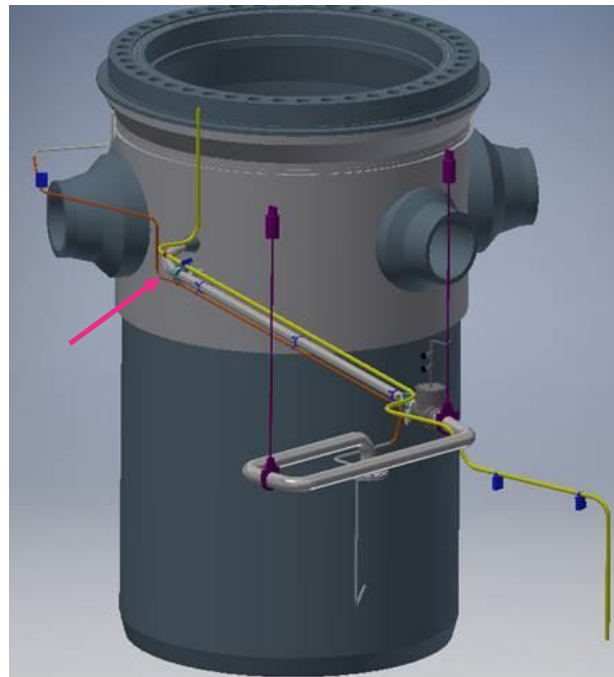
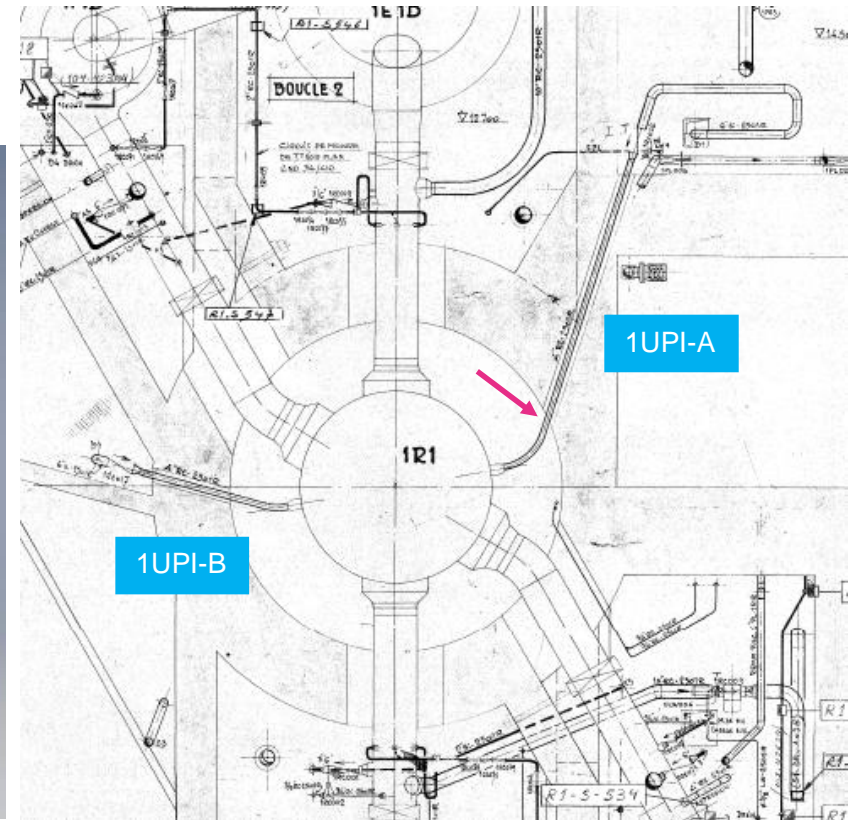
- | Doel 1
- | April 23, 2018
- | Leak on 1UPI-A
- | In reactor cavity (10 mSv/hr)
- | 4"sch160
- | Type 316 SS
- | ASME III Cl.1

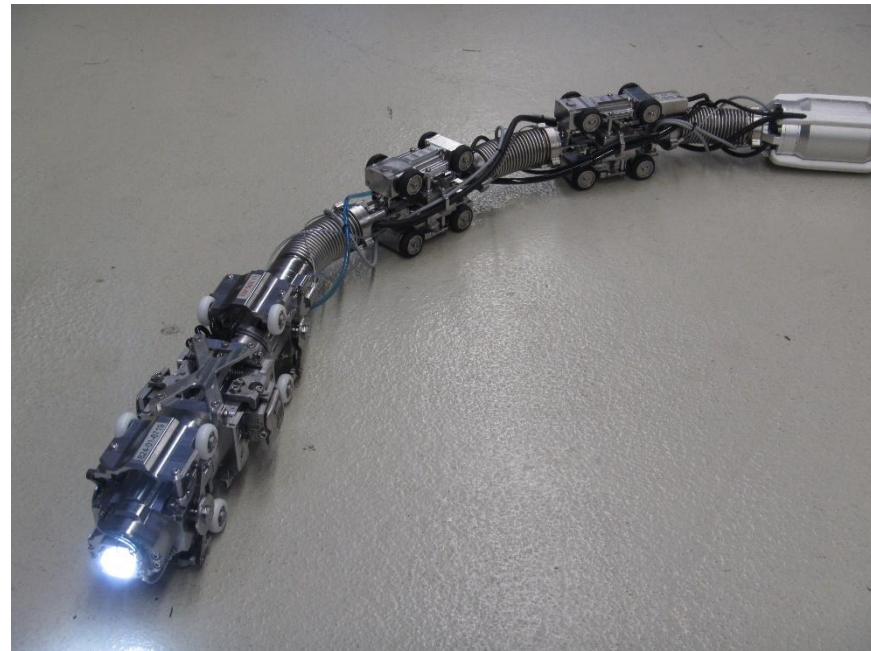
- | Mechanized VT, ET, UT, UT-TOFD (FRAMATOME GmbH Erlangen) of all 4 UPI lines
 - From inside, access through check-valve
 - Dry (pneumatic plug in RPV nozzle)
 - Several carriers
- | Manual UT of welds
 - From outside

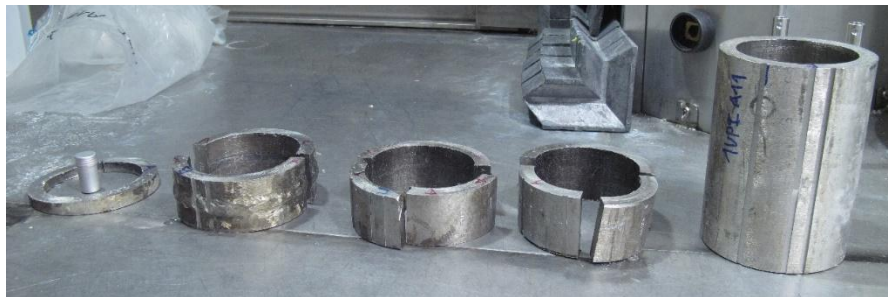
- | Doel 1 UPI-A ► SCK•CEN (Mol, Belgium) ►► THERMAL FATIGUE
- | Doel 2 UPI-A ► FRAMATOME GmbH (Erlangen, Germany) ►► THERMAL FATIGUE

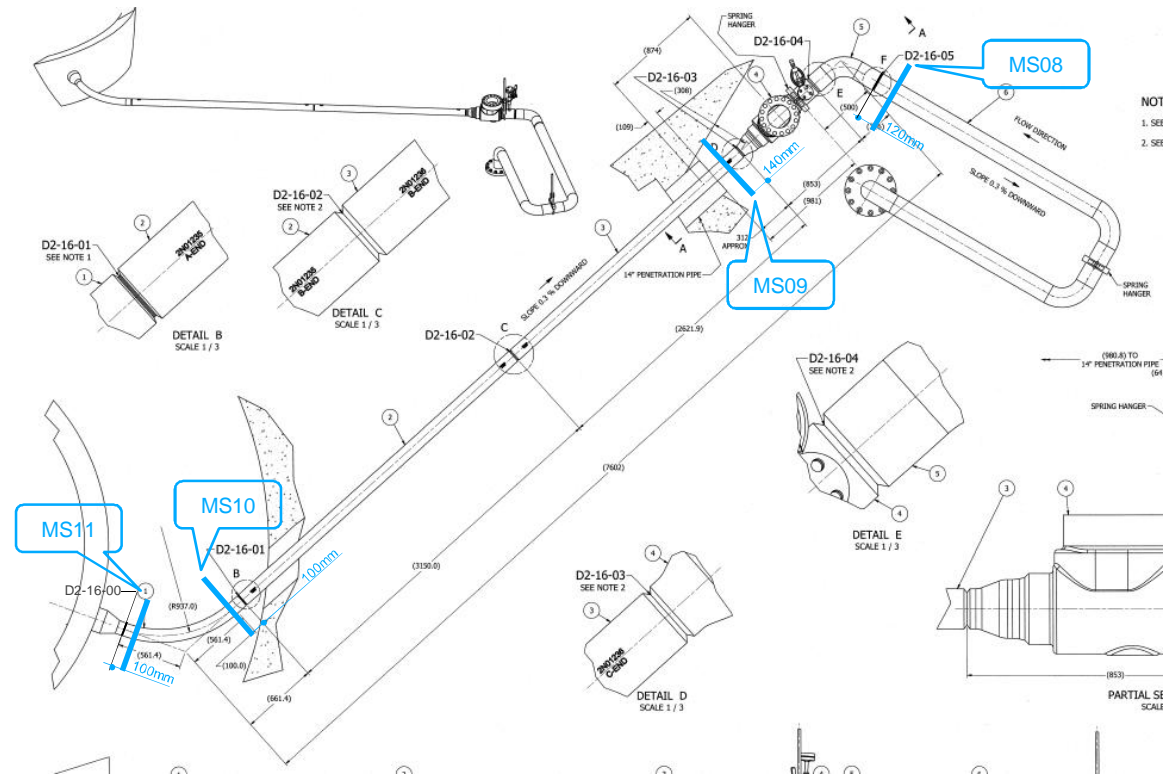
MS09

DT_{top-bottom} ~40°C (A,B)
 Range: 120°C – 160°C (A)
 Range: 200°C – 240°C (B)

MS10

DT_{top-bottom} <10°C (A)
 DT_{top-bottom} <30°C (B)
 Fluctuations in range: 210°C – 250°C

MS11

DT_{top-bottom} ~0°C
 Small fluctuations as a function of time
