# **Inspection of Control Rod Guide Assemblies in Belgian NPPs**

International Workshop on Age-Related Degradation of Reactor Vessels and Internals, USNRC, Washington, 23-24/5/2019

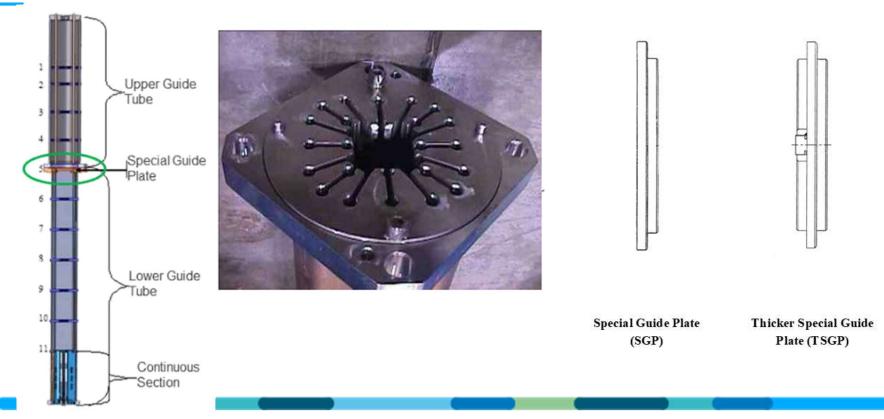
# **Tihange 3 Thicker Special Guide Plates**

- GCWM inspection performed in 04/2018
- Extensive guide cards wear:
  - 35 guide tubes in "green" zone
  - 8 guide tubes in "yellow" zone
  - 9 guide tubes in "red" zone
    - -> 15 guide tubes were predicted not to be able to make two more fuel cycles → contingency measures
      - 2 guide tubes swapped with spare tubes already in reactor
      - 13 "Special Guide Plates" (specific feature of 17x17 guide tubes, where one guide plate is bolted and can be removed) replaced by Thicker Special Guide Plates (1.5 inch thick instead of 1 inch)

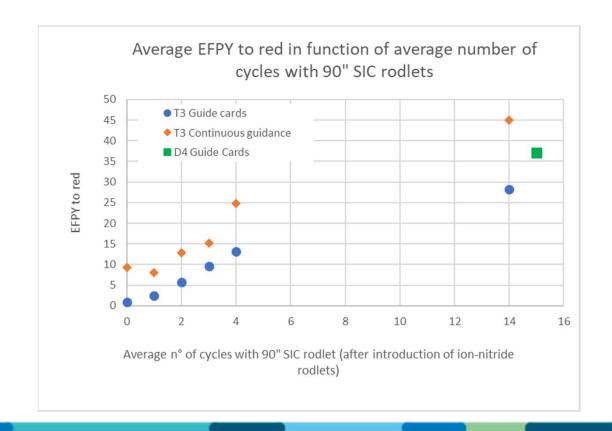
# Possible reason of differences between Doel 4 and Tihange 3

- Internal analysis: Both units use "hybrid" RCCAs with combination of Ag-In-Cd in lower part and B<sub>4</sub>C above; there is however one difference:
  - In Doel 4 all RCCAs have 90" Ag-In-Cd (two bars of 50" and 40") since ion-nitride rods were introduced
  - In Tihange 3 most RCCAs were 40" Ag-In-Cd from 1996 to 2012, except for D and SD banks (where RCCAs with 90" Ag-In-Cd were used).
  - Since 2012, 90" Ag-In-Cd RCCAs are progressively introduced in all positions
  - Guide tubes of D and SD banks in Tihange 3 show much less wear ("green")
  - 90" Ag-In-Cd RCCAs are heavier and stiffer, which influences vibration behaviour
  - There is a correlation between the number of cycles operated with 90" Ag-In-Cd RCCAs and the average number of EFPY to "red" condition, although the scatter is very high
- Westinghouse has been requested to come up with a reasoning on-going
