**Spring 2019 Workshop on Age-Related
Degradation of Reactor Vessels and Internals**
U.S. Nuclear Regulatory Commission Headquarters, May 23-24, 2019

**Operating Experience (OpE) on
RV Internals, RV Head Penetrations, and RCS Small Bore
Nozzles in Korea**

2015 Kori Unit 1 Baffle Bolts Inspections

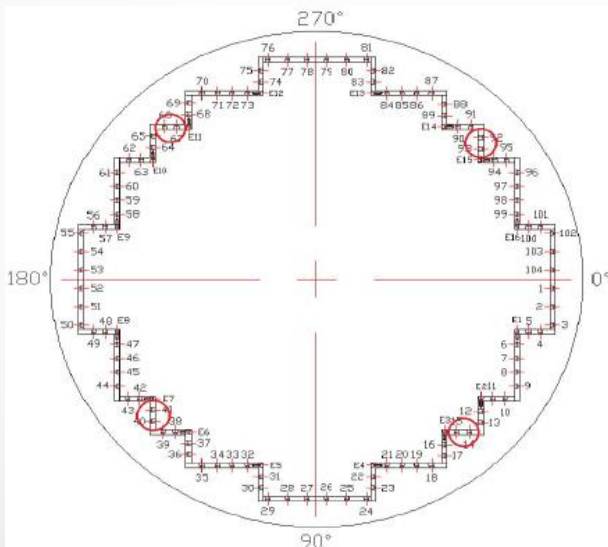
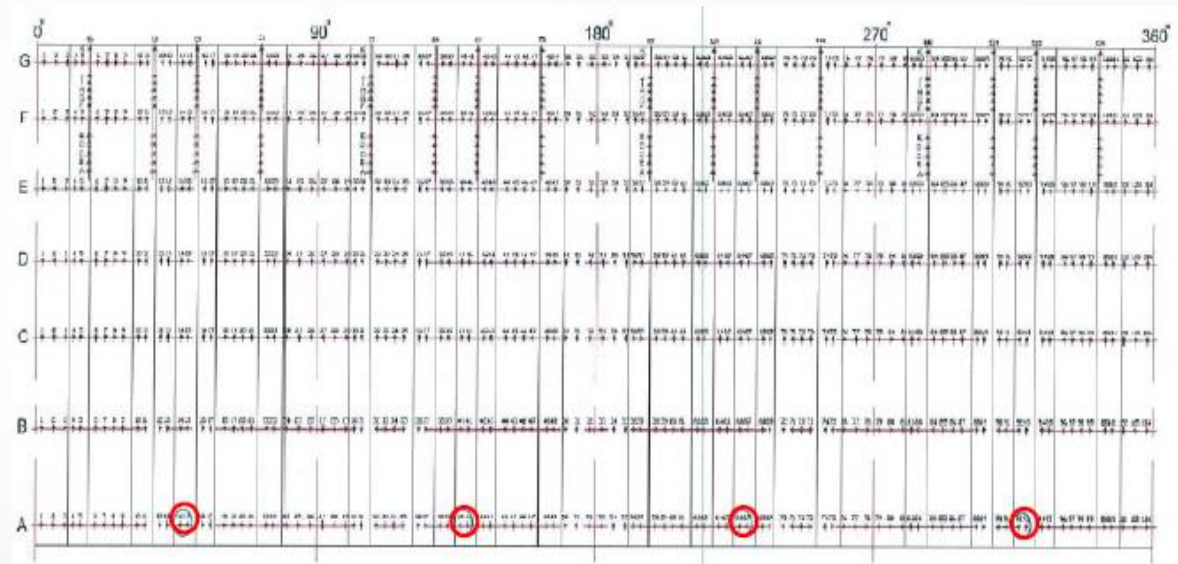
- 5/25, 2015 : No back-wall signals in 8 Baffle Former Bolts
- Defect unknown locations (DUL): 45°, 135°, 225°, 315° each 2 EA

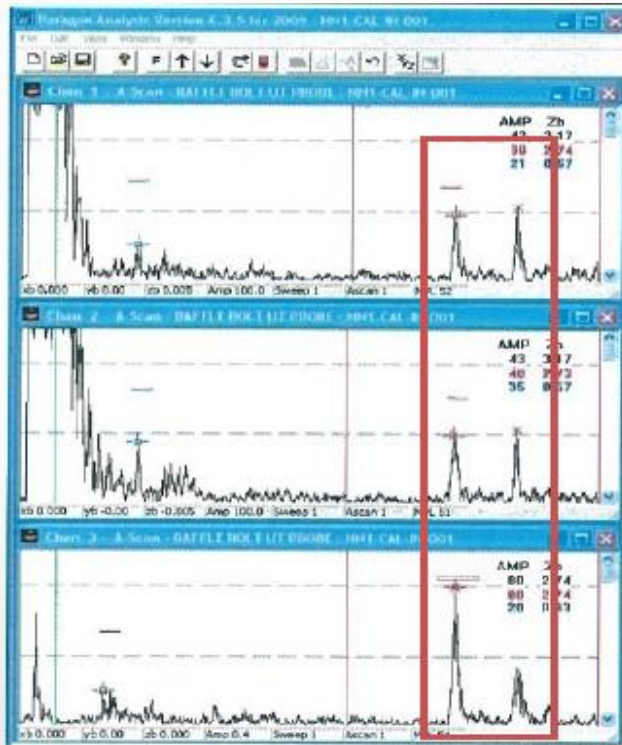
Sound Bolts

- Analysis of Signals from UT(2 elements, 3channels)

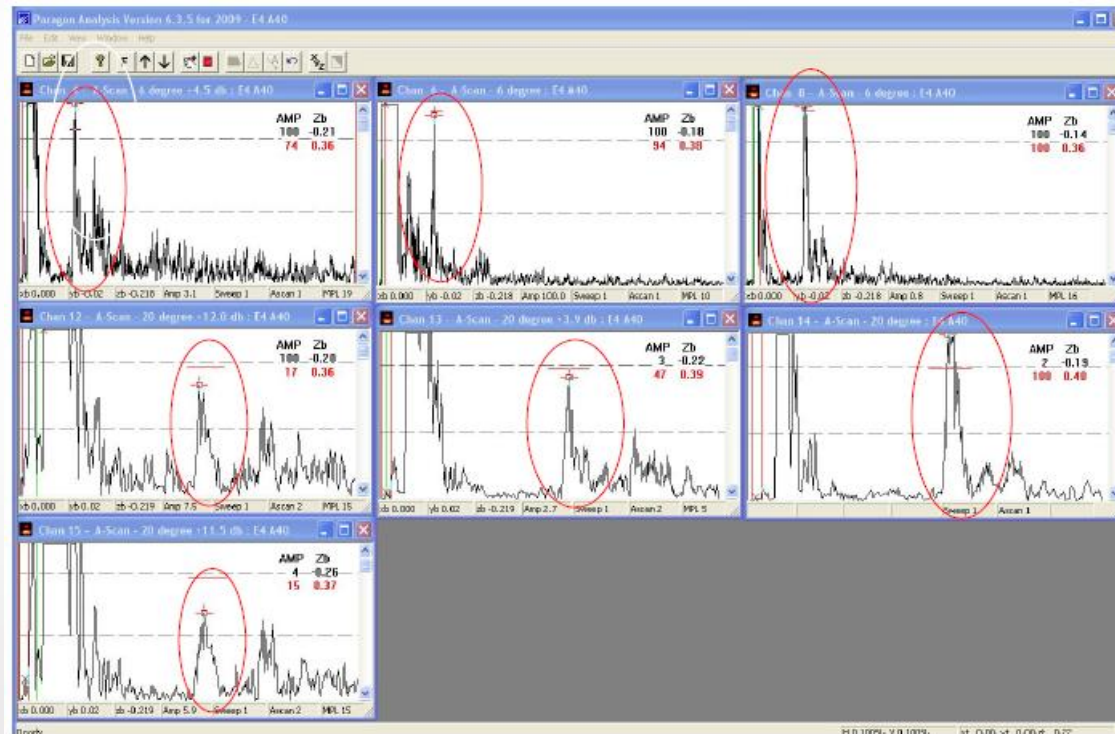
Defect Locations for bolts with DUL

- Analysis of Signals from UT(4 elements, 16channels)

- No back-wall signals in 8 BFBs were identified as DUL.
- UT with 4 Element probes found defects in shank which was located back locking bar.

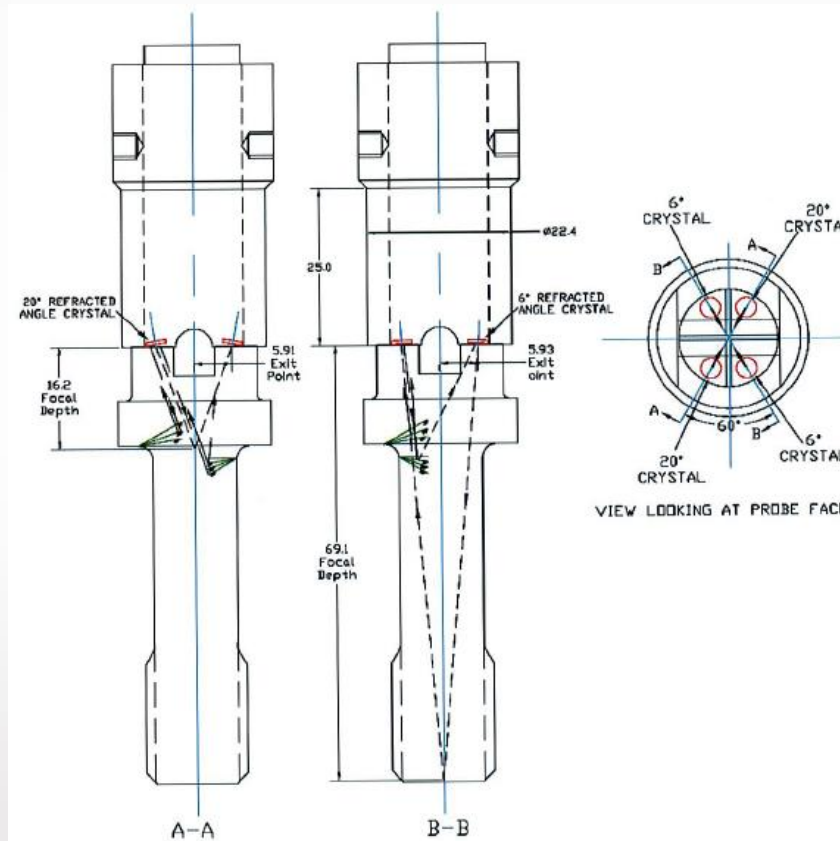
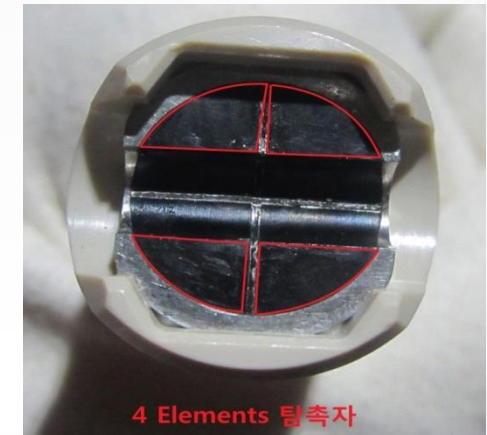
- Analysis of Signals from UT(4 elements, 16channels)
 - 20° Refracted Angle Crystal, 6° Refracted Angle Crystal

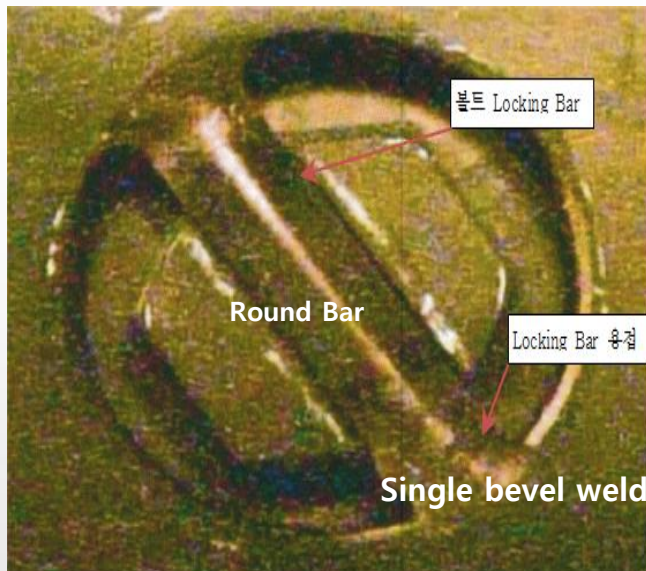
Kori #1

- Westinghouse 4 Loop, down flow reported lots of bolt degradation.
- D.C. Cook 2, 4 Loop, down-flow : Plate type locking bar, tack weld to baffle plate.
- Kori 1, 2 Loop, converted up-flow: Round type locking bar, welded to baffle plate.

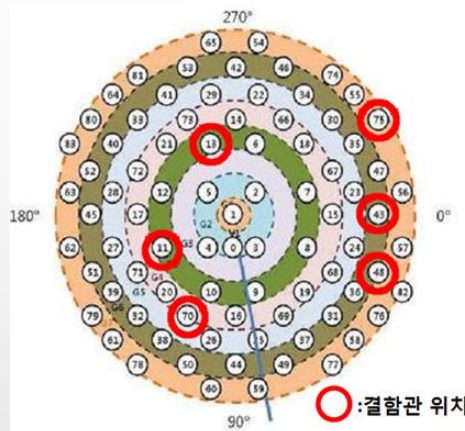
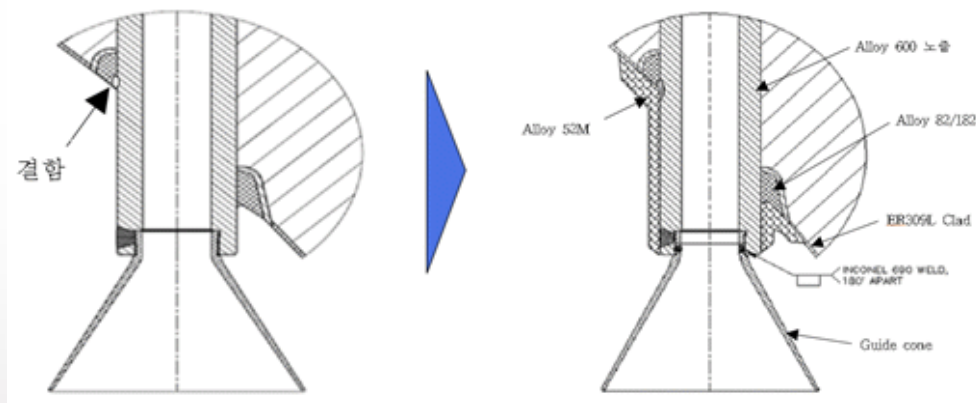
- UT detected six flaws : P11, P43, P70, P75, P13, P48
- All flaws were oriented axially and located in CRDM tube near the location of the J-groove weld toe
- Liquid penetrant examinations confirmed the existence, location, and orientation of the identified flaws and none of the flaws presented a leakage path to the upper surface of the RVHP
- Six penetrations were repaired with the embedded flaw technique

- Replacement of Reactor Vessel Closure Head
 - CRDM Nozzles(Alloy 600→690), J-groove weld(82/182→52/152)
 - Hanbit#3&4(2015), Hanwul#1&2(2022)
- Preventive Maintenance of Reactor Vessel Closure Heads
 - CRDM Nozzles(Alloy 690), J-groove weld(82/182→52/152)
 - Hanwul#3&4, Hanbit#5&6(~2022) using seal weld technique

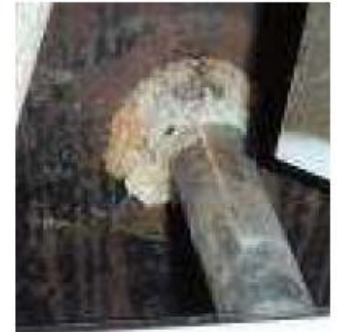
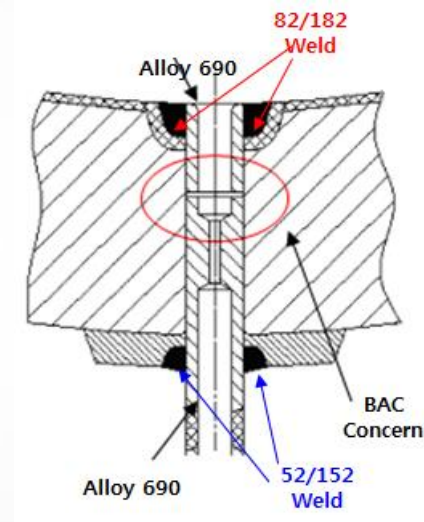
- Leak was discovered from sampling nozzle during visual inspection for evidence of boric acid deposits
 - Crack was short, axial and located near the J-groove welds to be attached nozzle to the hot leg piping
- The leak was repaired using half nozzle repair
- The plant qualified a UT technique to inspect the low alloy steel base metal for general corrosion
- There has been no indication of general corrosion of low alloy steel base metal

- 1st 2019 ~ 2021 : Small bore nozzles of RCS Hot Leg Pipings
 - Nozzles(Alloy 690), J-groove weld(**82/182**→**52/152**)
 - Hanbit#3&4, Hanwul#3&4, Hanbit#5&6 (**total 113EA**)
 - Preventive Maintenance : Half nozzle repair with pad or nod-pad
- 2nd 2021 ~ 2024 : Heater sleeve nozzles of Pressurizer
 - Nozzles(Alloy 690), J-groove weld weld(**82/182**→**52/152**)
 - Hanbit#3&4, Hanwul#3&4, Hanbit#5&6 (**total 258EA**)
 - Preventive Maintenance : Half nozzle repair with pad or nod-pad
