# Operating experience of a Swiss BWR (KKL)

Jens Heldt Leibstadt NPP

Folie 2 | 23.05.2019 | International Workshop on Age-Related Degradation of Reactor Vessels and Internals; NRC Headquarters, Rockville, May 2019

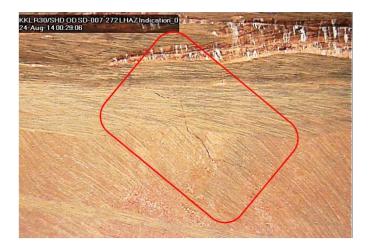
# **Indications in Core Shroud**

- Made out of 304L / 308L
- OD of Weld SD-007: two small indications found by VT in 2012
  maximum length of 22 mm
- Reinspection after 2 und 5 years revealed no apparent change of both indications

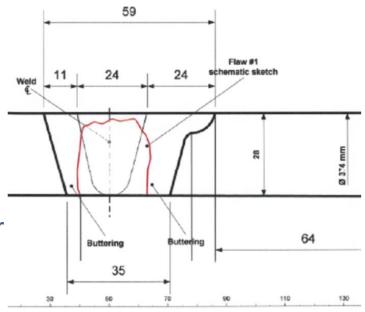
### **RPV Nozzle Dissimilar Metal Welds (DMW)** Outage 2012: Indication overlaid at N5-nozzle

- Ferritic nozzle and safe end
- DMW: Alloy 182 (Butter) / Alloy 82
- No Mechanical Stress Improvement (MSIP)
- ID-connected axial indication found in 2012
- Reevaluation of prior UT-inspection in 2004
  ~1.5 mm/year crack growth
- Full Structural WOL with Alloy 52

- Axial orientation
- Found in weld metal
- Length 22 mm (shorter at base?)
- Depth 26 mm (~ 93% wall thickness)
- Multifaceted and branched
- Emanating from edge of ID weld repair
- Clear ID connection
- Flaw is indicative of interdendritic stress corrosion cracking

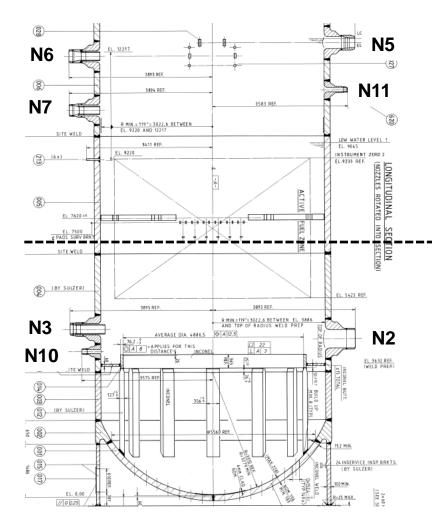
# Assessment of OLNC / HWC Mitigation according to BWRVIP-219

### Not mitigated:

- N5: Feed Water
- N6: Core Spray (HPCS / LPCS)
- N7: RHR / LPCI
- N11: CRD-Return

### Mitigated:

- N2: Recirc Out
- N3: Recirc Inlet
- N10: Jet Pump Instrumentation
