To: David Miller, Navarro
From: David Dander, Navarro
Date: April 25, 2019
CC: Daniel Nordeen, Navarro Engineering
Ellen Tomlinson, Navarro Environmental and Spatial Data Management
Anthony Martinez, Navarro Safety and Health / Radiological Control
Re: Cell Cover Standpipe Decommissioning Trip Report

Site: Shiprock, New Mexico, UMTRCA Disposal Site

Task: Decommission cell standpipes 205–208 according to *Proposed Decommissioning Plan for Cell Cover Standpipe, Shiprock, New Mexico, Disposal Site (S19957)*

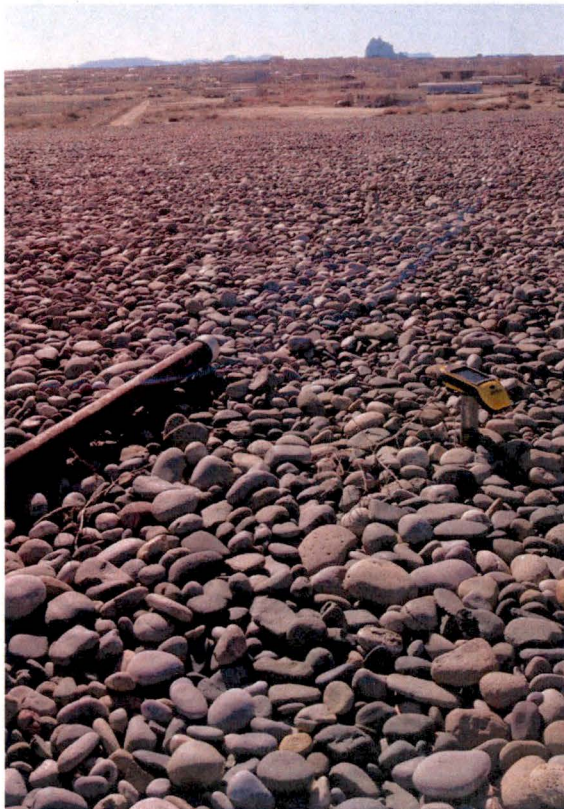
Photograph 2. Location 205

Water levels and total depths were measured at the five 1.75-inch aluminum access tubes, or standpipes, as shown in Table 1 below (see Photographs 2–5).

Rusted steel casings (3-inch) were also present at the four locations (205–208) shown in Figure 1 and Photographs 1–4. Each had apparently been previously backfilled to surface (top of radon barrier) level and subsequently rusted through. The one standing 3-inch casing at location 208 (see Photograph 4) broke off when pushed. The fragmented rusty remnants left in the ground at each location were dug out as best as possible several inches into the radon barrier. A slight mound of radon barrier material was placed and compacted above each former 3-inch casing location before riprap was pulled back into place. At location 205, the breakoff point was never located although the steel casing was lying in the area. A painted rock was left at that approximate location based on fragmented iron seen in the riprap (see right side of Photograph 16). A painted rock was left at the sites of all nine abandoned standpipes (see Photographs 16–19); coordinates were already in the Environmental Quality Information System (EQUIS) database.

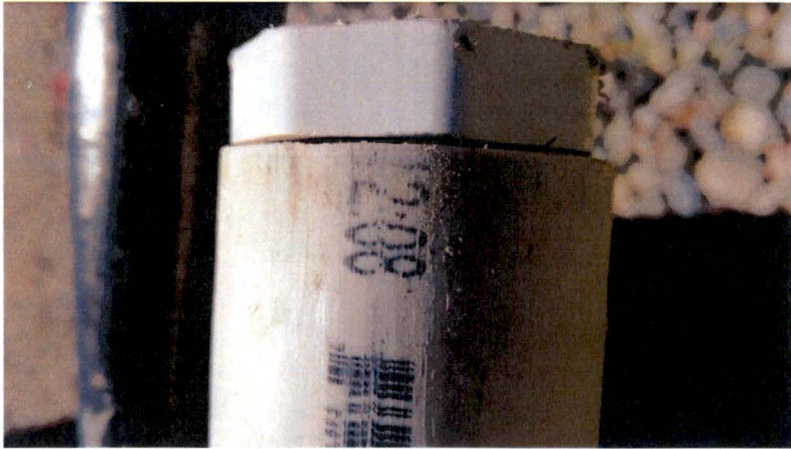
Photograph 6. Casing Compaction Rod

Radon barrier materials were sieved through a ¼-inch screen, and dry material was used for the initial lift, which was slightly over 1.5-feet, to avoid contacting cell water on the compaction rod (see Photograph 6). Subsequent lifts used moisture-conditioned radon barrier material mixed in a bucket, then placed and packed in 6-inch lifts up to near surface. The standpipe top and packing rod were scanned for radioactivity at each location, and scans did not detect anything above background.

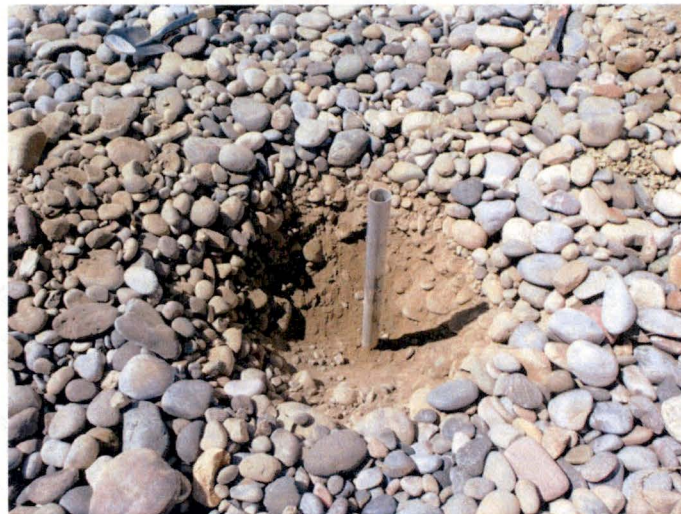
Large riprap was pulled away from each 1.75-inch standpipe. The bedding layer was also dug out into a separate pile, and no bentonite seal was observed around the standpipes. The extensive deposition of windblown silts within the bedding layer made it difficult to differentiate from the radon barrier below, except the bedding layer was a bit looser and included more large particles. An excellent example of this windblown deposition process was observed while this work was being performed (i.e., a dust devil), as shown in Photograph 7. Profiles of the riprap, bedding layer, and upper radon barrier at each location are shown in Photographs 8–11.

Photograph 8. Location 208 Riprap Dug Out

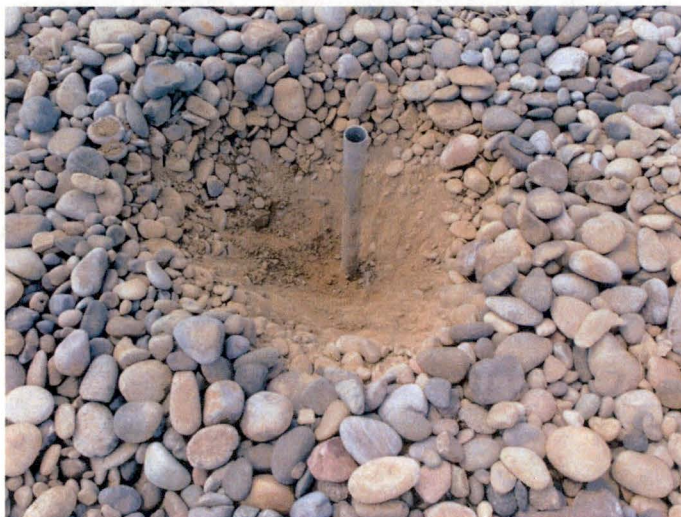
Photograph 9. Location 206 Riprap Dug Out

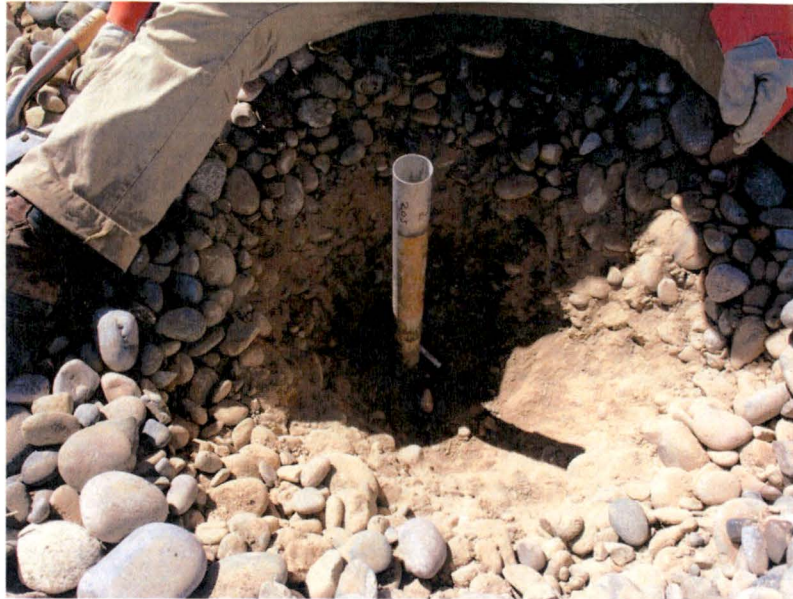
Photograph 10. Location 207 Riprap Dug Out

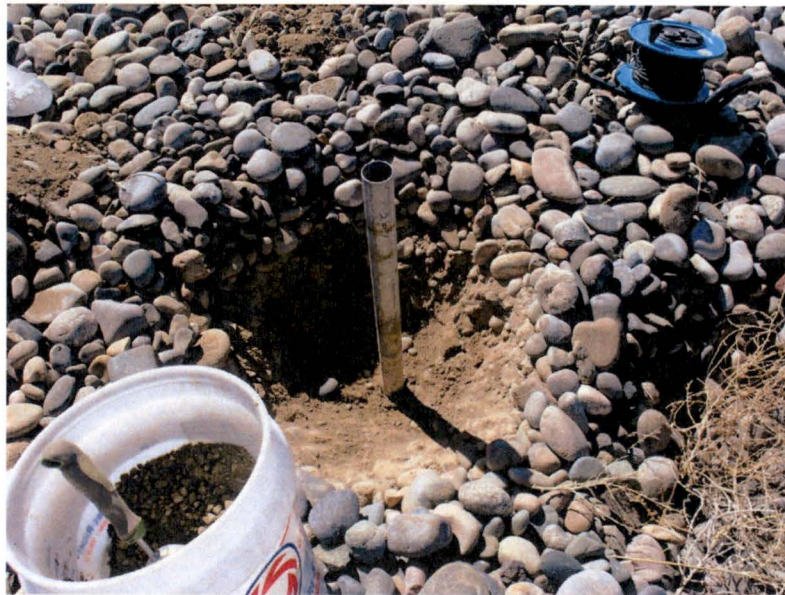
Photograph 11. Location 208 Riprap Dug Out

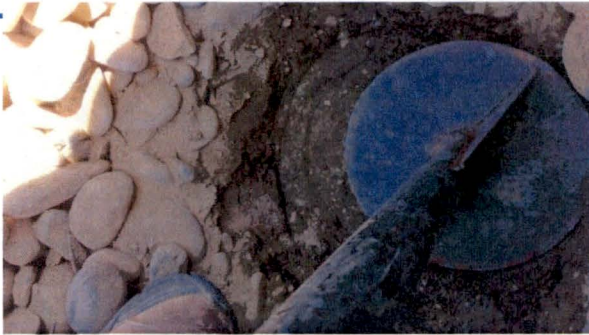
Photograph 12. Near Surface Compaction Tool Used

Additional moisture-conditioned radon barrier material was placed and then packed in lifts of 6 inches or less above the cut standpipes and the adjacent radon barrier, mounding slightly from the adjacent bedding layer (with windblown silts). The compaction tool shown in Photograph 12 was used to compact the radon barrier near the surface to final levels (see Photographs 13–15). Rock riprap was pulled back into place, and a painted rock was left above each abandoned standpipe.

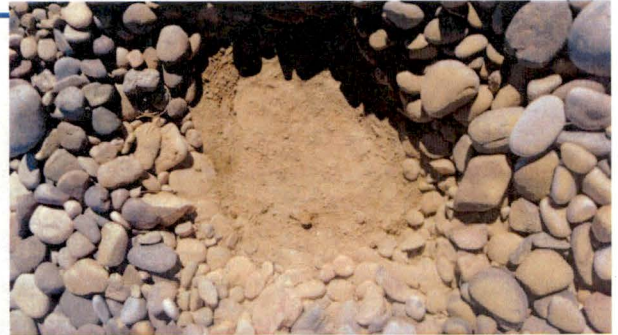
Photograph 14. Compacted Radon Barrier at Location 206B

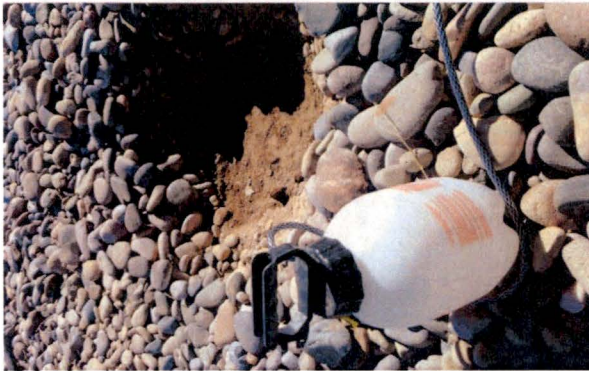
Photograph 13. Compacted Radon Barrier at Location 206

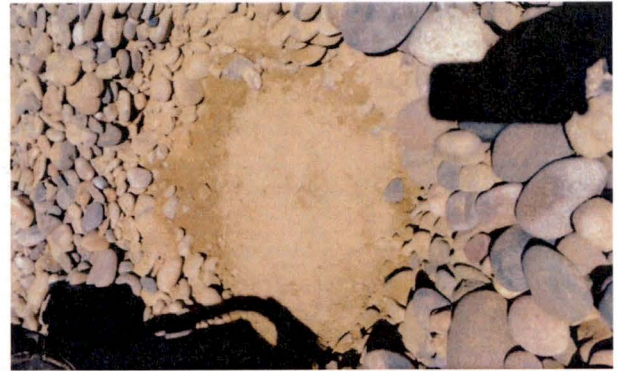
Photograph 15. Compacted Radon Barrier at Location 205

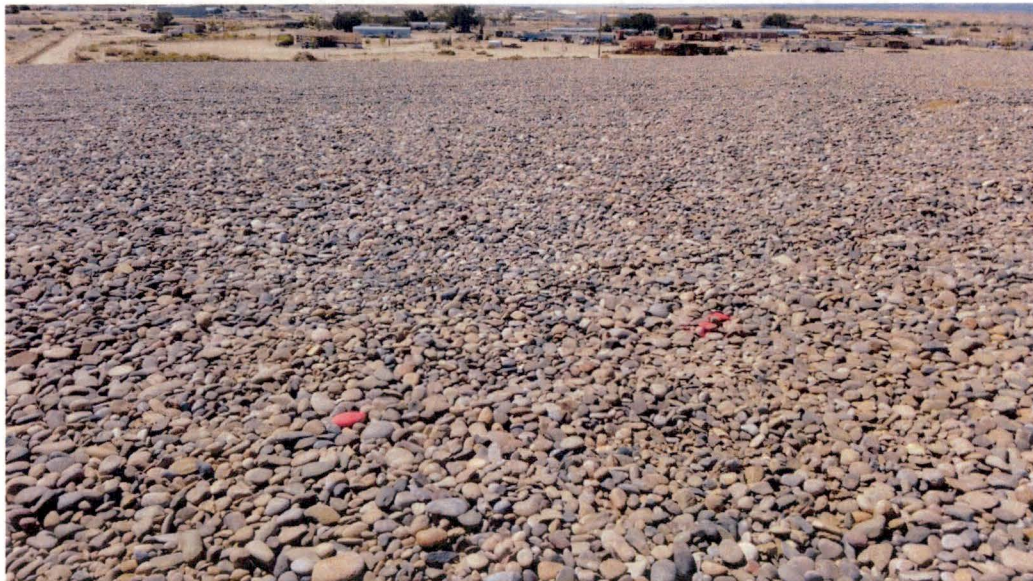
Photograph 16. Final Surface at Location 205

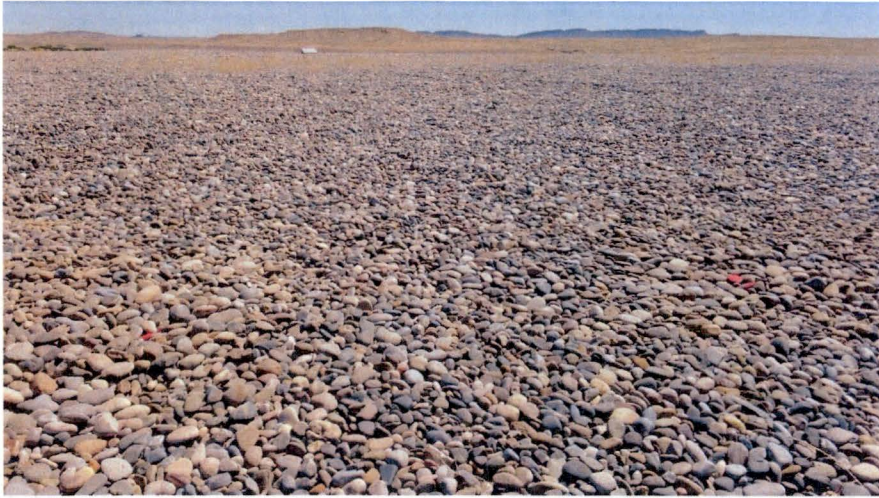
Photograph 17. Final Surface at Location 206

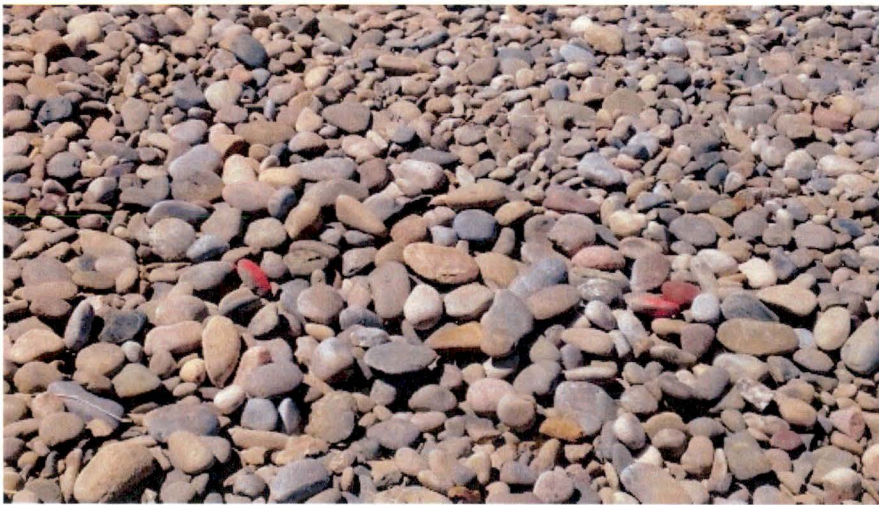
Photograph 18. Final Surface at Location 207

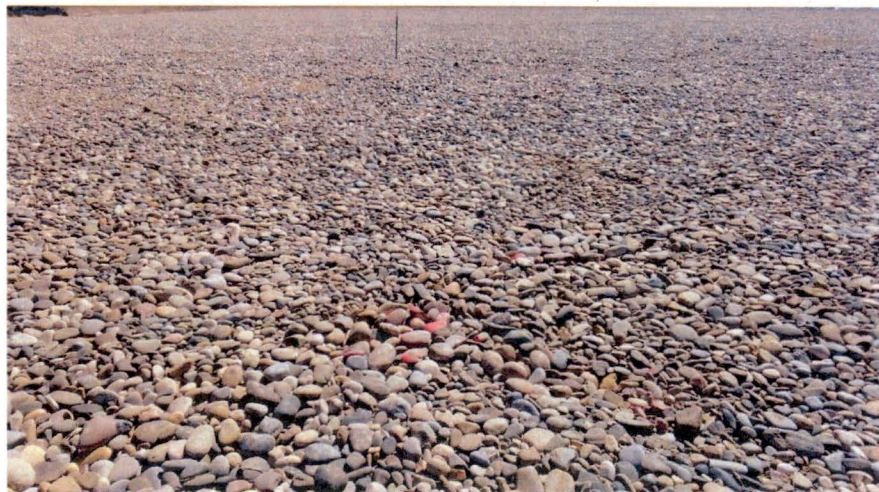
Photograph 19. Final Surface at Location 208
