June 28, 2019

SUBJECT: NRC OBSERVATIONAL SITE VISIT AT THE SLICK ROCK,
COLORADO DISPOSAL SITE

Report: WM-00086/2019-001

Facility: Slick Rock Disposal Site

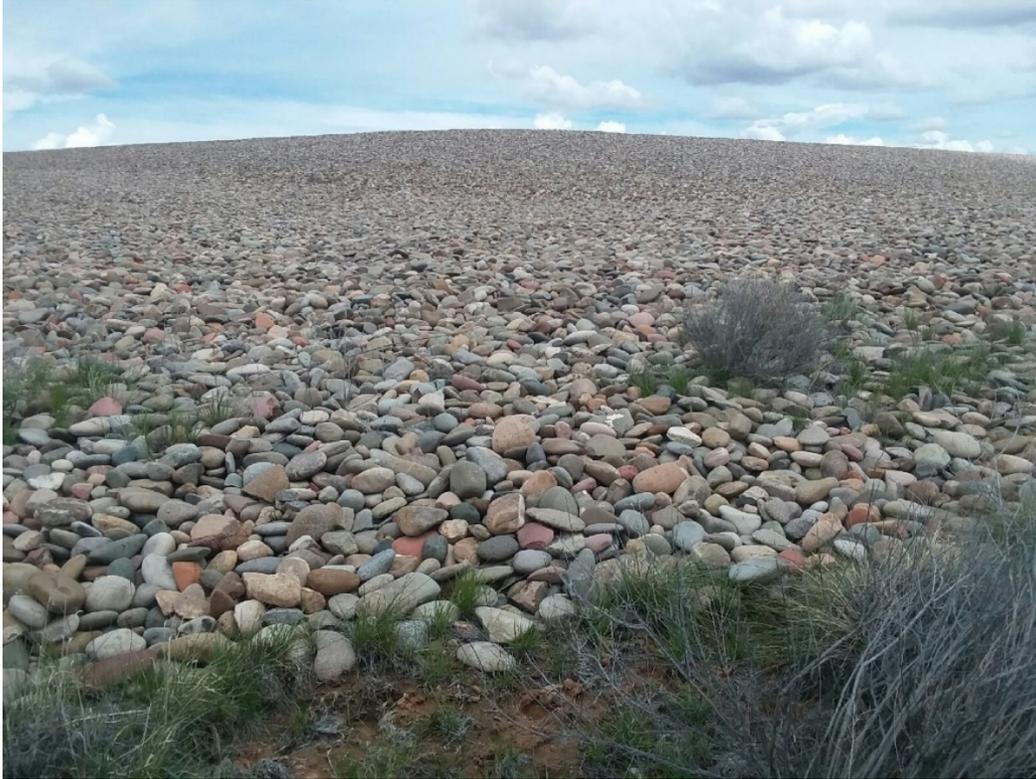
The DOE inspectors checked the disposal cell for evidence of erosion, settlement, slumping, displacement, and any other feature that required maintenance or repair. The rock surfaces on the cover and side slopes were found to be in excellent condition (Figures 1 and 2). The DOE inspectors identified one low area in the southwestern apron. This low area was characterized as 40-50 feet long, 2-3 feet wide, and several inches deep. The DOE staff noted this low area on the site map and planned to observe the status of this area over time.

Figure 1: View of the Slick Rock Disposal Cell and apron from the south

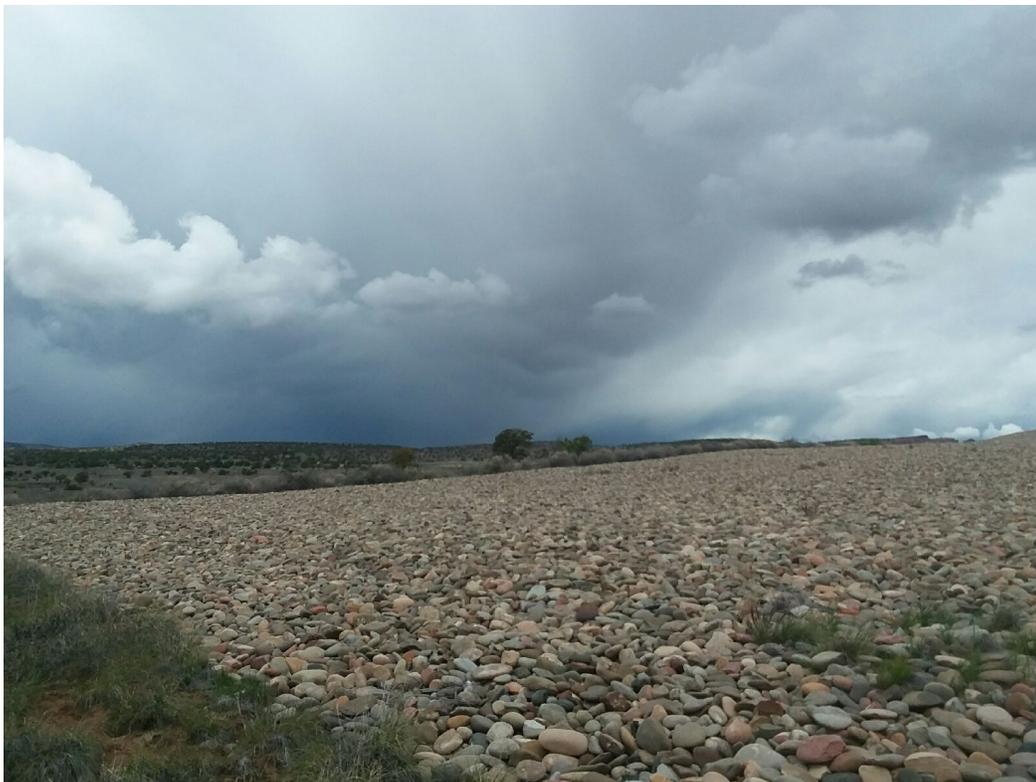
Figure 2: Rip-rap apron, with vegetation, at south corner of the disposal cell

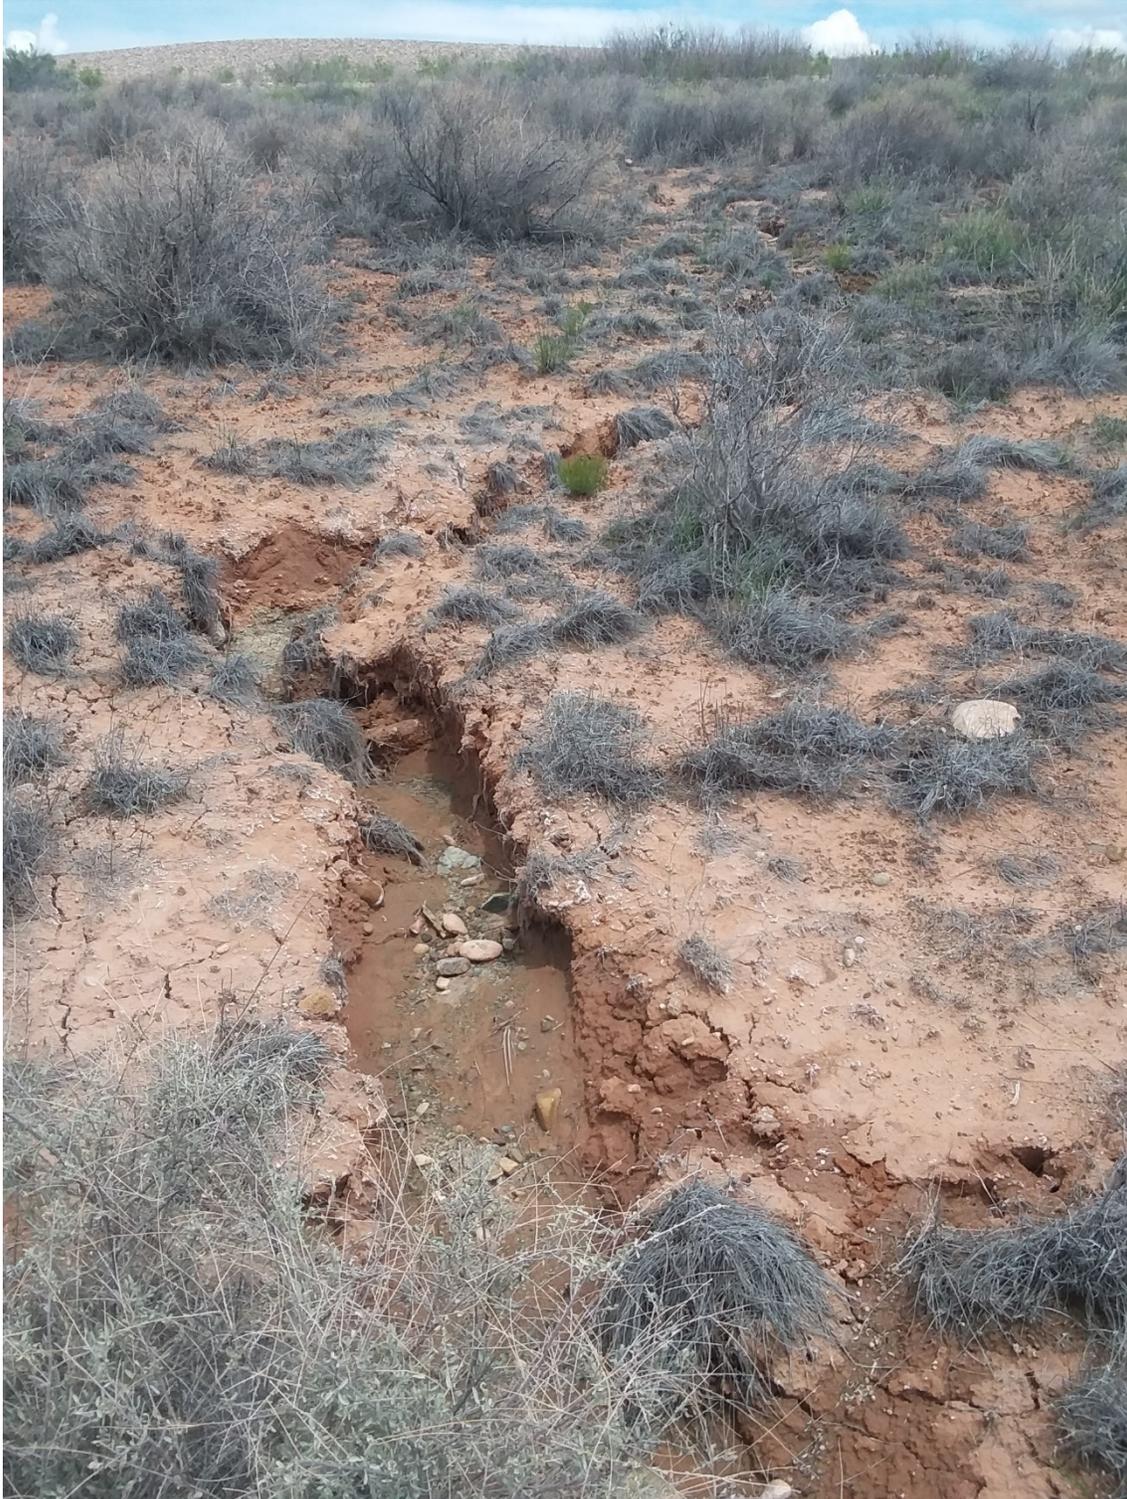
The rills and erosion gullies observed during the 2018 inspection were still visible (Figure 3). The DOE staff concluded that the erosion had not changed significantly since the previous inspection. In summary, the DOE staff did not consider the erosion to be significant, and the erosion had no observable impact on the disposal cell itself. The DOE staff did not believe that repairs were necessary at this time, but the DOE staff will continue to monitor site erosion during future inspections. The DOE staff also observed the condition of the retention pond (Figure 4). The retention pond was dry at the time of the inspection.

Figure 3: Erosional gully near retention pond (facing north towards disposal cell)

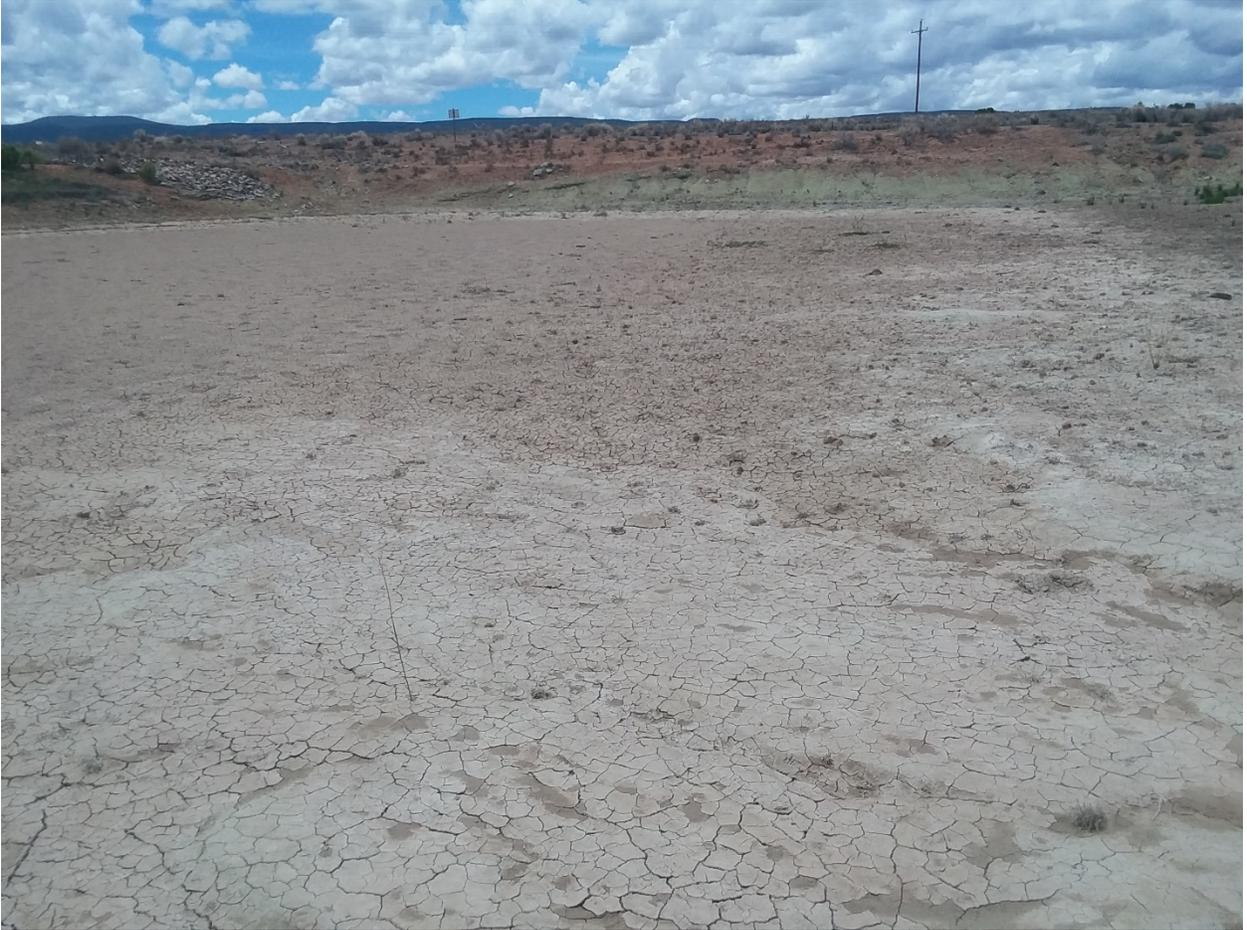
Figure 4: Retention pond south of disposal cell (facing south)
