Anchor Darling Double Disc Gate Valve Wedge Pin Failures

Greg Krueger (Exelon)
BWROG Vice Chairman

BWROG EOC & NRC Meeting
July 17, 2019

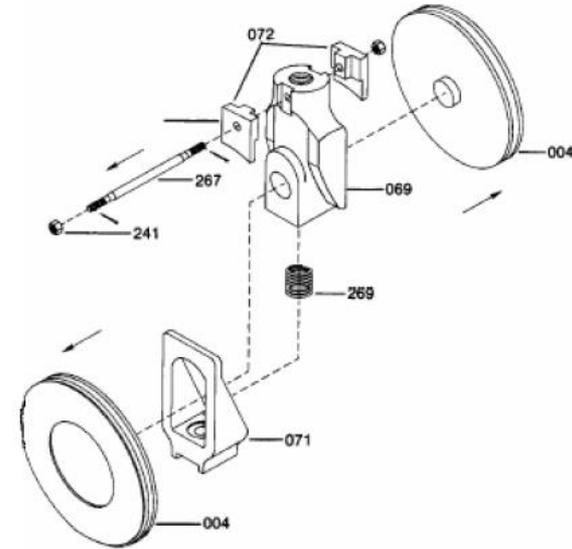
- On February 25, 2013, Flowserve issued a 10CFR Part 21 Notification concerning wedge pin failure of an Anchor Darling Double Disc Gate Valve at Browns Ferry Plant Unit 1. Disassembly and inspection revealed that the valve stem to wedge anti-rotation pin had broken in several locations and the disc retainer had fallen from the wedge assembly and was found between the valve discs. Flowserve in their 10CFR Part 21 Notification concluded that the root cause of the wedge pin failure was excessive load on the wedge pin. The stem operating torque exceeded the torque used to tighten the stem into the upper wedge before installation of the wedge pin, ultimately causing the wedge pin to shear. Flowserve states that this situation can potentially on any A/D DDGV with a threaded stem to upper wedge connection operated by an actuator that applies torque to the stem to produce the required valve operating force.

- On February 11, 2017, Exelon's LaSalle U2 experienced a stem-disc separation of their High Pressure Core Spray Pump Discharge Valve. It was concluded that the 12" MOV had failed during the refueling outage sometime between the local leak rate testing and the HPCS system fill and vent procedure. The subject MOV was identified as one of 22 LaSalle MOVs potentially susceptible to wedge pin failures. LaSalle had been monitoring this valve using the guidance provided under the original version of the BWROG VTRG guidance. The MOV was last diagnostically tested in 2015. Post failure analysis of the 2015 diagnostic test traces identified anomalies of the valve open pullout region that were not present in the 2011 and 2005 traces.
