**NEI 99-02 FAQ 19-02 - Final Response  
Brunswick RCS Leakage**

Plant: Brunswick Nuclear Power Plant Unit 1

Date of Event: March 28, 2019

Performance Indicator: BI02 - Reactor Coolant System Leakage

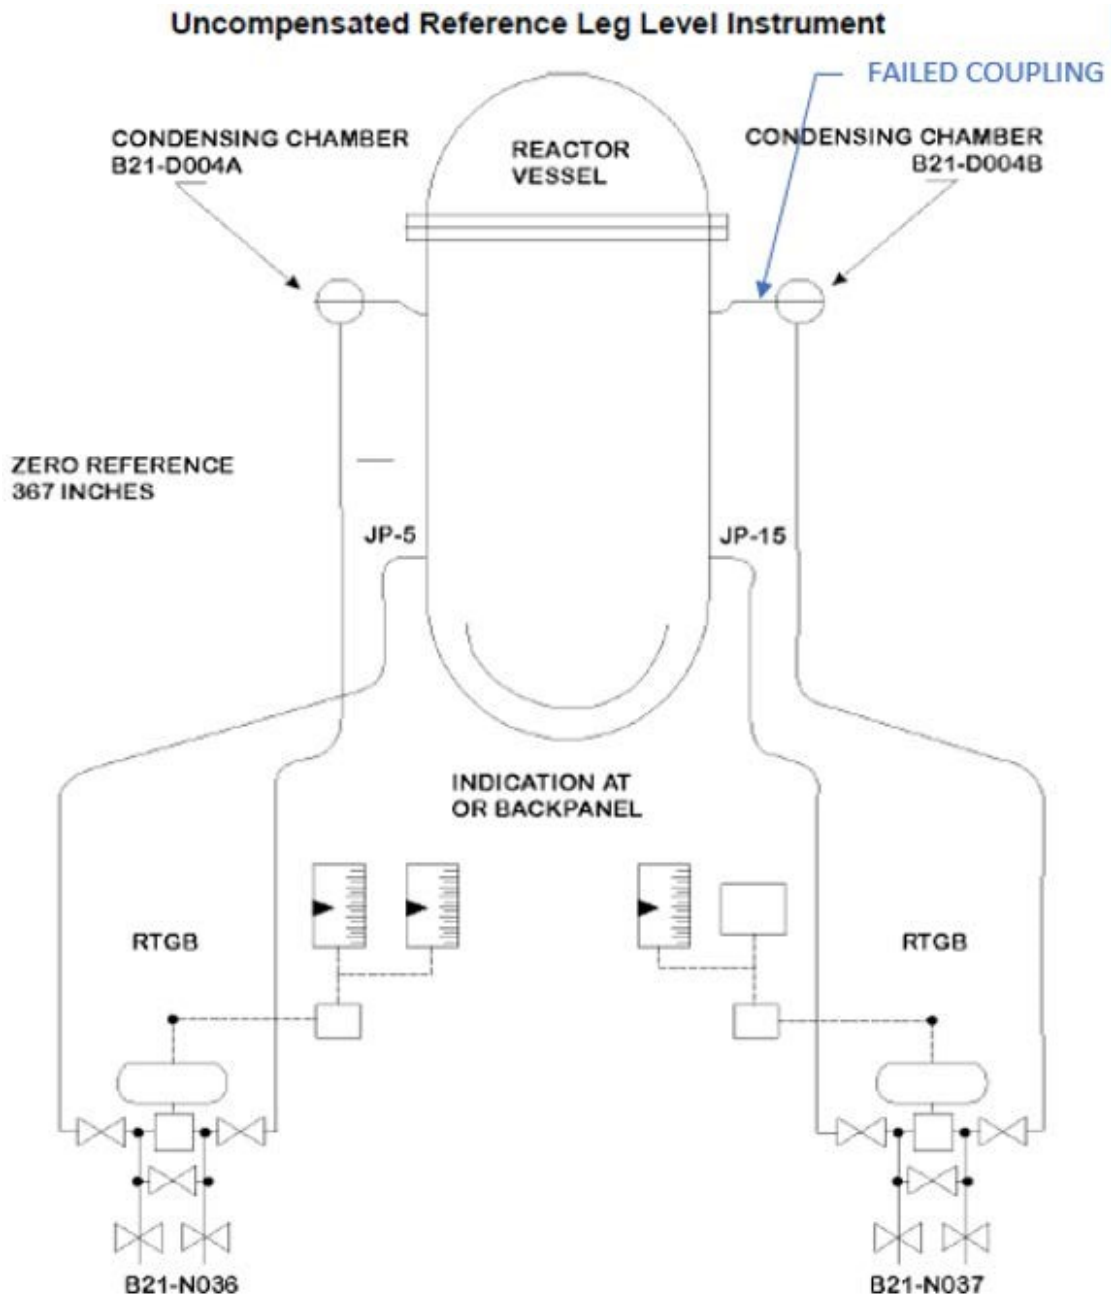
Figure 1, RCS Leak location

Contrary to this, the March 28, 2019, Brunswick event resulted from the immediate circumferential separation of a 1-inch coupling on the steam side sensing line for reactor vessel level indication, as shown in Figures 1 and 2. Based on the material of construction and environmental conditions (i.e., temperature, hydrogen), the post-event metallurgical report determined the coupling showed no evidence of localized plastic deformation. The coupling experienced hydrogen embrittlement and did not exhibit a leak-before-break failure mechanism. There were no precursors to this event and the resulting leakage from the break exceeded the Technical Specification (TS) limit. RCS leakage was stable and well below the TS limit before the event. The steam leak could not be isolated from the reactor vessel. Operations took prompt action to reduce power, commenced a plant shutdown, and depressurized the reactor to stop the leak. The leakage resulted in the declaration of an Unusual Event (UE). Operations completed an uncomplicated reactor shutdown. It was the last reading taken before entering Mode 4 (i.e., the Mode in which the SR is no longer applicable) that caused the PI to transition from Green to White. RCS leakage was stable and was being appropriately managed before the event. Based on these unique circumstances, Brunswick requests an exemption to exclude reporting the leakage from the event in the RCS Leakage PI. This would result in the PI returning to Green for March 2019.

Investigation inside containment determined that a 1-inch coupling on line 1-B21-774 located on the steam side of a reactor level condensing chamber experienced a 360° circumferential separation at the approximate center of the coupling as shown in Figures 1 and 2 below. This opened a path for steam from the reactor to leak into the drywell. Reactor water level was maintained in the established level band, below the level of the sensing line nozzle, throughout the event. The impact from the coupling failure has been analyzed by the Duke Probabilistic Risk Assessment staff and determined to be very low safety significance.

An evaluation was performed to address the couplings installed in both units. All couplings exposed to reactor steam (i.e., potentially susceptible) were removed and replaced with welded fittings prior to startup of Units 1 and 2. In addition, the installation procedure for the couplings was placed on hold pending revision, to prevent any further installation of Cryofit couplings.

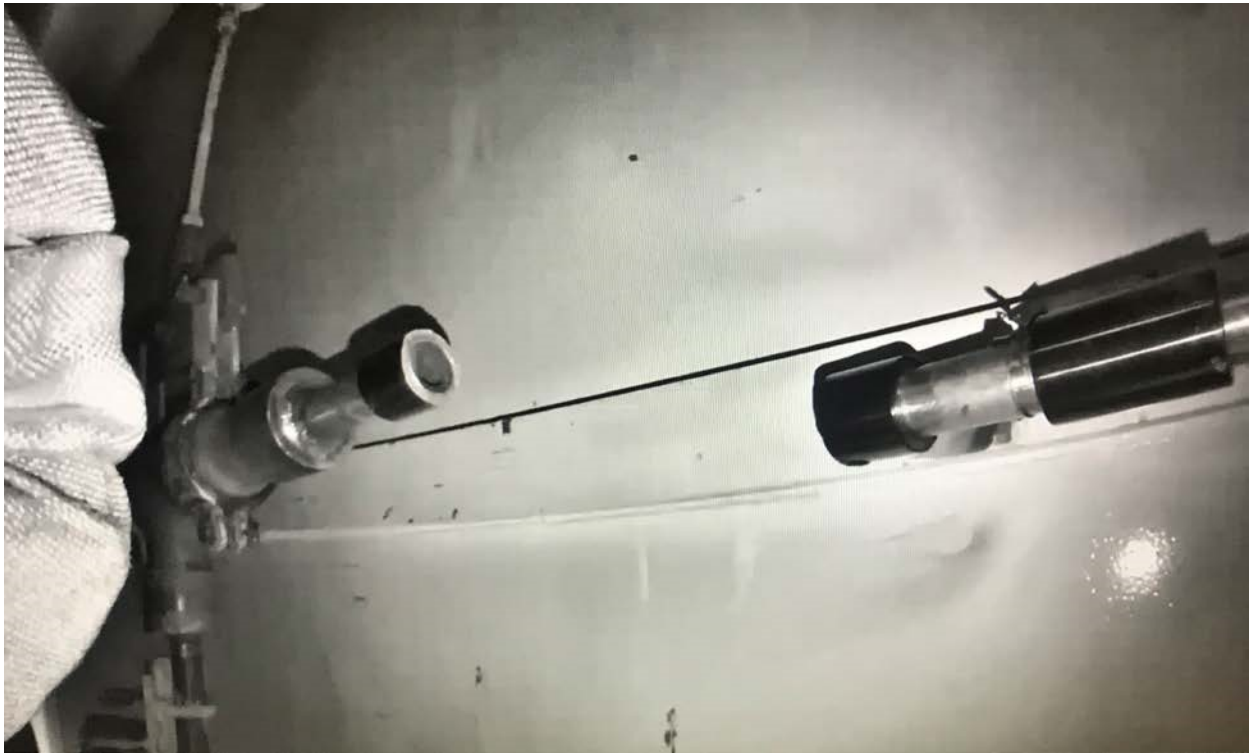
Figure 2, Picture of failed 1-inch coupling:

A Root Cause Evaluation was initiated following the March 28, 2019. The coupling that failed was a 1" Cryofit (cryogenic) coupling. Cryofit couplings are devices used to connect small bore piping (1-inch nominal pipe size and less) without welding. They are fabricated from a shape memory alloy (SMA) material composed primarily of Nickel-Titanium-Iron (TiNi) which experiences a phase change at cryogenic (extremely low) temperatures. To prepare for installation, the Cryofit coupling is cooled below the transformation temperature. The ends of the coupling are then expanded and the coupling is stored in the cold, expanded state. The pipe ends are inserted into the coupling while it is cold. The phase change causes the coupling to shrink as its temperature rises from its installation temperature of less than -200° F to ambient temperature and above. This results in an interference fit that does not require welding. This unique effect is produced by a phase transformation, i.e., an instantaneous shear transformation between the alloy's body-centered cubic austenite phase and its highly twinned martensite phase. These couplings had been installed at Brunswick for approximately 30 years.

characterize the failed material. Using metallurgical analysis and investigation of the process conditions at the coupling location, the Root Cause Evaluation team determined that the failure was due to hydrogen embrittlement of the Tinel material. This resulted from many years of exposure to high temperature and high levels of hydrogen. This conclusion is supported by the transgranular cleavage, high hardness values in the region exposed to the process fluid, and a hydrogen rich environment, which are all consistent with hydrogen embrittlement.

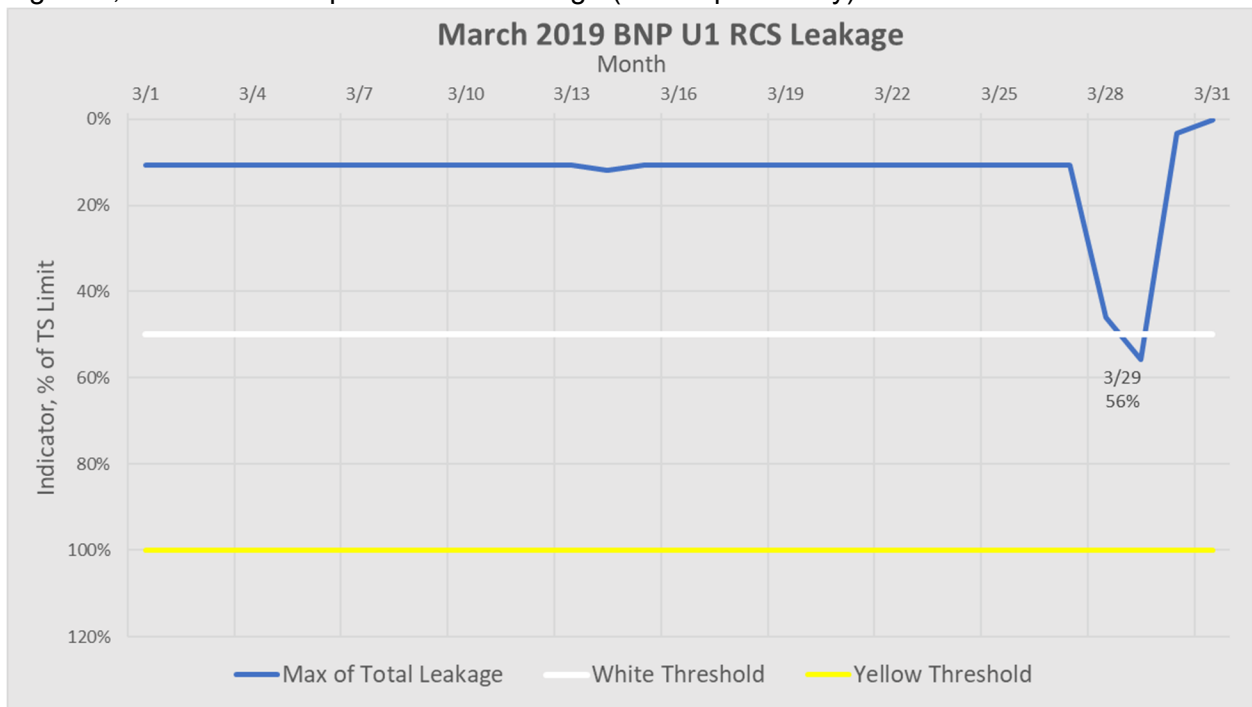
Figure 3, March 2019 Reported RCS Leakage (4-hour periodicity)

The PI is intended to monitor leak-before-break situations that are viewed as precursors of a more catastrophic failure. In the Brunswick event, RCS Total leakage had been steady for the month of March as shown below in Figure 3. There was no advanced indications of degradation or leakage from the coupling and no trend that worsened over time due to operator inaction.

As shown in Figure 3, RCS Leakage trends were stable and low in the Green performance band for the month leading up to the coupling failure. The coupling failure occurred without warning. Drywell leakage and temperature in the vicinity of the coupling did not increase prior to the failure. There was no opportunity for Operations staff to identify this condition in advance of failure. As no precursors were present, no mitigating actions could have been taken in advance of the leak and the actions taken following the leak indicate prompt and conservative response on the part of the licensee. In addition, the location of the leak prevented it from being isolated until the plant was depressurized, which added to the volume of the leakage calculated in the PI. Despite timely operator actions to accomplish this, the volume of leakage calculated in the PI resulted in one calculation data point exceeding the threshold for White. The degradation mechanism of the coupling will be evaluated under other NRC processes.
