May 23, 2019

Subject: Answer to Notice of Violation and Proposed Imposition of Civil Penalty  
USNRC License No.: 42-32219-01  
Docket No.: 030-35252  
NRC Inspection Report 030-35252/2018-003; EA-18-124

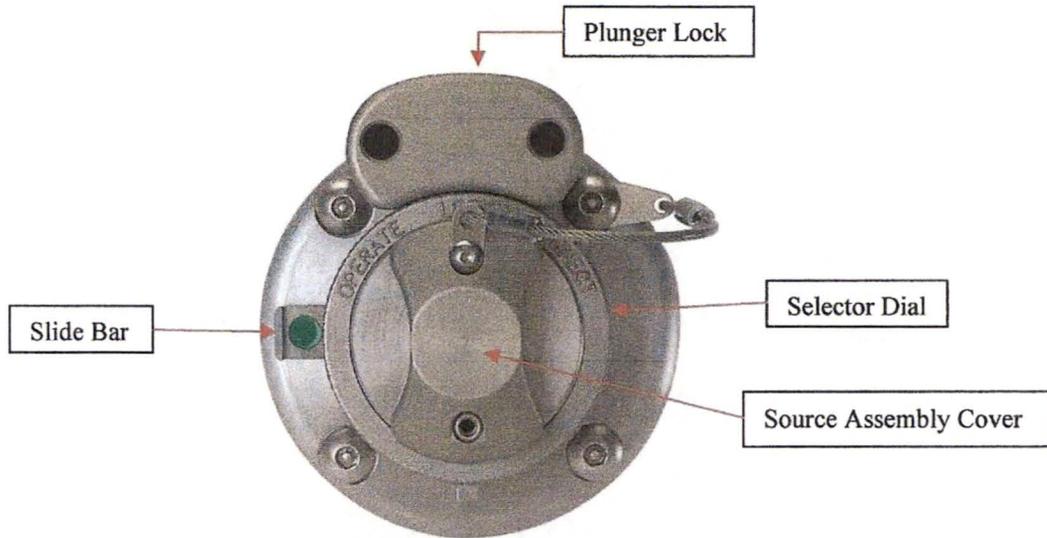
Figure 1: [REDACTED] Lock Assembly

**Mitigating Factors:** The exposure device being utilized was a [REDACTED] which by design incorporates three independent locking mechanisms to prevent accidental movement or exposure of the source. (See description and picture below.)

- 1) A positive locking mechanism (slide bar) which secures the source assembly in the exposure device and prevents movement of the source;
- 2) A selector dial which prevents movement of the positive locking mechanism until time to expose the source. The selector dial has three positions: lock, connect and operate. The selector dial can be rotated left from the lock position to the connect position or right to the operate position with the lock position being in the top center. Turning the selector dial to the connect position unlocks and opens the rear cover of the lock assembly for inspection of the source assembly and/or connection of the drive assembly. In the connect position, the source assembly remains secured by the slide bar as in this position there is no way to engage the slide bar. Turning the selector dial to the operate position exposes an opening in the dial whereby the slide bar can be engaged to release the source assembly when ready to make an exposure; and,

- 3) A keyed plunger lock which prevents the selector dial from being rotated.

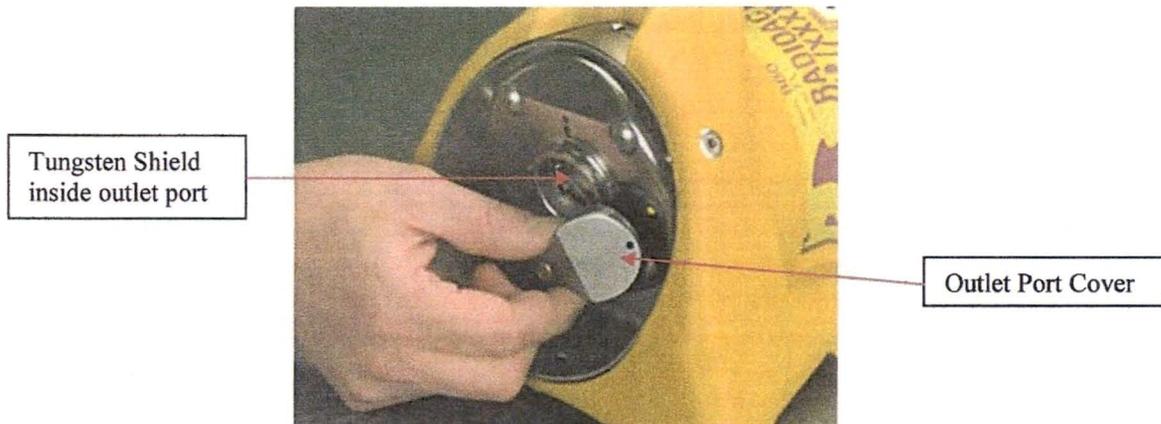
Figure 2: [REDACTED] Front Outlet Port

The device also incorporates a tungsten shield at the exit port that can only be opened once a guide tube is connected to the device. The tungsten shield provides a shielding factor to reduce exposure from the source, but also provides another level of security as it prevents the source from projecting out of the exposure device unless a guide tube is connected.
