**Calvert Cliffs CC2R23 180-Day Steam Generator Tube Inspection
Report**

Calvert Cliffs Unit 2

STEAM GENERATOR TUBE INSPECTION REPORT

REFUELING OUTAGE 23

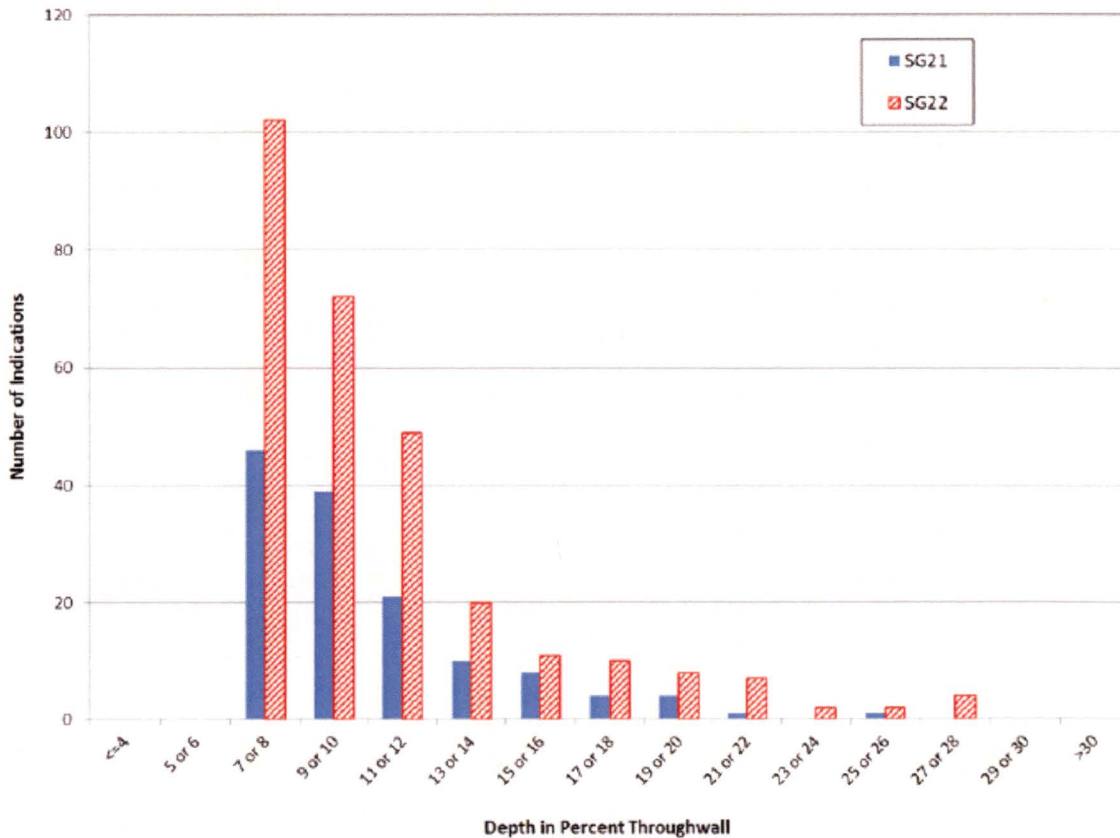
Figure 1 – Distribution of Fan Bar Wear Depth

Table 2 provides a summary of the fan bar wear indications from CC2R23. The maximum depth among these indications was 28% TW, which is consistent with results from previous inspections. Growth of the repeat indications was minimal and consistent with previous results.

Figure 1 provides the distribution of fan bar wear depths for both steam generators as reported with the bobbin coil probe. As shown in the figure, SG22 contained more indications. Most of the indications in both SG's are less than 20% TW.

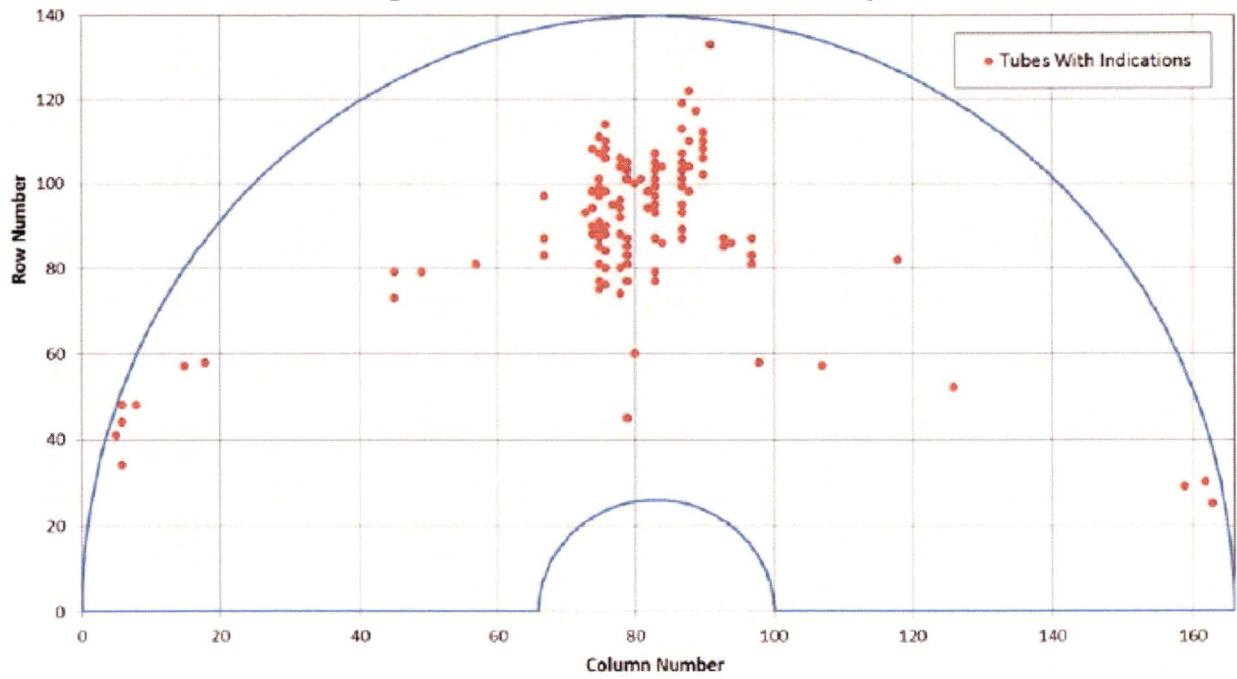
Figure 2 – SG21 Fan Bar Wear Map

Figures 2 and 3 provide tube map locations of the reported FBW. Although the tube maps shown in Figures 2 and 3 provide a view of the tubesheet primary face from the hot leg side, both the hot leg and cold leg FBW indications are included on each map. Most of the wear continues to occur in larger U-bend radius tubes clustered towards the center-most tube columns.

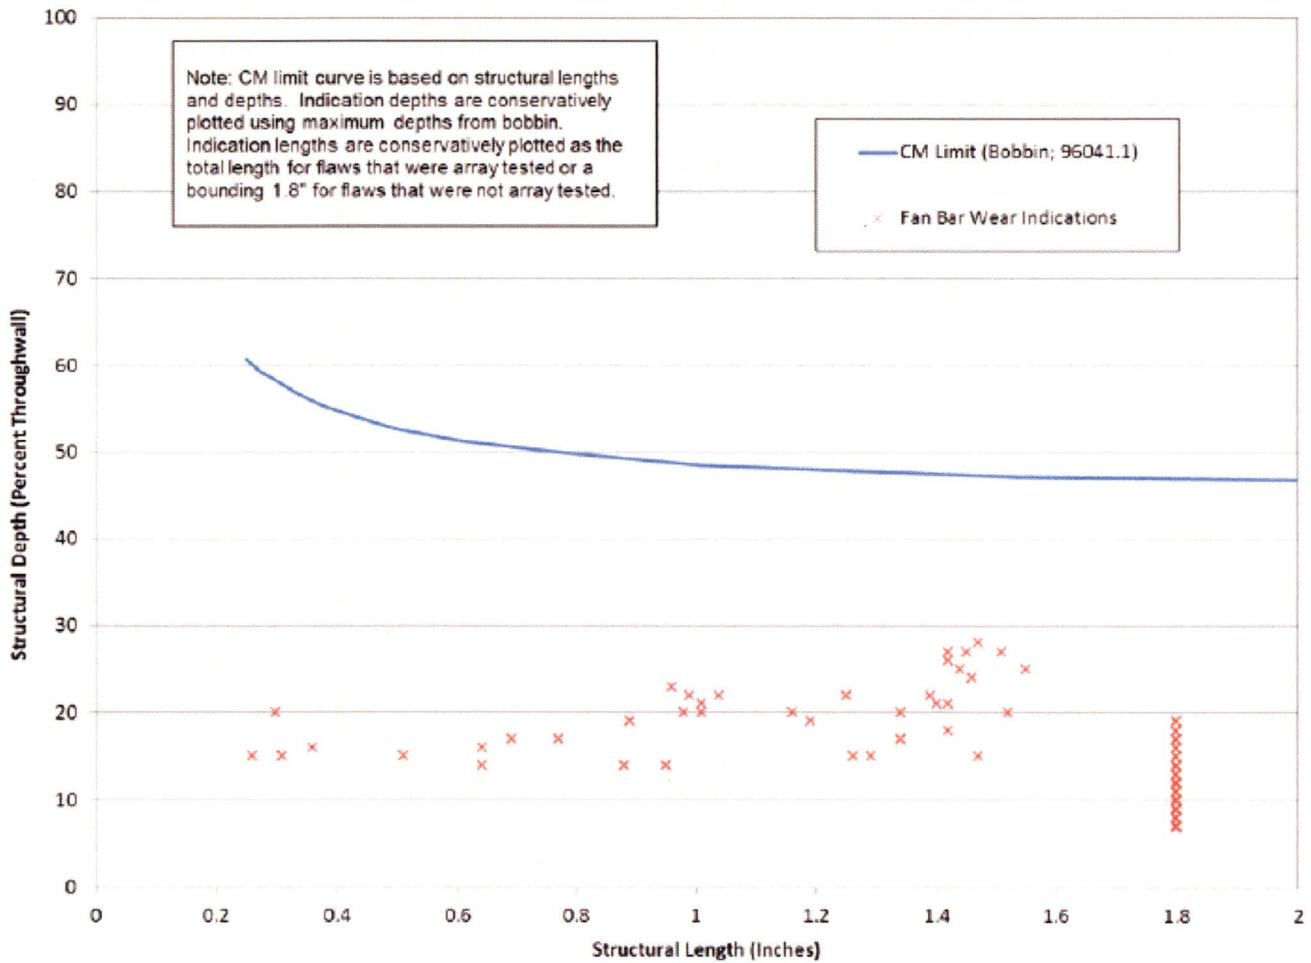
Figure 4 – Condition Monitoring Results for Fan Bar Wear

EPRI Examination Technique Specification Sheet (ETSS) 96041.1 was used for depth sizing of fan bar wear. Based on the sizing parameters for this technique, the CM curve shown in Figure 4 was generated and documented in the CMOA. A minimum of the twenty deepest indications in each steam generator were inspected with array to validate the flaw shape and length assumptions. The longest of these deepest flaws measured 1.55 inches with array. Most of the indications were tapered, but a few indications had relatively flat profiles.

The indications that were inspected with array were plotted at their total length as measured with array probes. All other fan bar wear indications detected by bobbin were conservatively plotted at a bounding axial length of 1.8 inches based on current and previous length sizing of the deepest indications. Since some of the indications were flat, all indications were conservatively plotted using the maximum bobbin depth as opposed to the structural (or burst-equivalent) depth. As shown, all indications lie well below the CM curve. Hence, structural integrity of the fan bar wear indications is demonstrated.

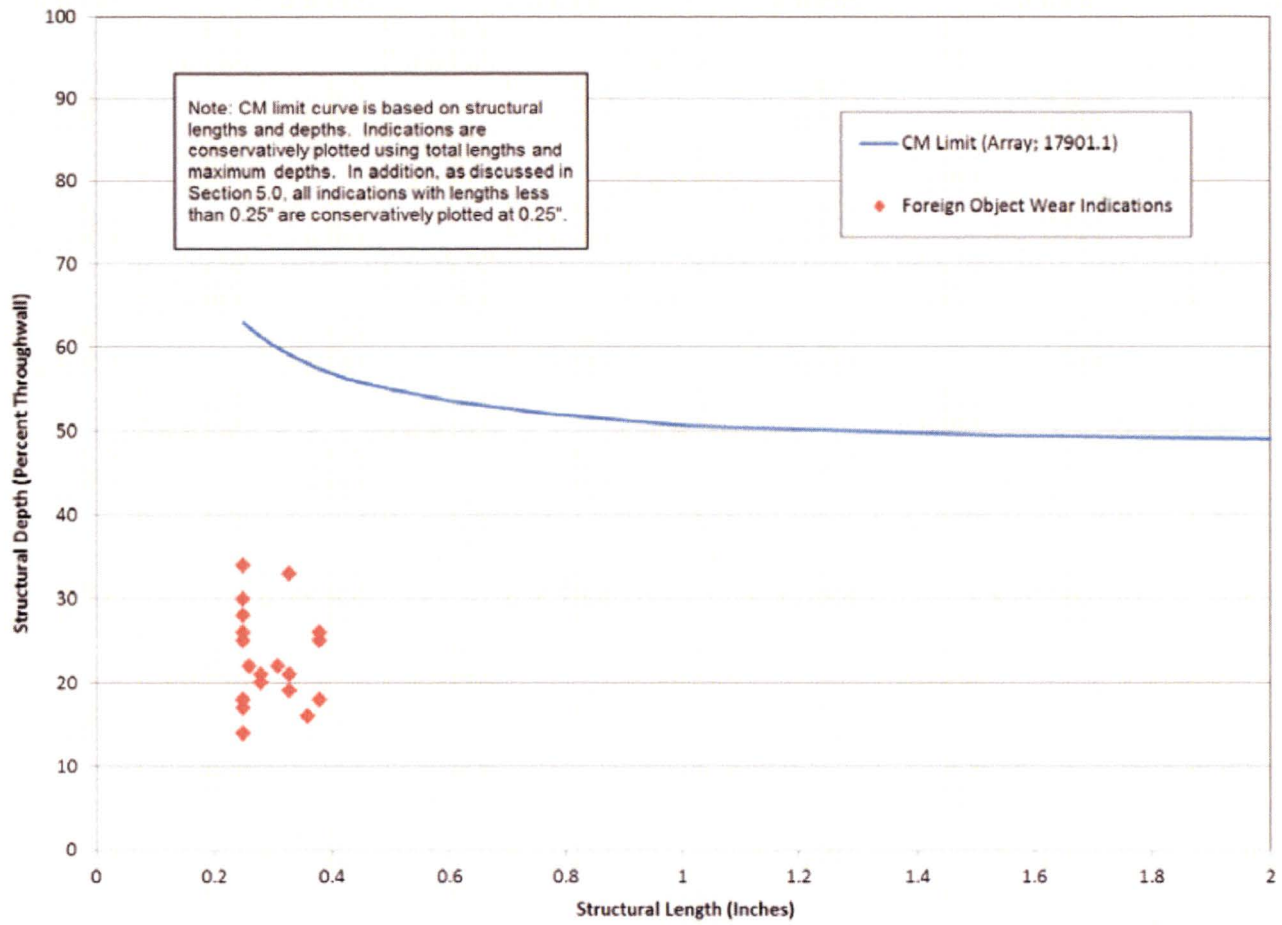
Figure 5 – Condition Monitoring for Foreign Object Wear

EPRI Examination Technique Specification Sheet (ETSS) 17901.1 was used for depth and length sizing of all foreign object wear indications. Based on the sizing parameters for this array probe technique, the CM curve shown in Figure 5 was generated and documented in the CMOA. As shown, all 22 indications lie well below the CM curve. Hence, structural integrity of the foreign object wear indications is demonstrated.

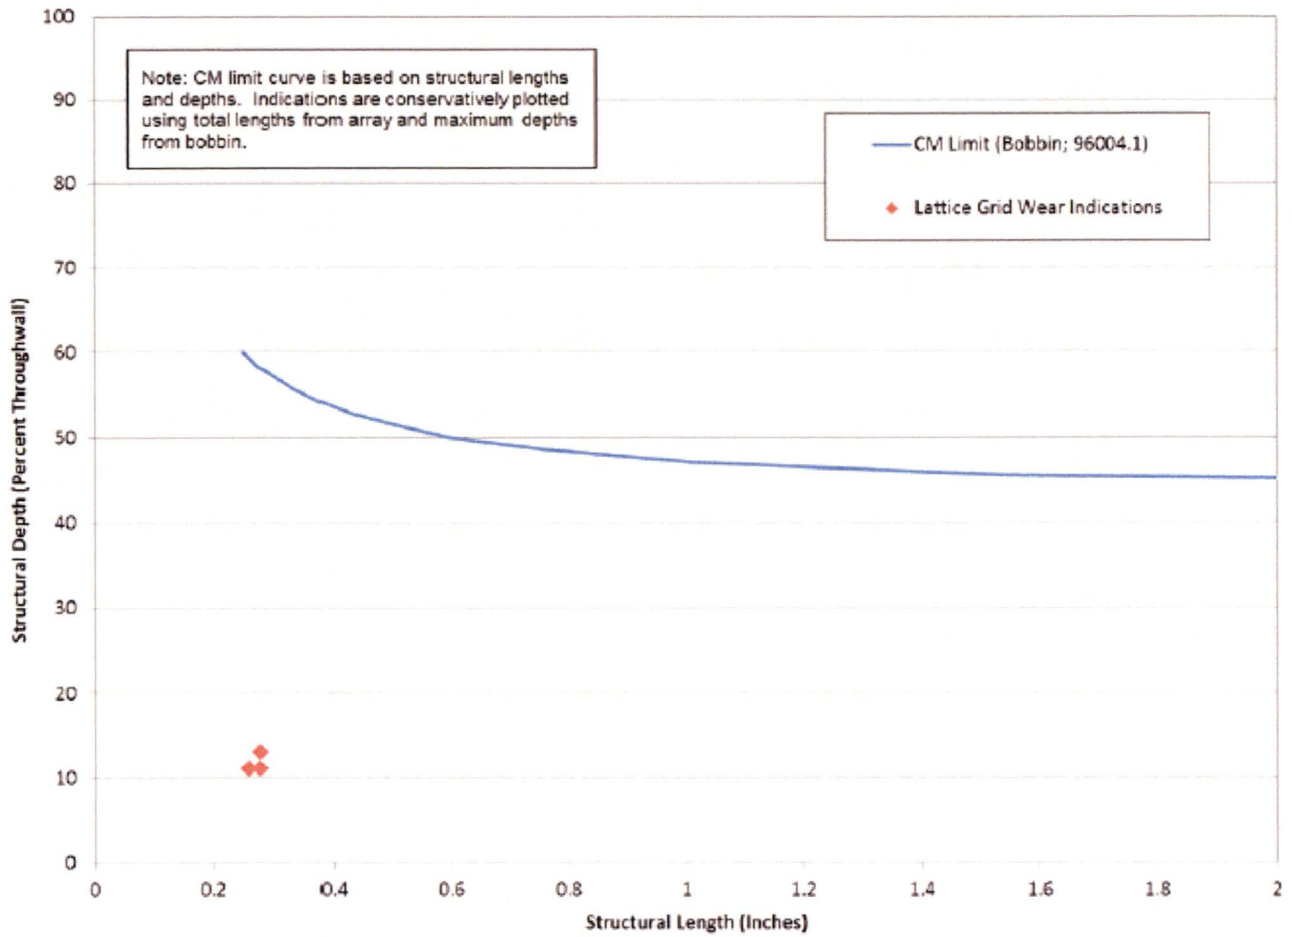
Figure 6 – Condition Monitoring for Lattice Grid Wear

EPRI Examination Technique Specification Sheet (ETSS) 96004.1 was used for depth sizing of lattice grid wear. Based on the sizing parameters for this technique, the CM curve shown in Figure 6 was generated and documented in the DA. Since all three of the lattice grid wear indications were inspected with the Array probe, the lengths measured from the Array inspections are reflected in the figure. As shown, all 3 indications lie well below the CM curve. Hence, structural integrity of the lattice grid wear indications is demonstrated.
