June 17, 1977

THREE MILE ISLAND NUCLEAR STATION
UNIT 1

REACTOR CONTAINMENT BUILDING
RING GIRDER SURVEILLANCE TEST
THREE YEARS AFTER S. I. T.

METROPOLITAN EDISON COMPANY
Subsidiary of General Public Utilities, Corp.

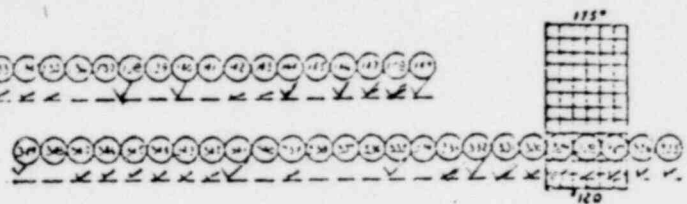
TABLE 3
 CONCRETE CRACKS ADJACENT TO DOME TENDON BEARING AREAS
 AND CONCRETE-TO-METAL GAPS
 Southwest (S.W.) Quadrant

1. All cracks are less than 0.005 in. wide.
2. Unless otherwise noted the cracks extend from the metal bearing plate across the adjoining two to four inches of concrete.
3. Bearing area blocked from inspection by vent stack.
4. Voids Discovered. (All Voids are shown on Figures 6-12).
5. D 247SW & D248SW have very narrow gaps (unmeasurable) between the bottom of the bearing plate and the adjoining concrete.
6. Note 4 & 5 refer to 1976 data. No additional cavities or voids were discovered during 1977.

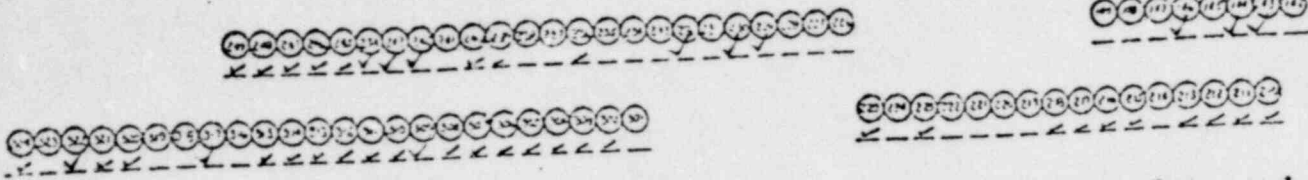
CONCRETE CRACKS ADJACENT TO DOME TENDON BEARING AREAS
AND CONCRETE-TO-METAL GAPS
Southeast (S.E.) Quadrant

- All cracks are less than 0.005 in. wide.
- Unless otherwise noted the cracks extend from the metal bearing plate across the adjoining two to four inches of concrete.
- No gaps were noted between concrete and bearing plates. Small cavities found. (approximately 1" deep and 1 in. 3/4 in volume.)
- Note 4 refers 1976 data. No additional cavities or voids were discovered during 1977.

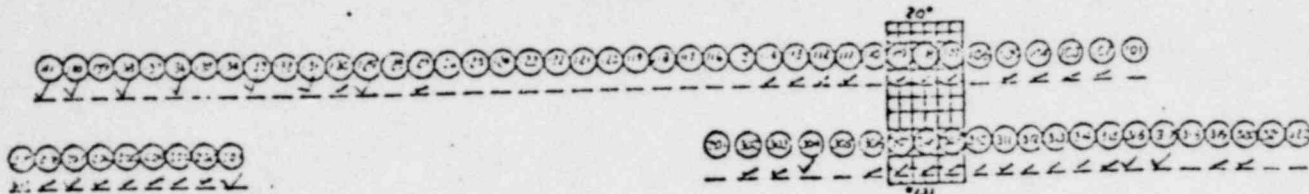
CONCRETE CRACKS ADJACENT TO DOME TENDON BEARING AREAS
AND CONCRETE-TO-METAL GAPS
Northeast (N.E.) Quadrant

- All cracks are less than 0.005 in. wide.
- Unless otherwise noted the cracks extend from the metal bearing plate across the adjoining two to four inches of concrete.
- Five cracks less than 0.005 inc. radiate down from the bottom of the bearing plate, spaced approximately five inches on centers and terminating about one inch from the edge of the bearing plate.
- Four cracks -- similar to those described in Note 3.
- Void Discovered. (All Voids are shown on Figures 6-12).
- Note 4 & 5 refer to 1976 data. No additional cavities or voids were discovered during 1977.

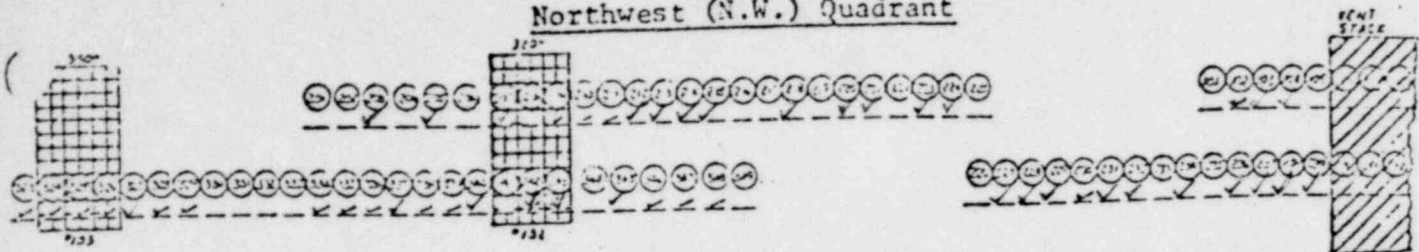
TABLE 6
 CONCRETE CRACKS ADJACENT TO DOME TENDON BEARING AREAS
 AND CONCRETE-TO-METAL GAPS
 Northwest (N.W.) Quadrant

- NOTES
1. All cracks are less than 0.005 in. wide
 2. Unless otherwise noted the cracks extend from the metal bearing plate across the adjoining two to four inches of concrete.
 3. Bearing area blocked from inspection by vent stack.
 4. Void Discovered. (All Voids are shown on Figures 6-12).
 5. Note 4 refers to 1976 data. No additional cavities or voids were discovered during 1977.

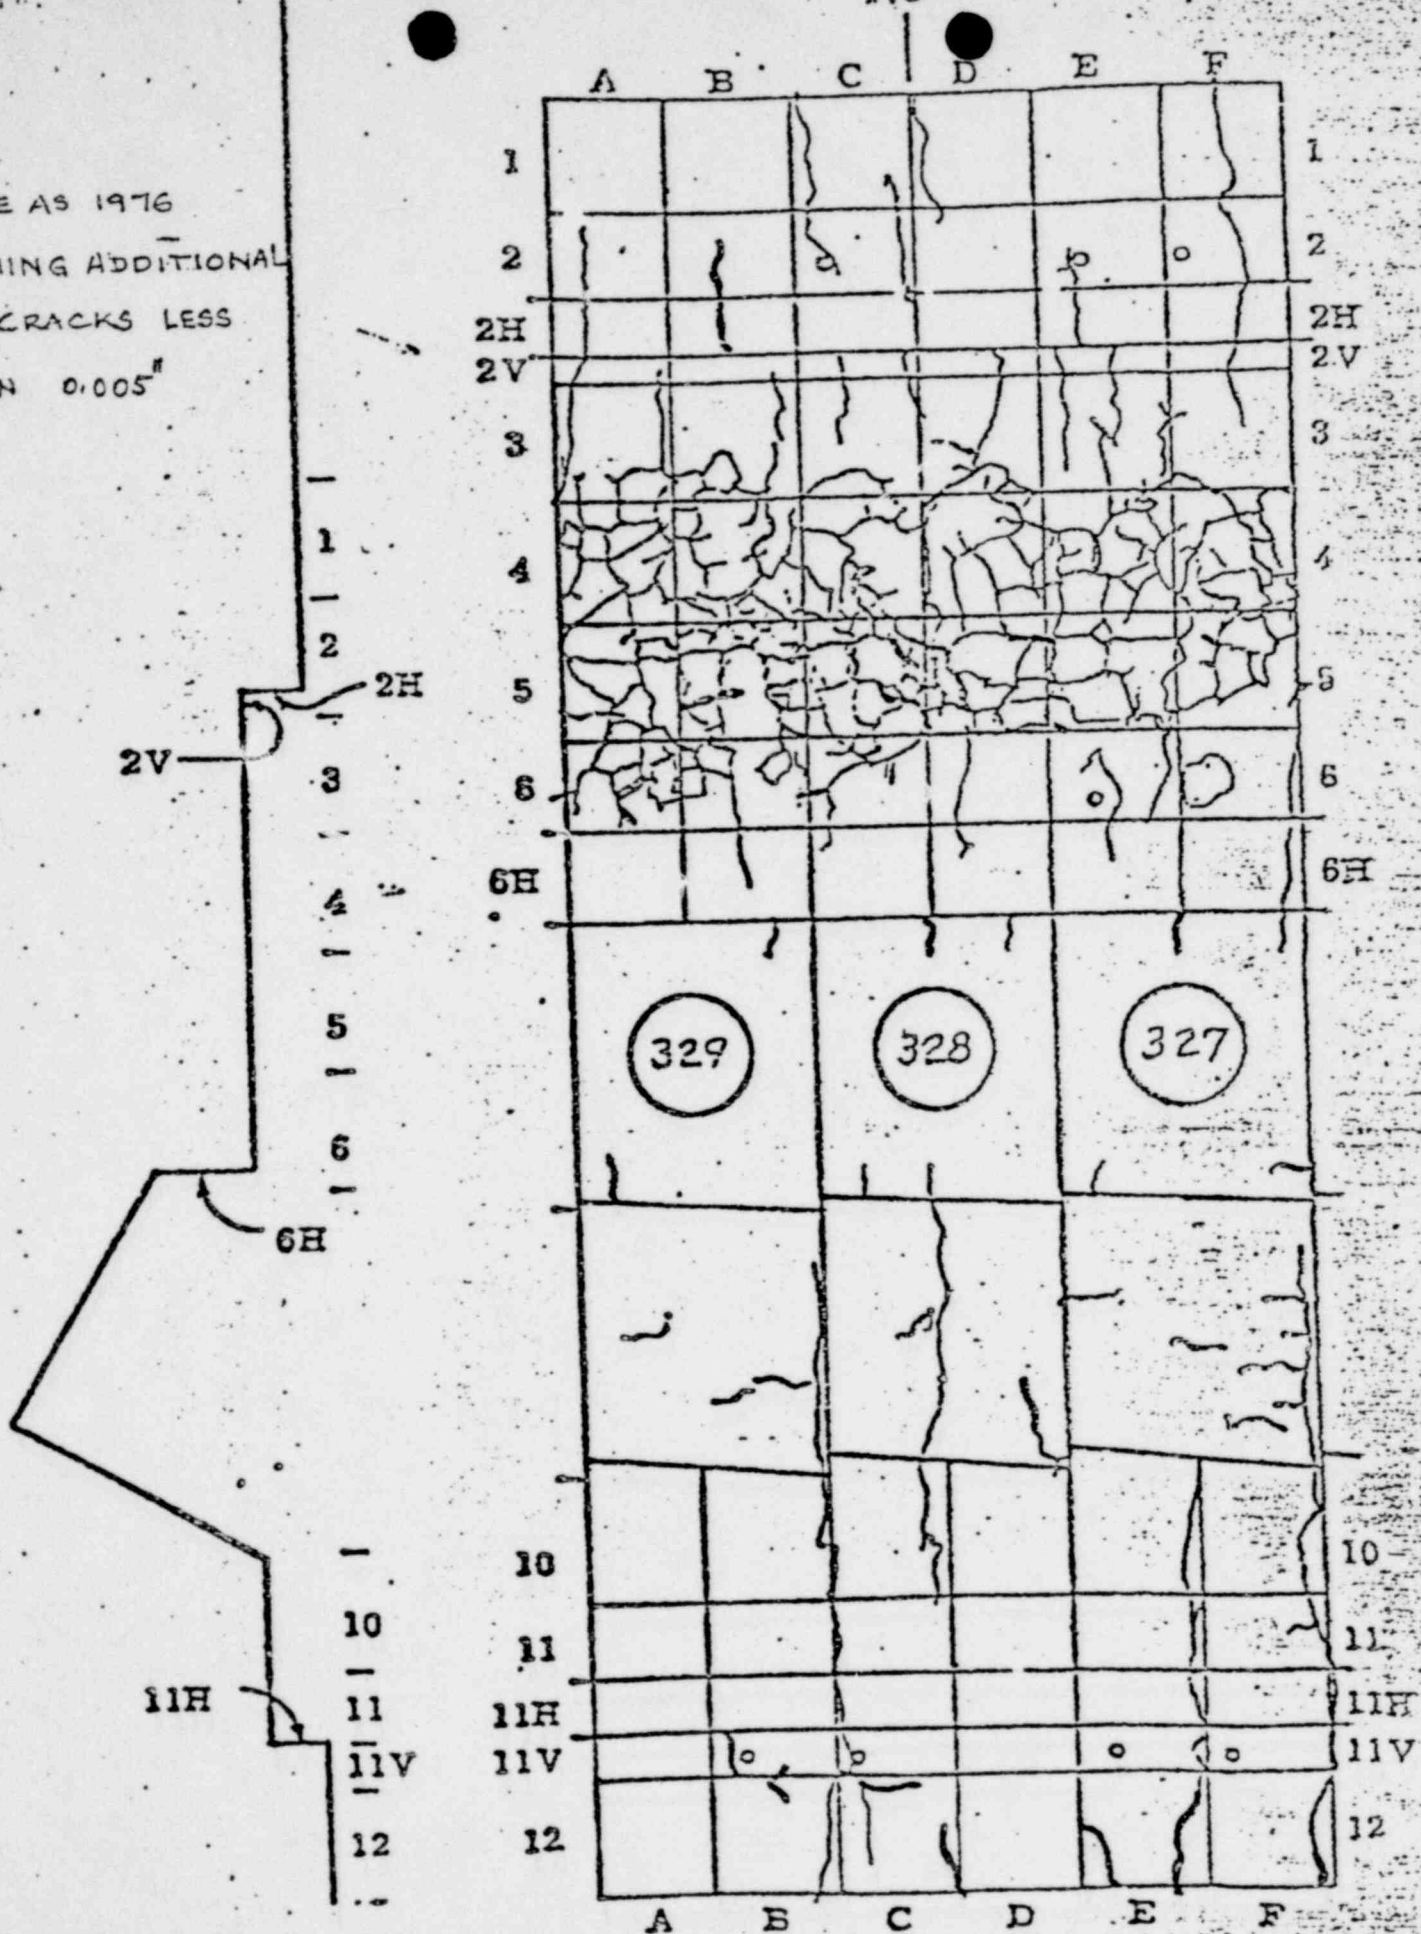
FIGURE 2

Crack widths as shown in the crack pattern charts for the white-washed areas, Figures two through five, do not indicate any crack wider than 0.010 inch, which is the acceptance criteria (Tech. Spec. 4.4.2.2.C2). There has been a decrease in the width of a few cracks charted during previous surveillance inspections.

SAME AS 1976

NOTHING ADDITIONAL

ALL CRACKS LESS

THAN 0.005"

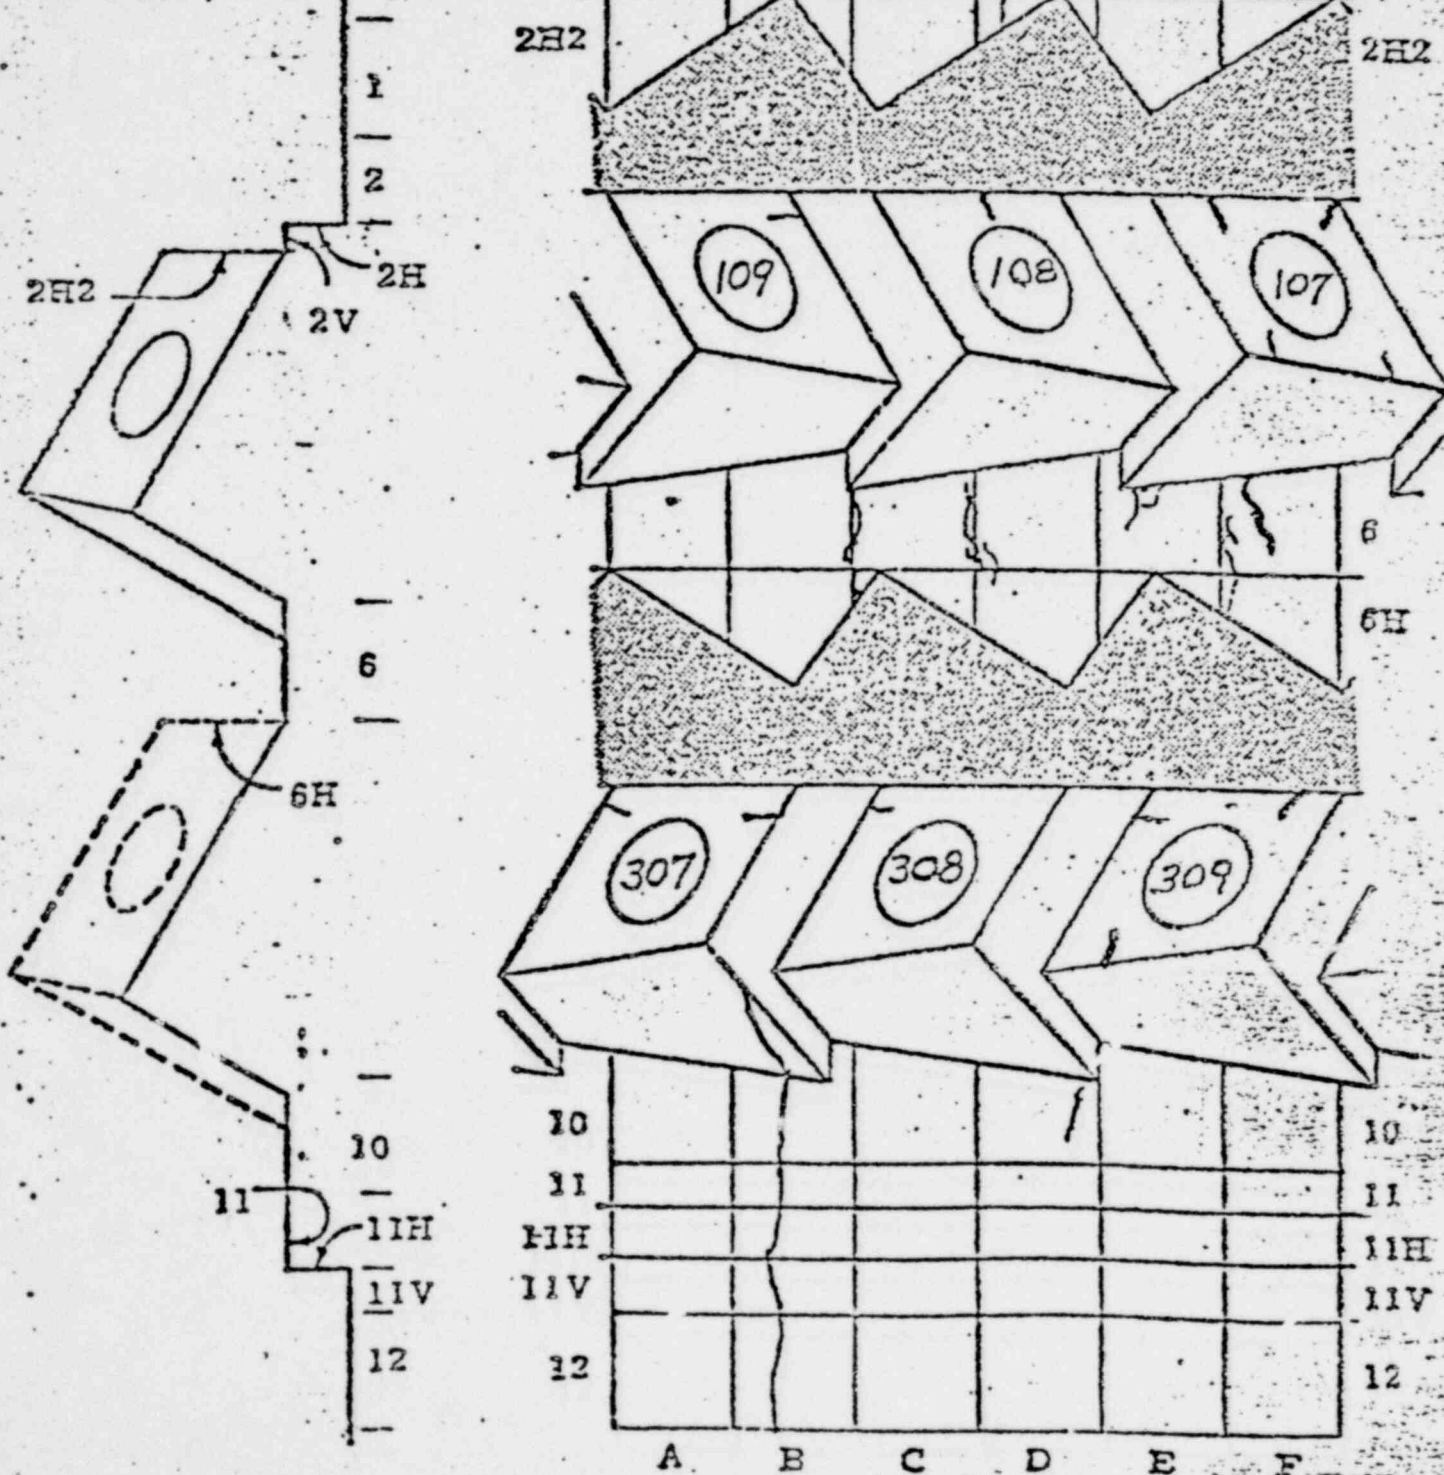
AREA NO. 13F FIGURE 3

ALL CRACKS ARE LESS THAN 0.005 IN. WIDE

SAME AS IN 1976
NOTHING ADDITIONAL
ALL CRACKS LESS THAN 0.005

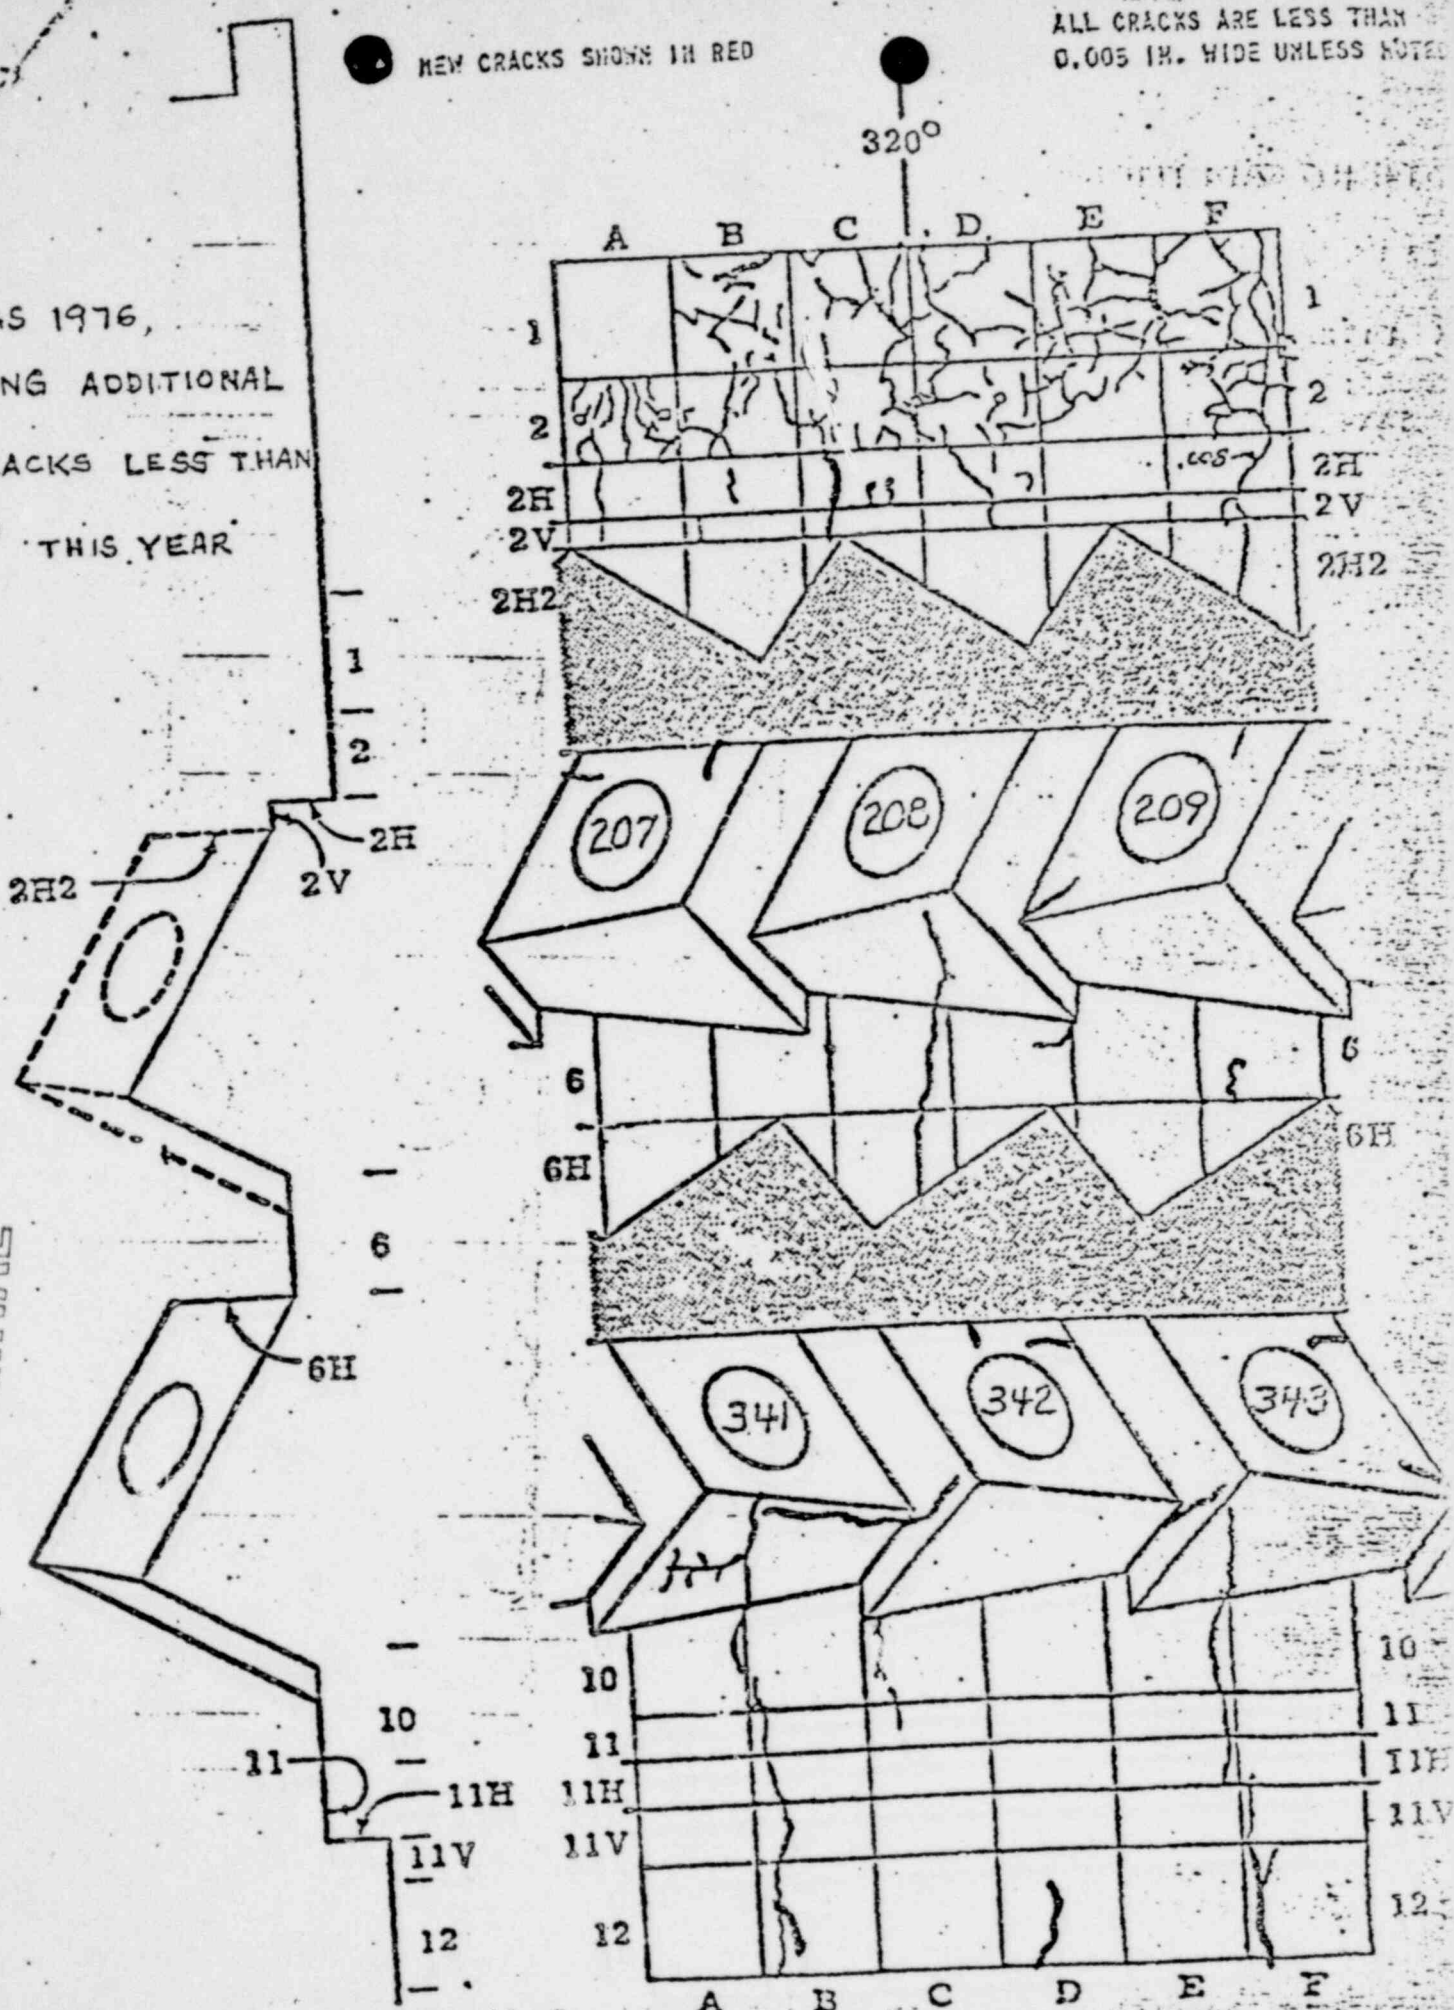
CRACK PATTERN AREA AT AZIMUTH 320° AREA 5132

SAME AS 1976,
NOTHING ADDITIONAL
ALL CRACKS LESS THAN
0.005" THIS YEAR

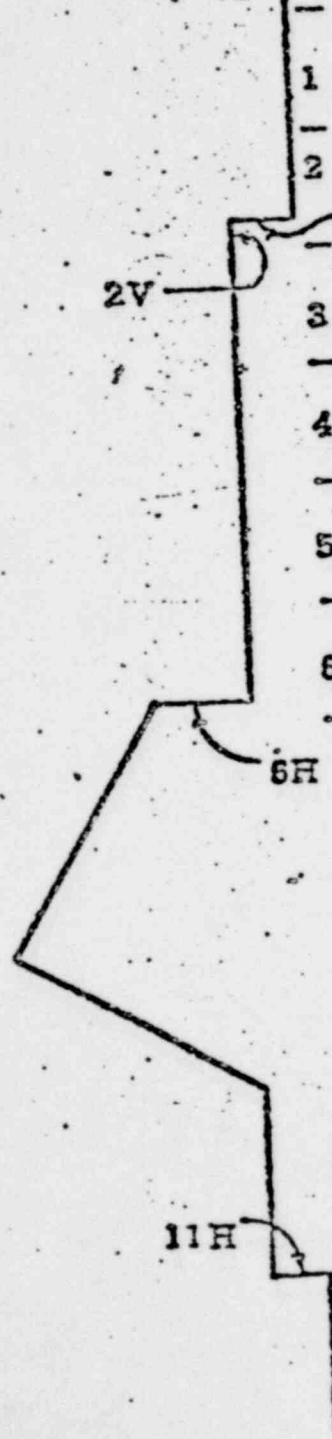
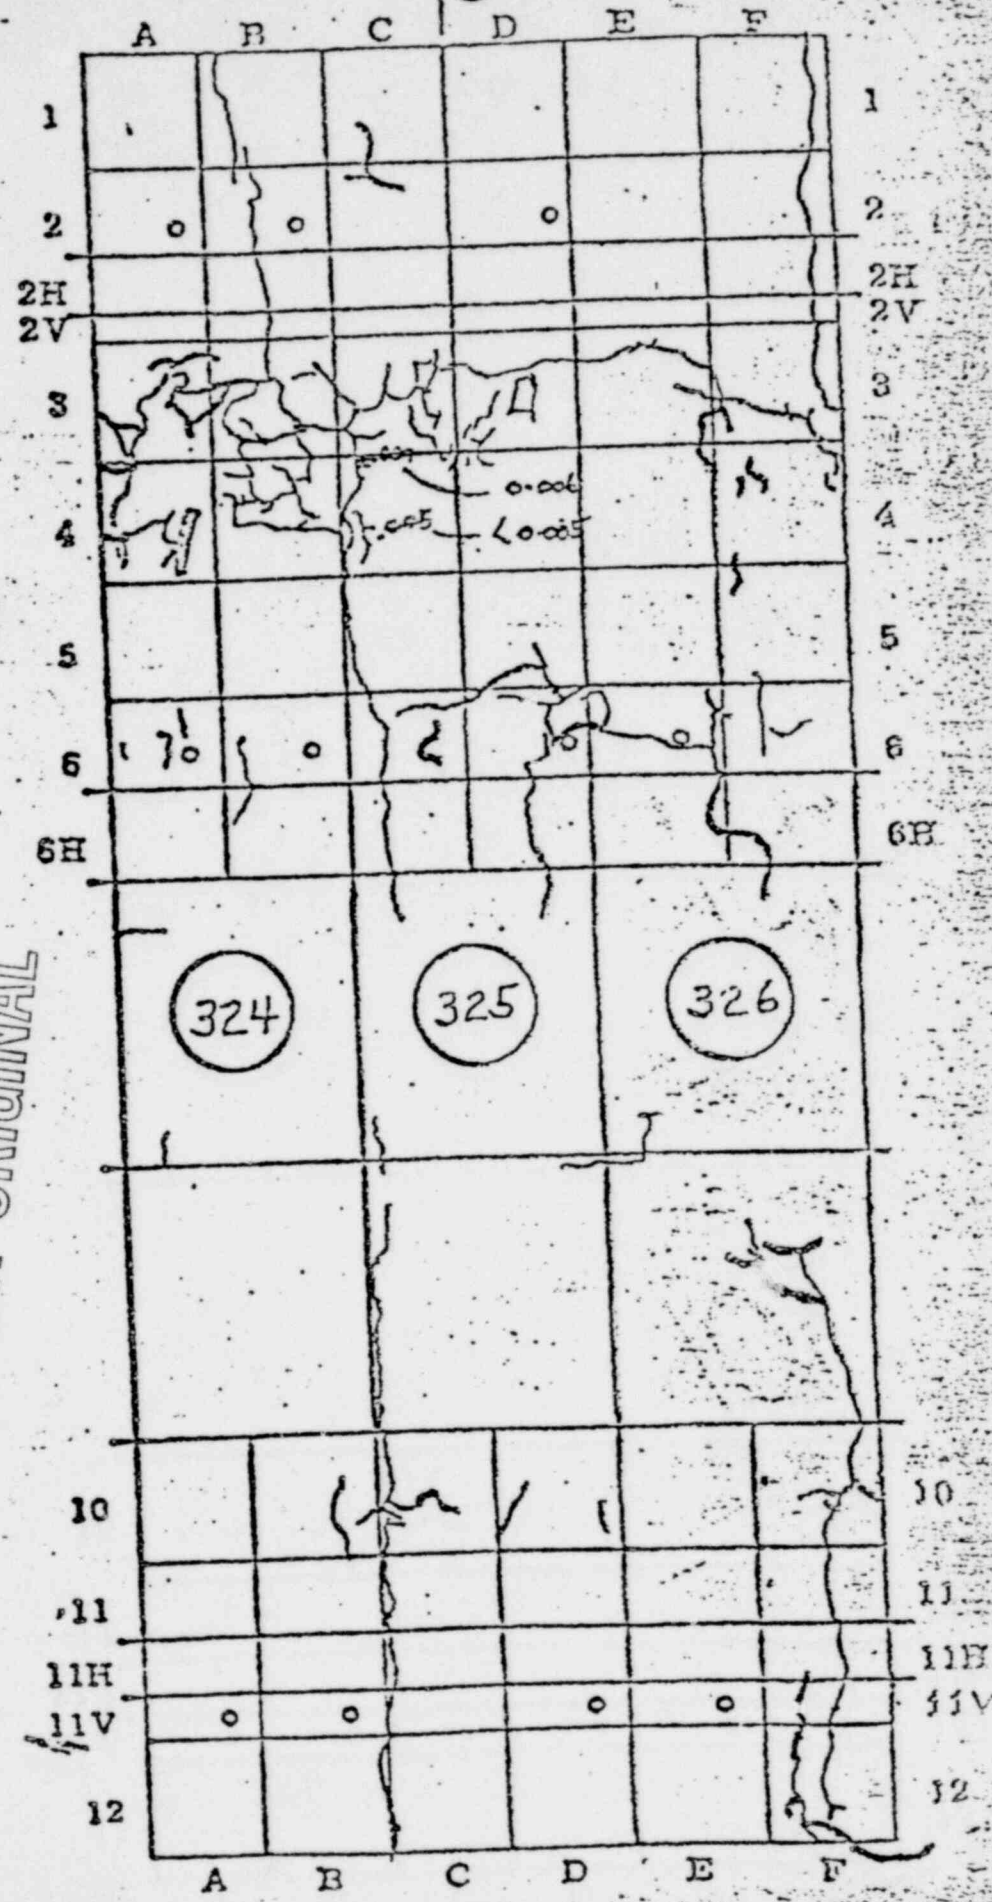
CRACK PATTERN AREA AT AZIMUTH 350°
AREA NO. 133

NOTHING ADDITIONAL
EXCEPT AS NOTED
I.E. DECREASE IN SIZE
OF TWO CRACKS
