LICENSEE EVENT REPORT

Attachment to LER-79-020-01X-1  
Consumers Power Company  
Big Rock Point Plant  
Docket 50-155

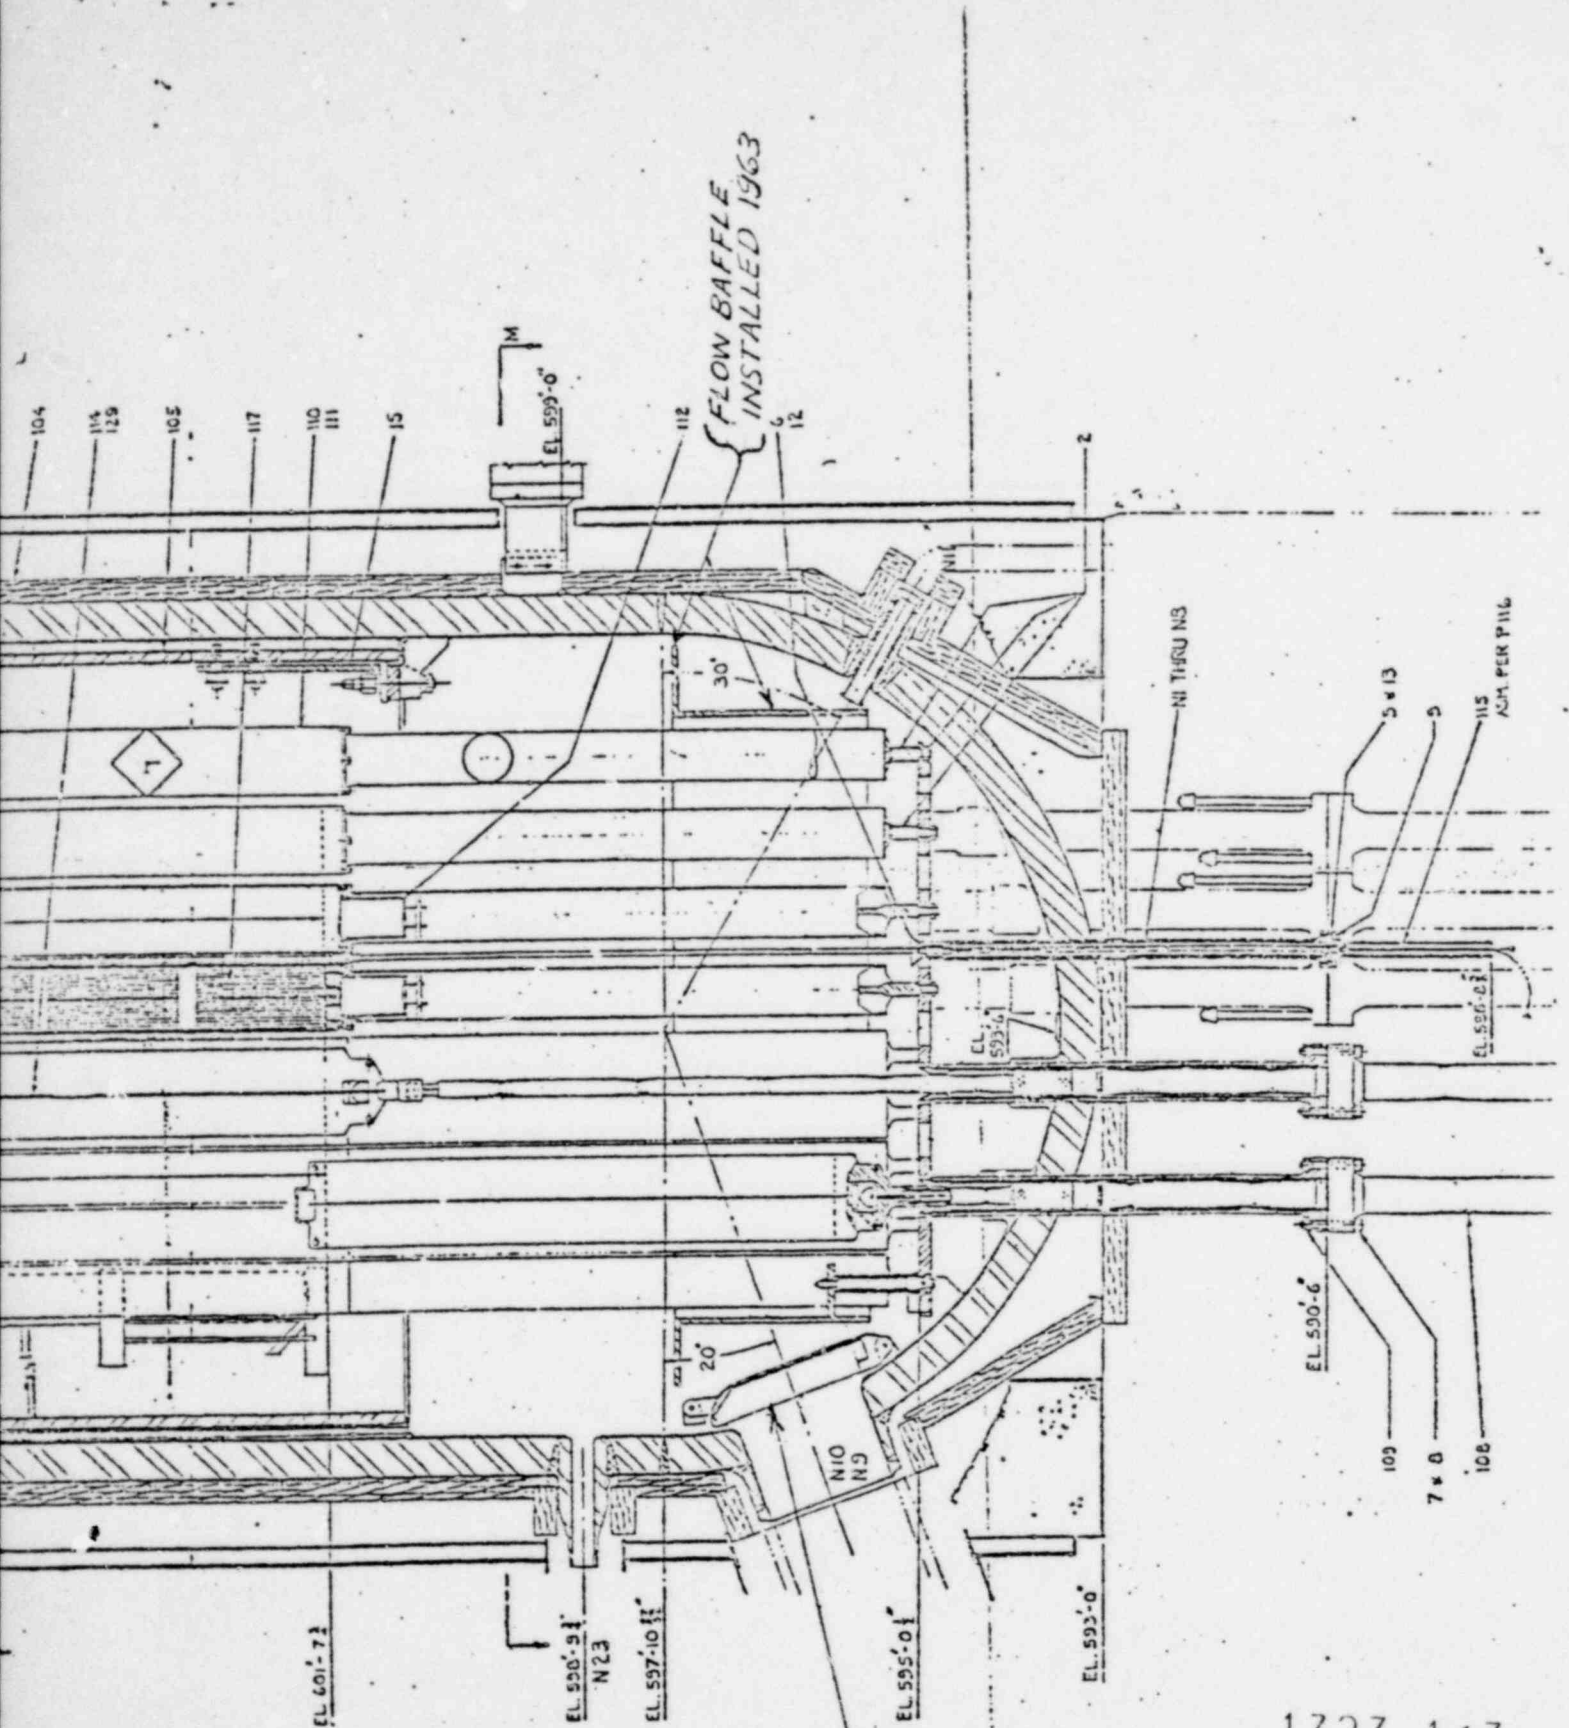
In parallel with activities associated with LER 79-18, fuel and other internals were removed from the reactor for accessibility to the lower areas of the vessel. On June 9, 1979, the main portion of the diffuser over the #1 recirculation pump 20" diameter inlet was found completely loose and lodged in the cavity between the vessel wall, the core support plate and the large flow baffle. A small portion of the diffuser, including one of the two upper attachment ears, was found below the core support plate.

Inspection of the diffuser over the #2 recirculation pump 20" diameter inlet revealed that the single lower attachment was loose which would allow that diffuser to move on its upper attachments in a hinge fashion and make contact with the large baffle. This probably was the source of the vibration type noise first noticed on April 20, 1979.

Fastener bolt wear and/or fatigue are postulated as the failure mechanism. The failed bolts (3 on the #1 diffuser and 1 on the #2 diffuser) are 5/8" diameter shoulder bolts with 1/2" diameter threaded section, and were installed for initial plant operation in 1962. All diffuser pieces have been accounted for and removed from the reactor. New diffusers with bolt fasteners of improved design were installed in October of 1979. Since many reactor components were removed for the repair work, a thorough cleaning of the lower portion of the reactor vessel was accomplished.

ONE OF TWO  
DEFECTIVE  
DIFFUSERS  
LER 79-20

[1] [0] Fastener bolt wear and/or fatigue are postulated as the failure mechanism.  
 [1] [1] New diffusers with redesigned bolt fasteners were installed in October, 1979.  
 [1] [2] All diffuser pieces have been accounted for and removed from the NSSS and  
 [1] [3] in addition a thorough cleaning has been conducted in the lower portions  
 [1] [4] of the reactor vessel.  
 7 8 9 80
