Wisconsin Electric POWER COMPANY
231 WEST MICHIGAN, MILWAUKEE, WISCONSIN 53201

DOCKET 50-266
STEAM GENERATORS
POINT BEACH NUCLEAR PLANT, UNIT 1

History of Tube Defects and Plugging

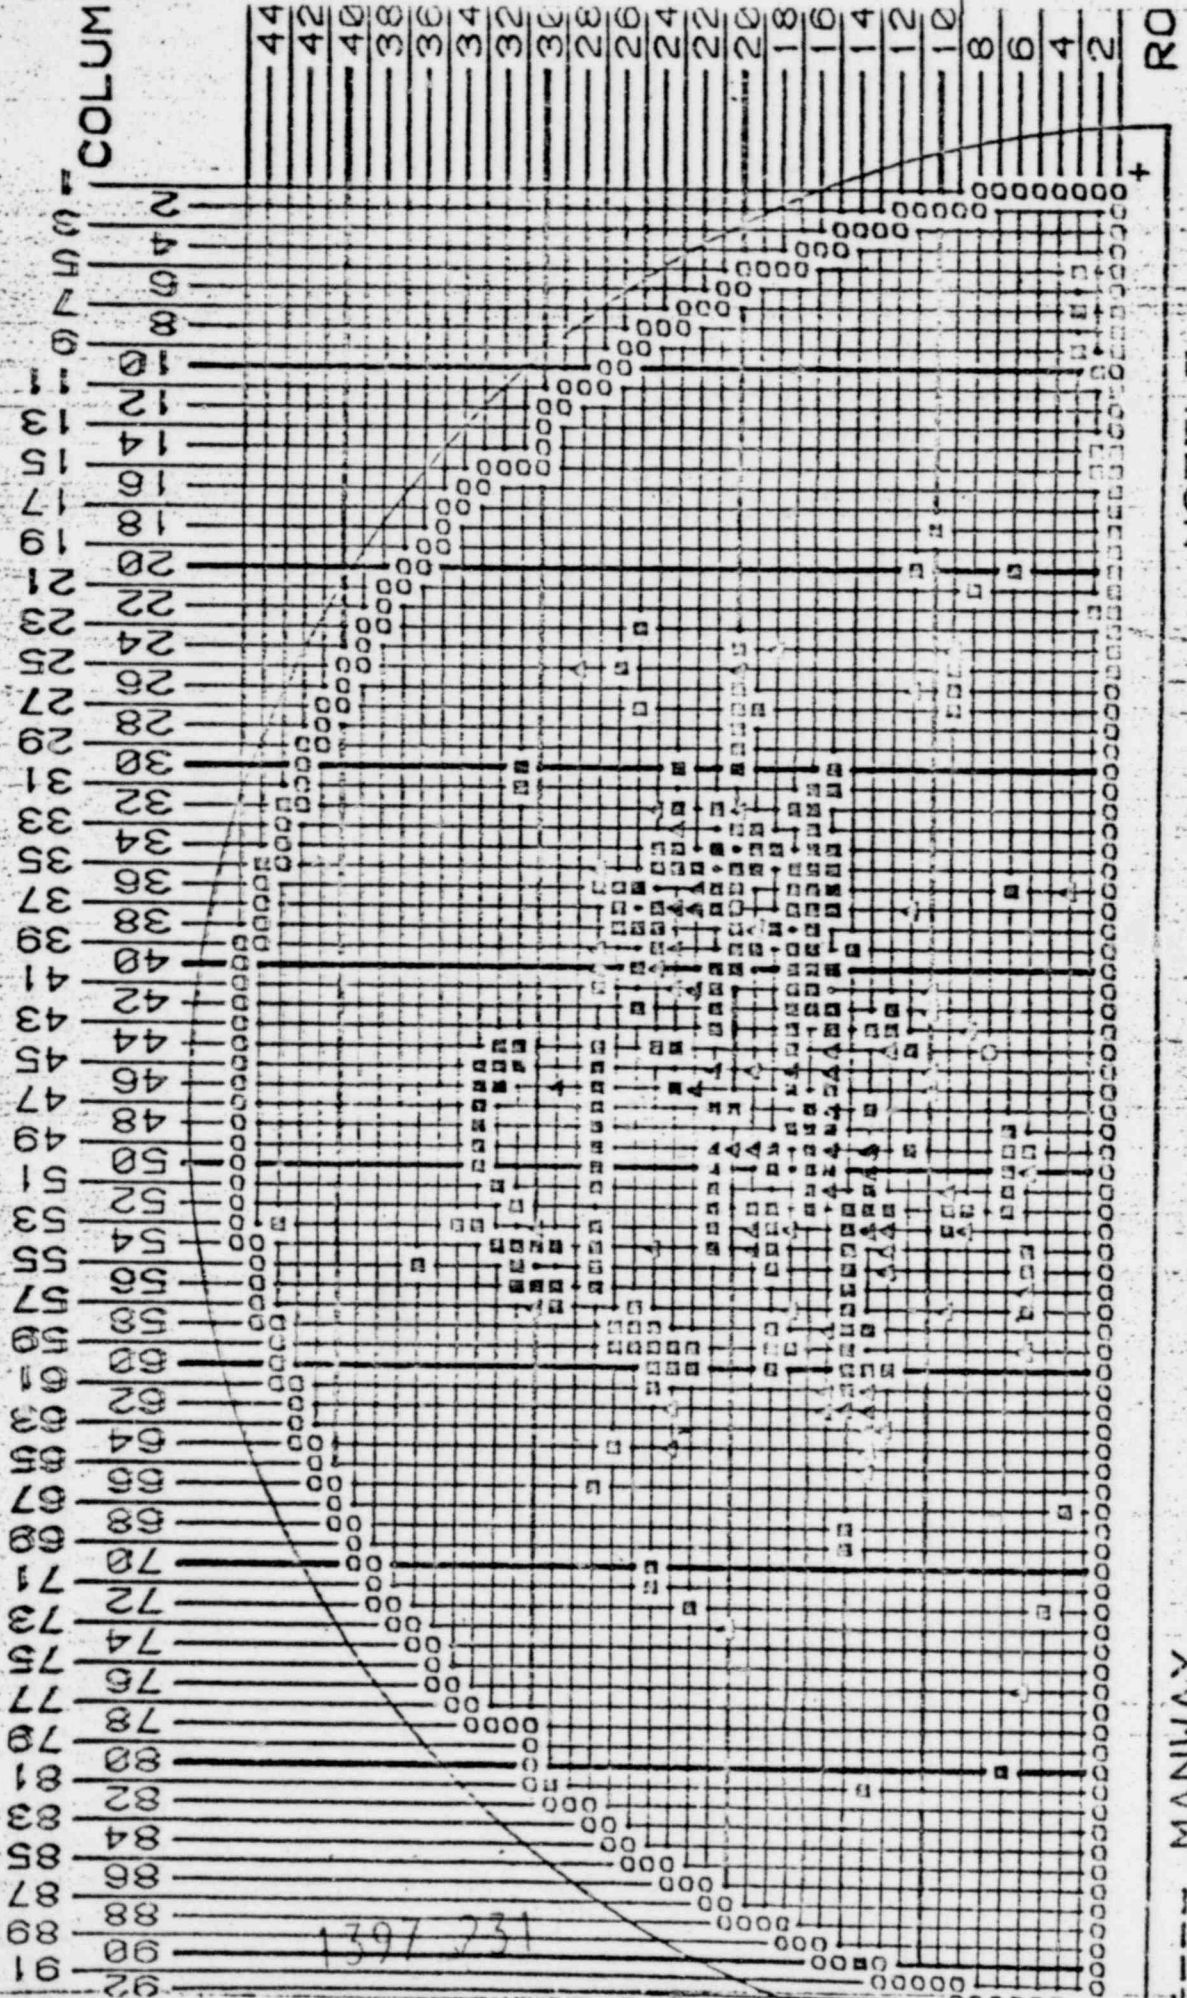
VIEWGRAPH 4

MANWAY □ - PREVIOUSLY PLUGGED
△ - Oct 79

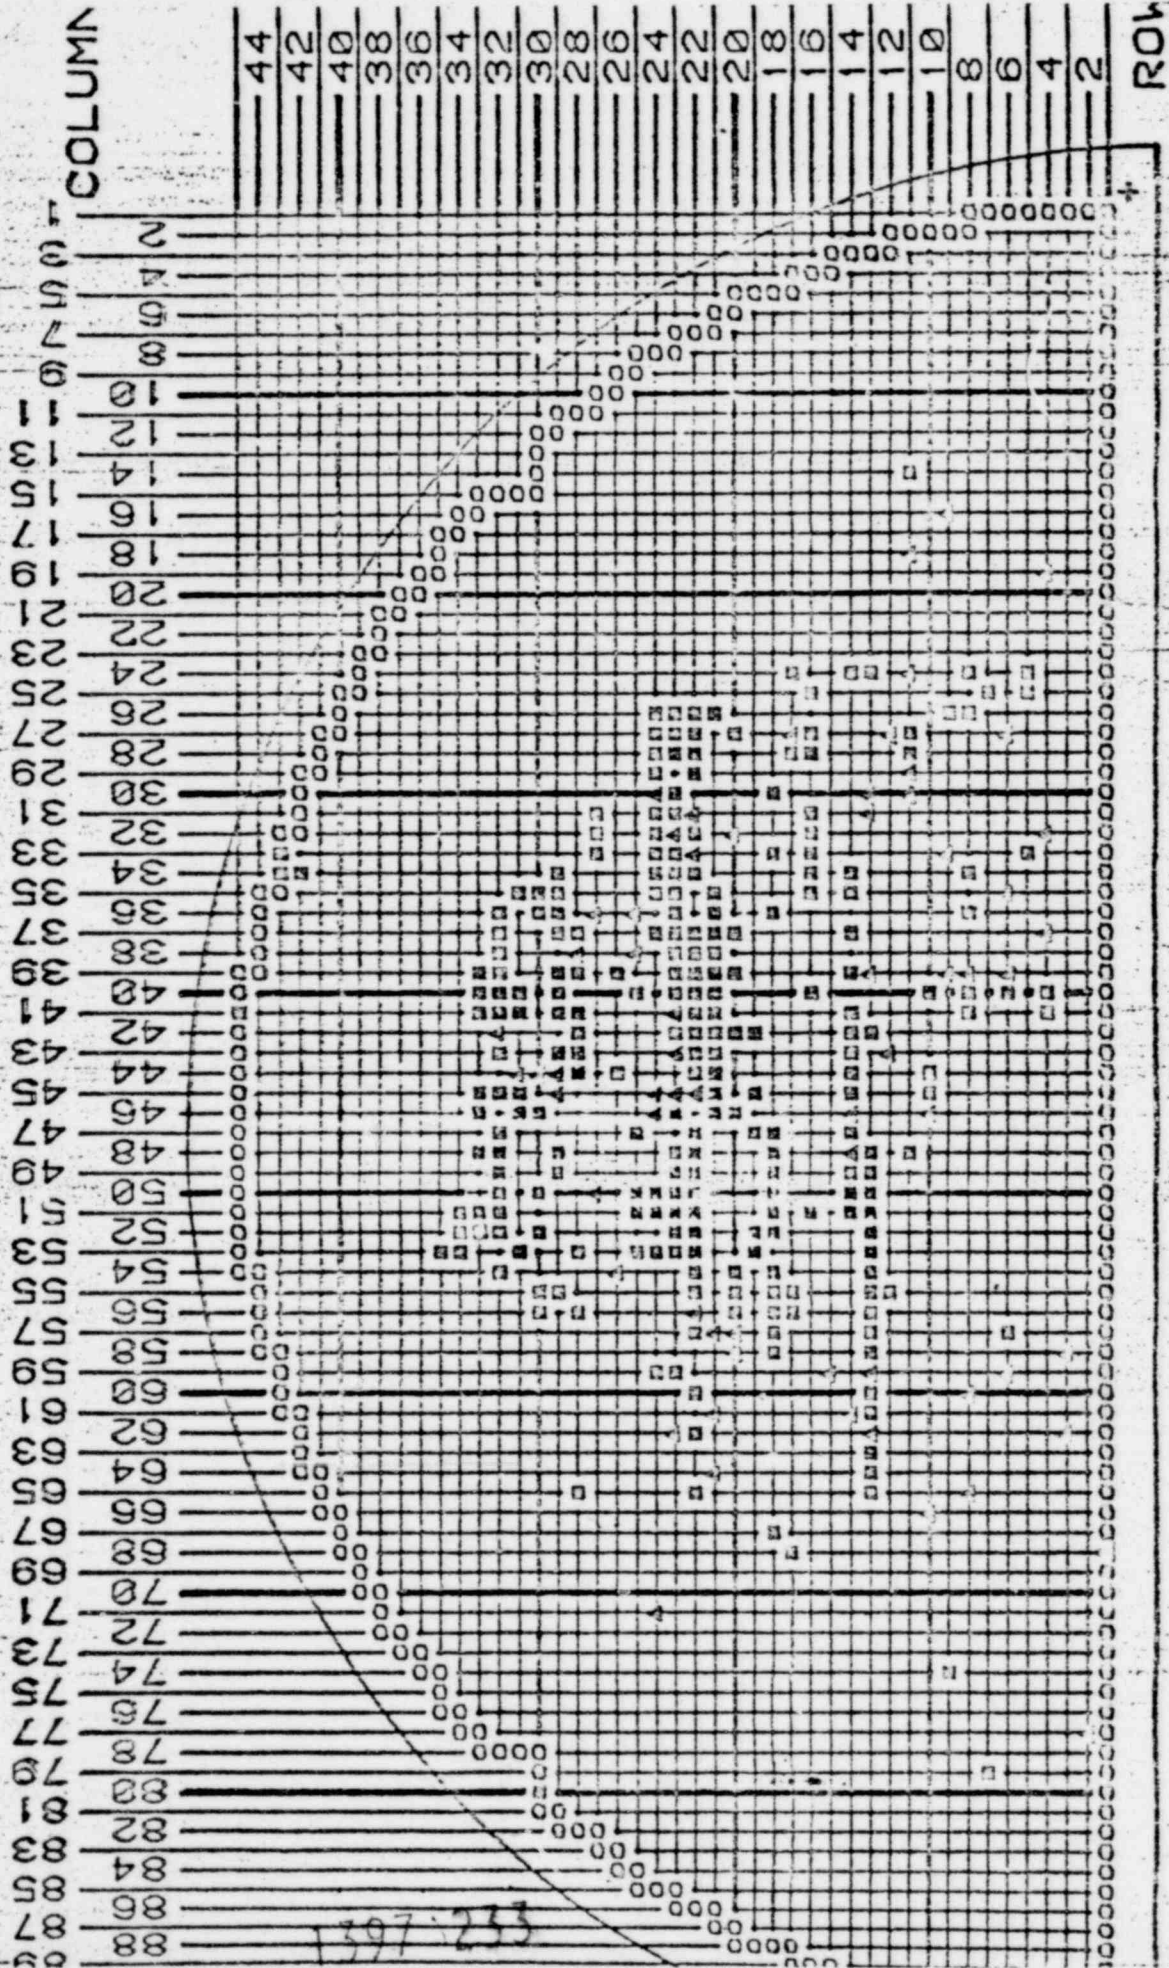
WEP-B

□ - PREVIOUSLY PLUGGED

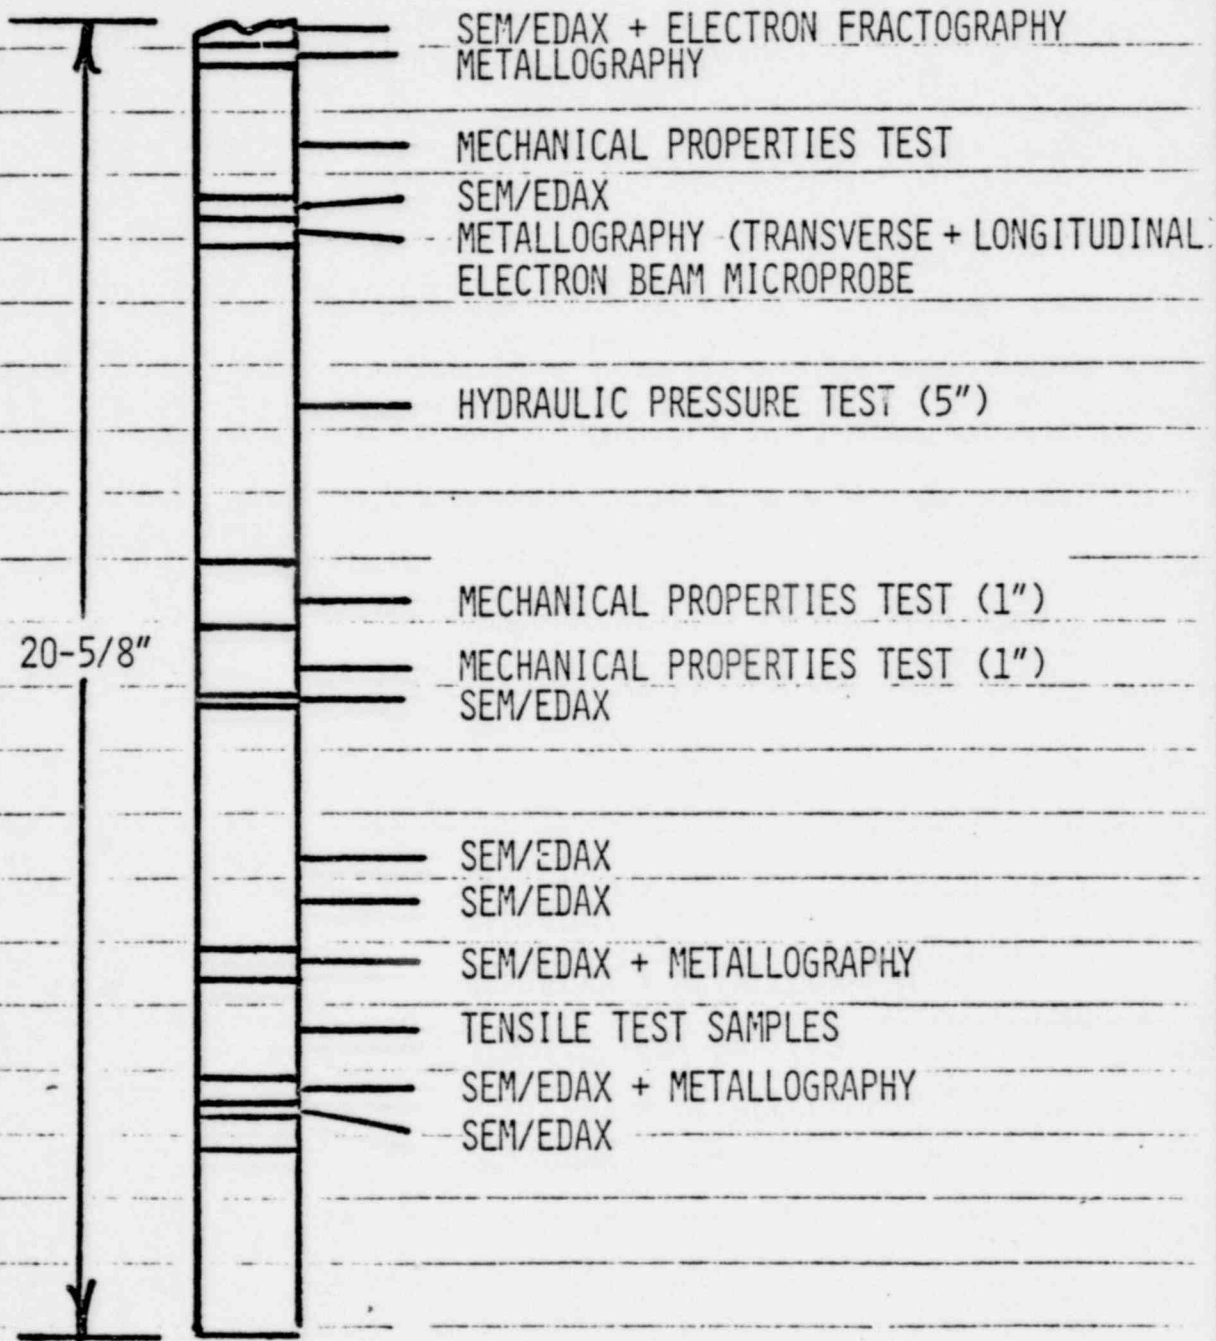
POINT BEACH 1, S/G A, TUBE 15-45, HL

Viewgraph 5 summarizes the results obtained on metallographic examination of all three tube sections. The 15-45 tube that showed an 89 percent in-plant eddy current signal was observed to have cracks through about 90 percent of the wall adjacent to the location of the in-plant signal. This confirms the plant eddy current signal (ECT). This confirmation was also obtained from SEM fractography of the field break which showed that the break was tensile overload ductile-shear due to the large pulling force and that the amount of material remaining to sustain this load was consistent with about 90 percent of the tube having been penetrated by intergranular attack (IGA).

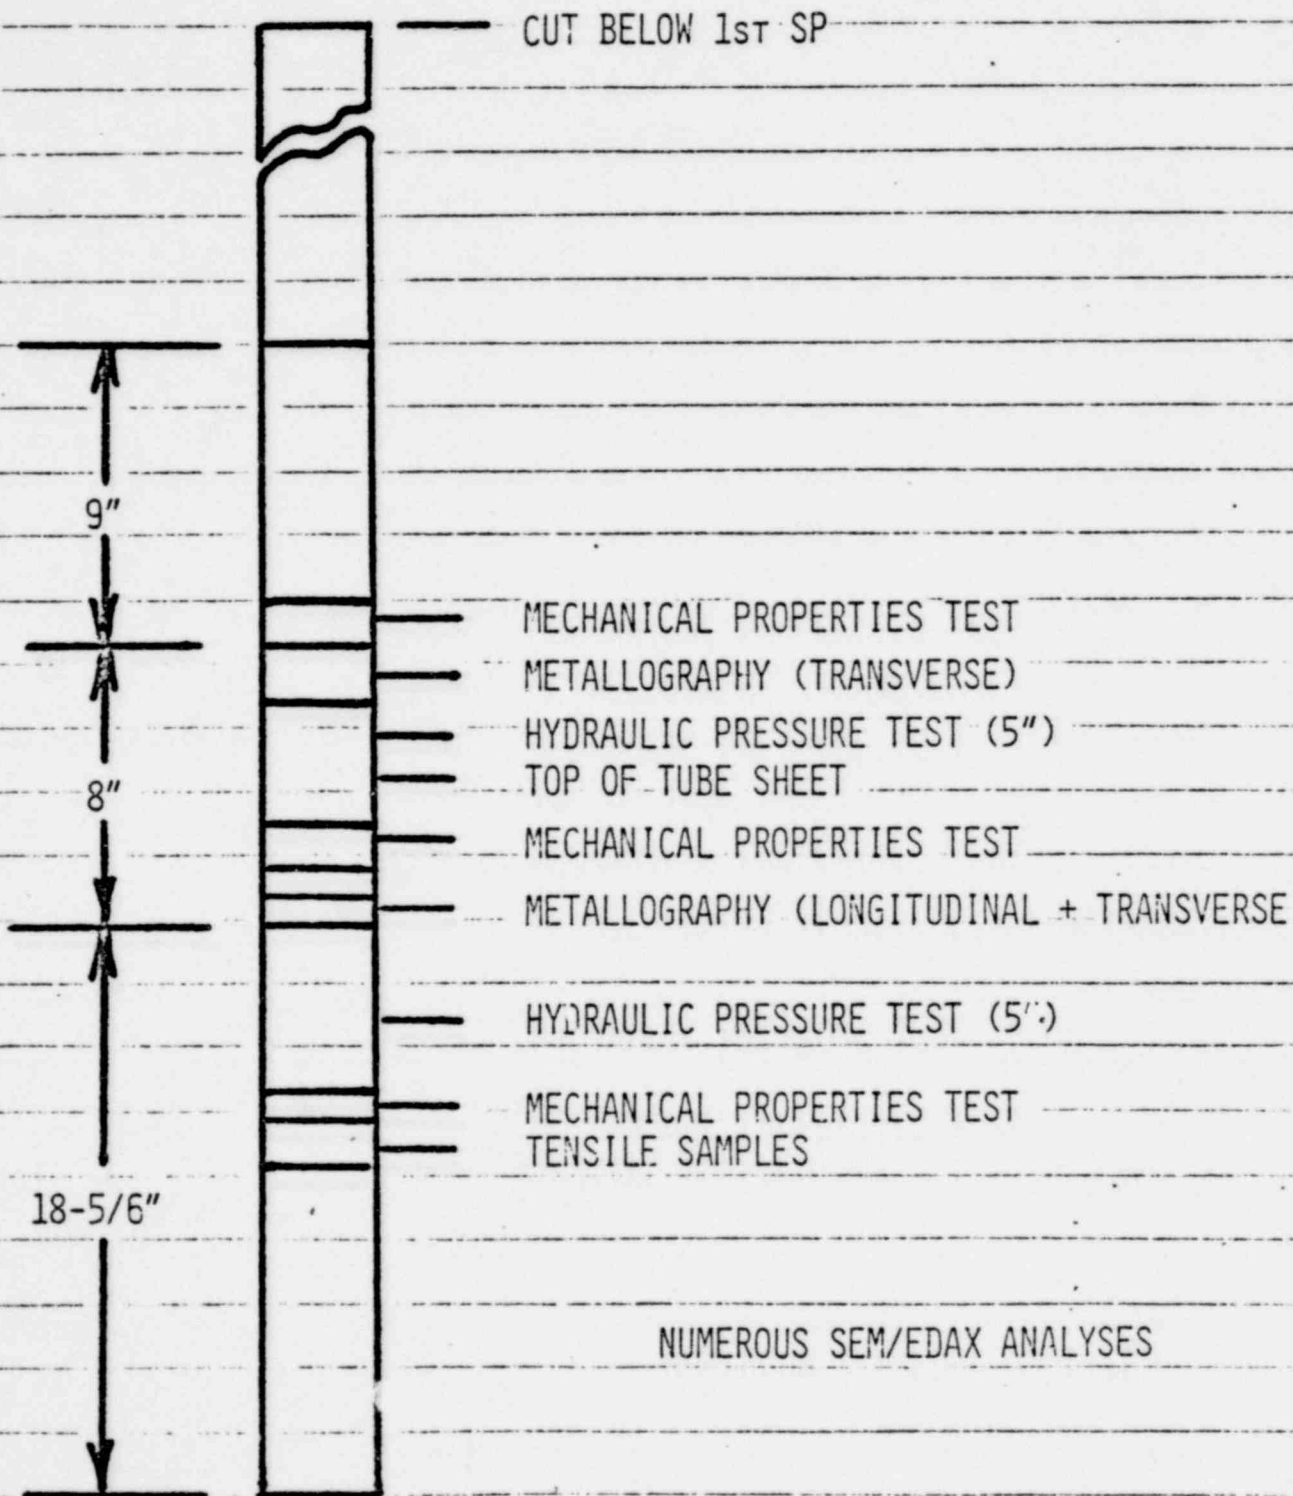
POINT BEACH 1, S/G A, TUBE 22-37, HL

The second tube showed uniform intergranular attack to a depth of about 5 mils within the crevice with IGA occasional deeper crack-like penetrations extending to 50 percent of the wall. No IGA was detected above the tubesheet.

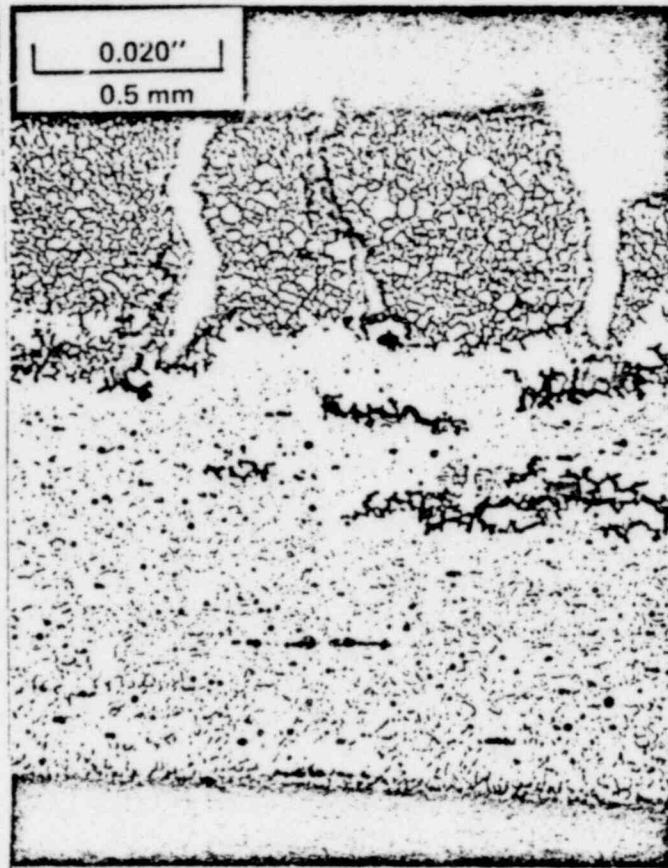
POINT BEACH 1, S/G A, TUBE A 15-45, HL
WITHIN TUBE SHEET: CENTRAL BUNDLE REGION
LONGITUDINAL CROSS SECTION

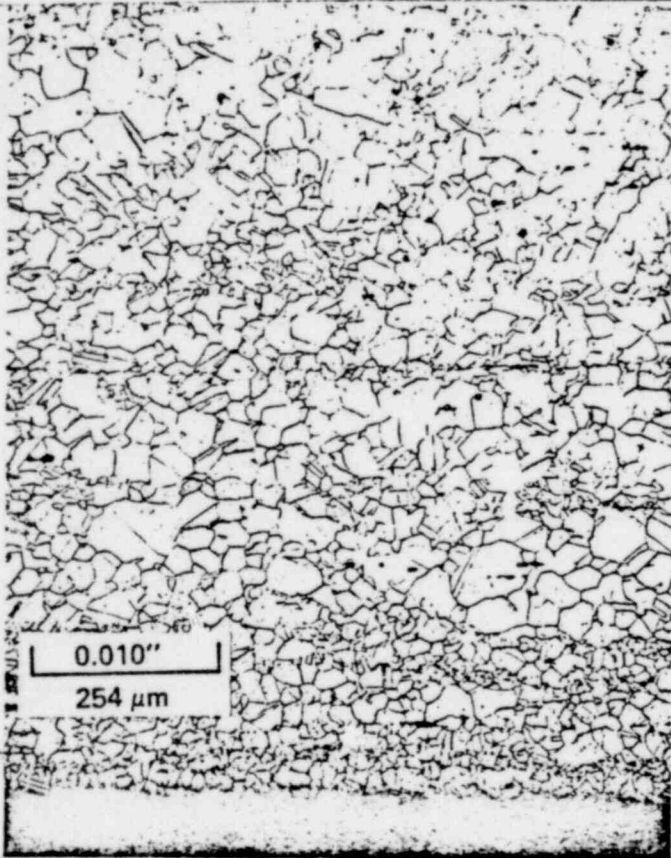
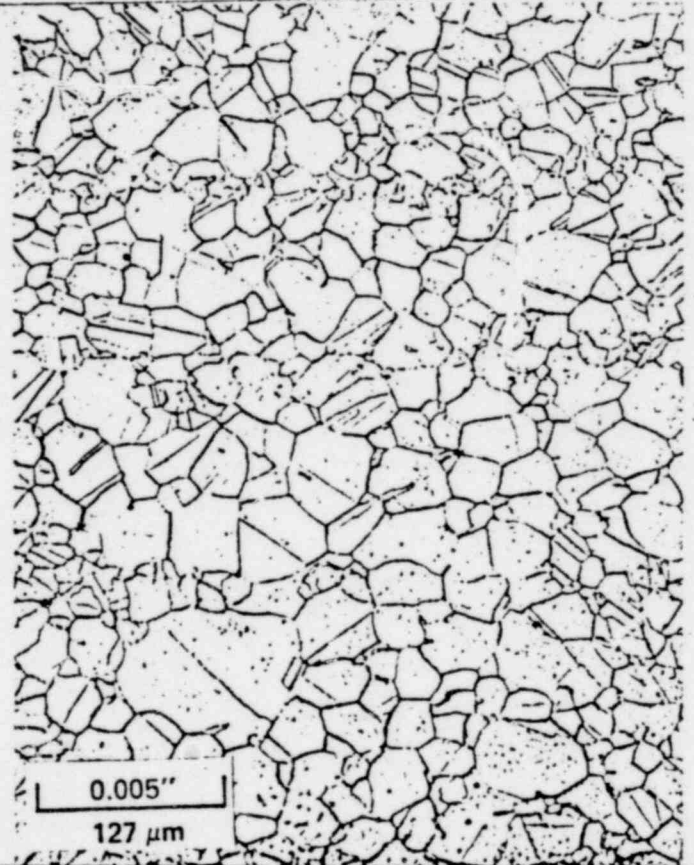
POINT BEACH 1, S/G A, TUBE 15-45
WITHIN TUBE SHEET: CENTRAL BUNDLE REGION
LONGITUDINAL CROSS SECTION
NORMAL INCONEL 600 MICROSTRUCTURE AT ID

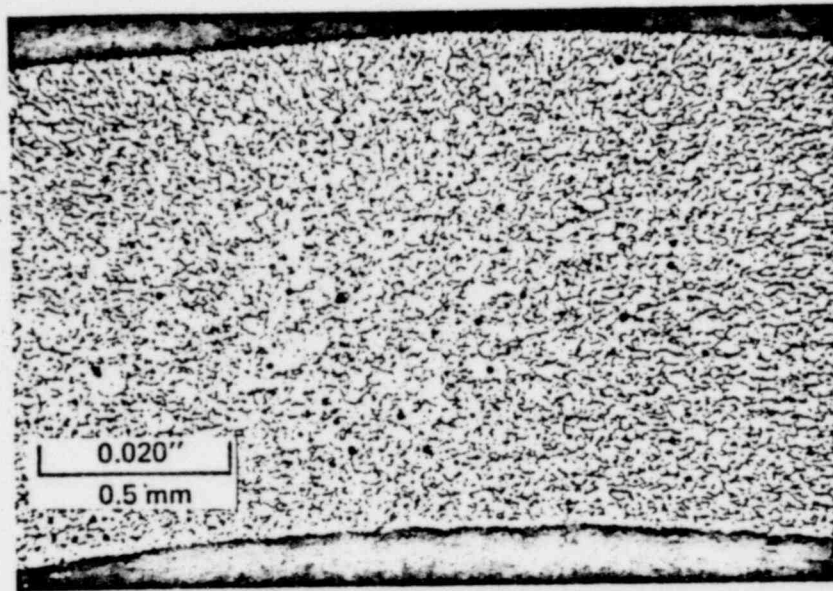
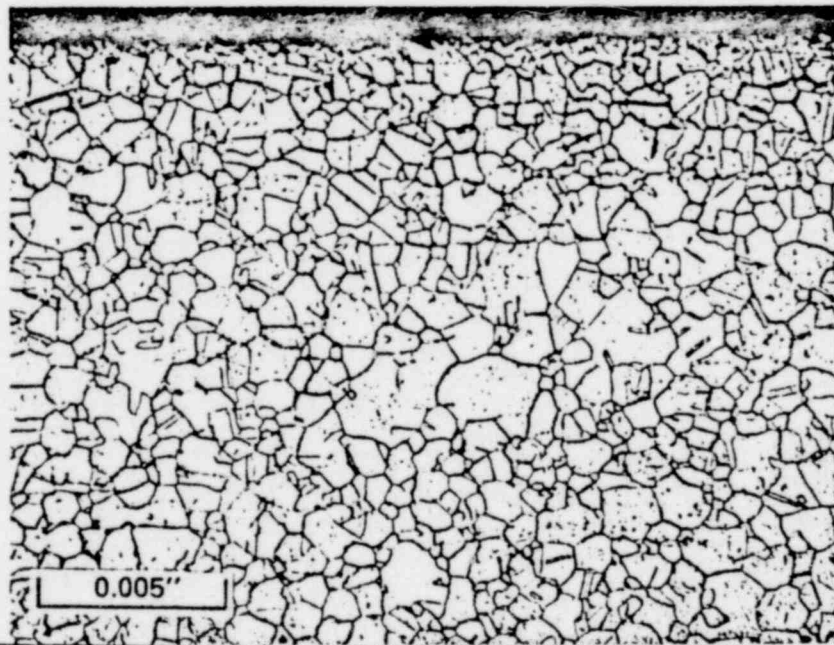
POINT BEACH 1, S/G A, TUBE 22-37, HL
ABOVE TUBE SHEET: CENTRAL BUNDLE REGION
TRANSVERSE CROSS SECTION
COMPLETELY FREE OF INTERGRANULAR PENETRATION

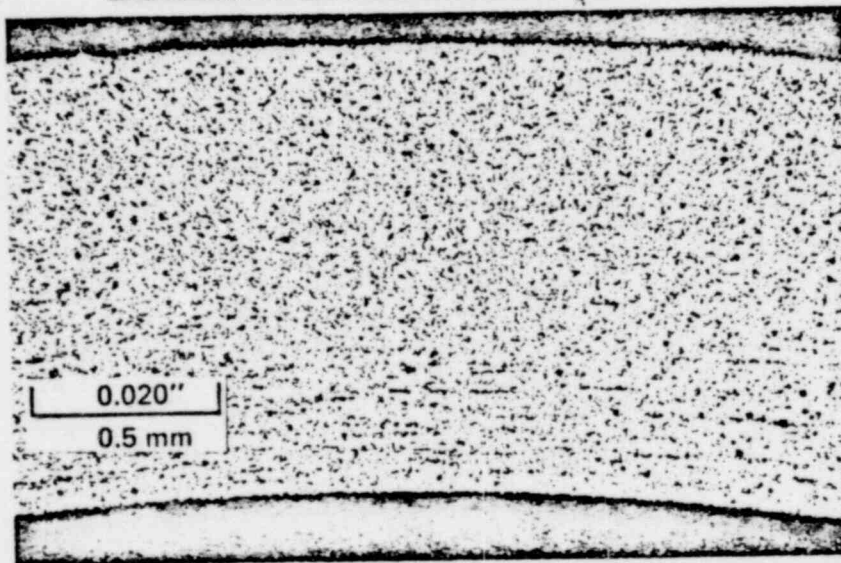
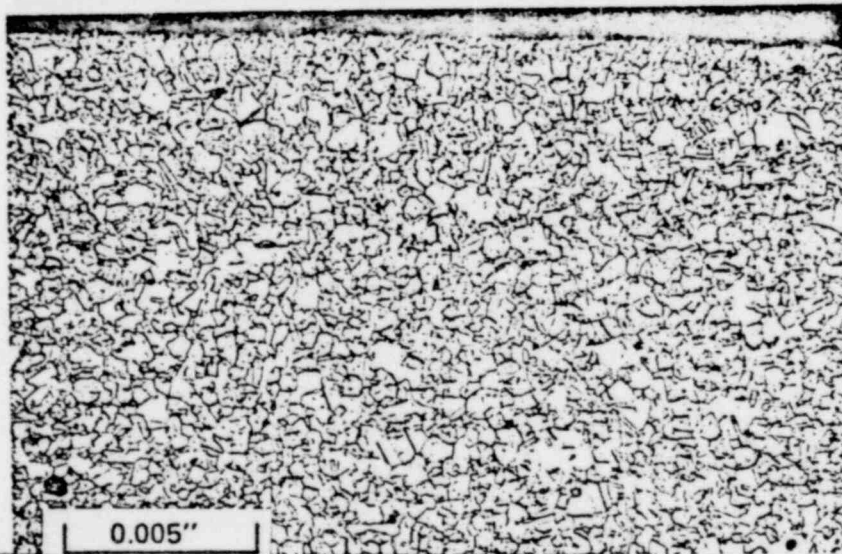
POINT BEACH 1, S/G A, TUBE 20-73, HL
ABOVE TUBE SHEET: PERIPHERAL BUNDLE REGION
TRANSVERSE CROSS SECTION
COMPLETELY FREE OF INTERGRANULAR PENETRATION
