REPORTABLE OCCURRENCE 79-53

FORT ST. VRAIN NUCLEAR GENERATING STATION
PUBLIC SERVICE COMPANY OF COLORADO
16805 WELD COUNTY ROAD 19 1/2
PLATTEVILLE, COLORADO 80651

REPORT NO. 50-267/79-53/03-L-0

IDENTIFICATION OF
OCCURRENCE:

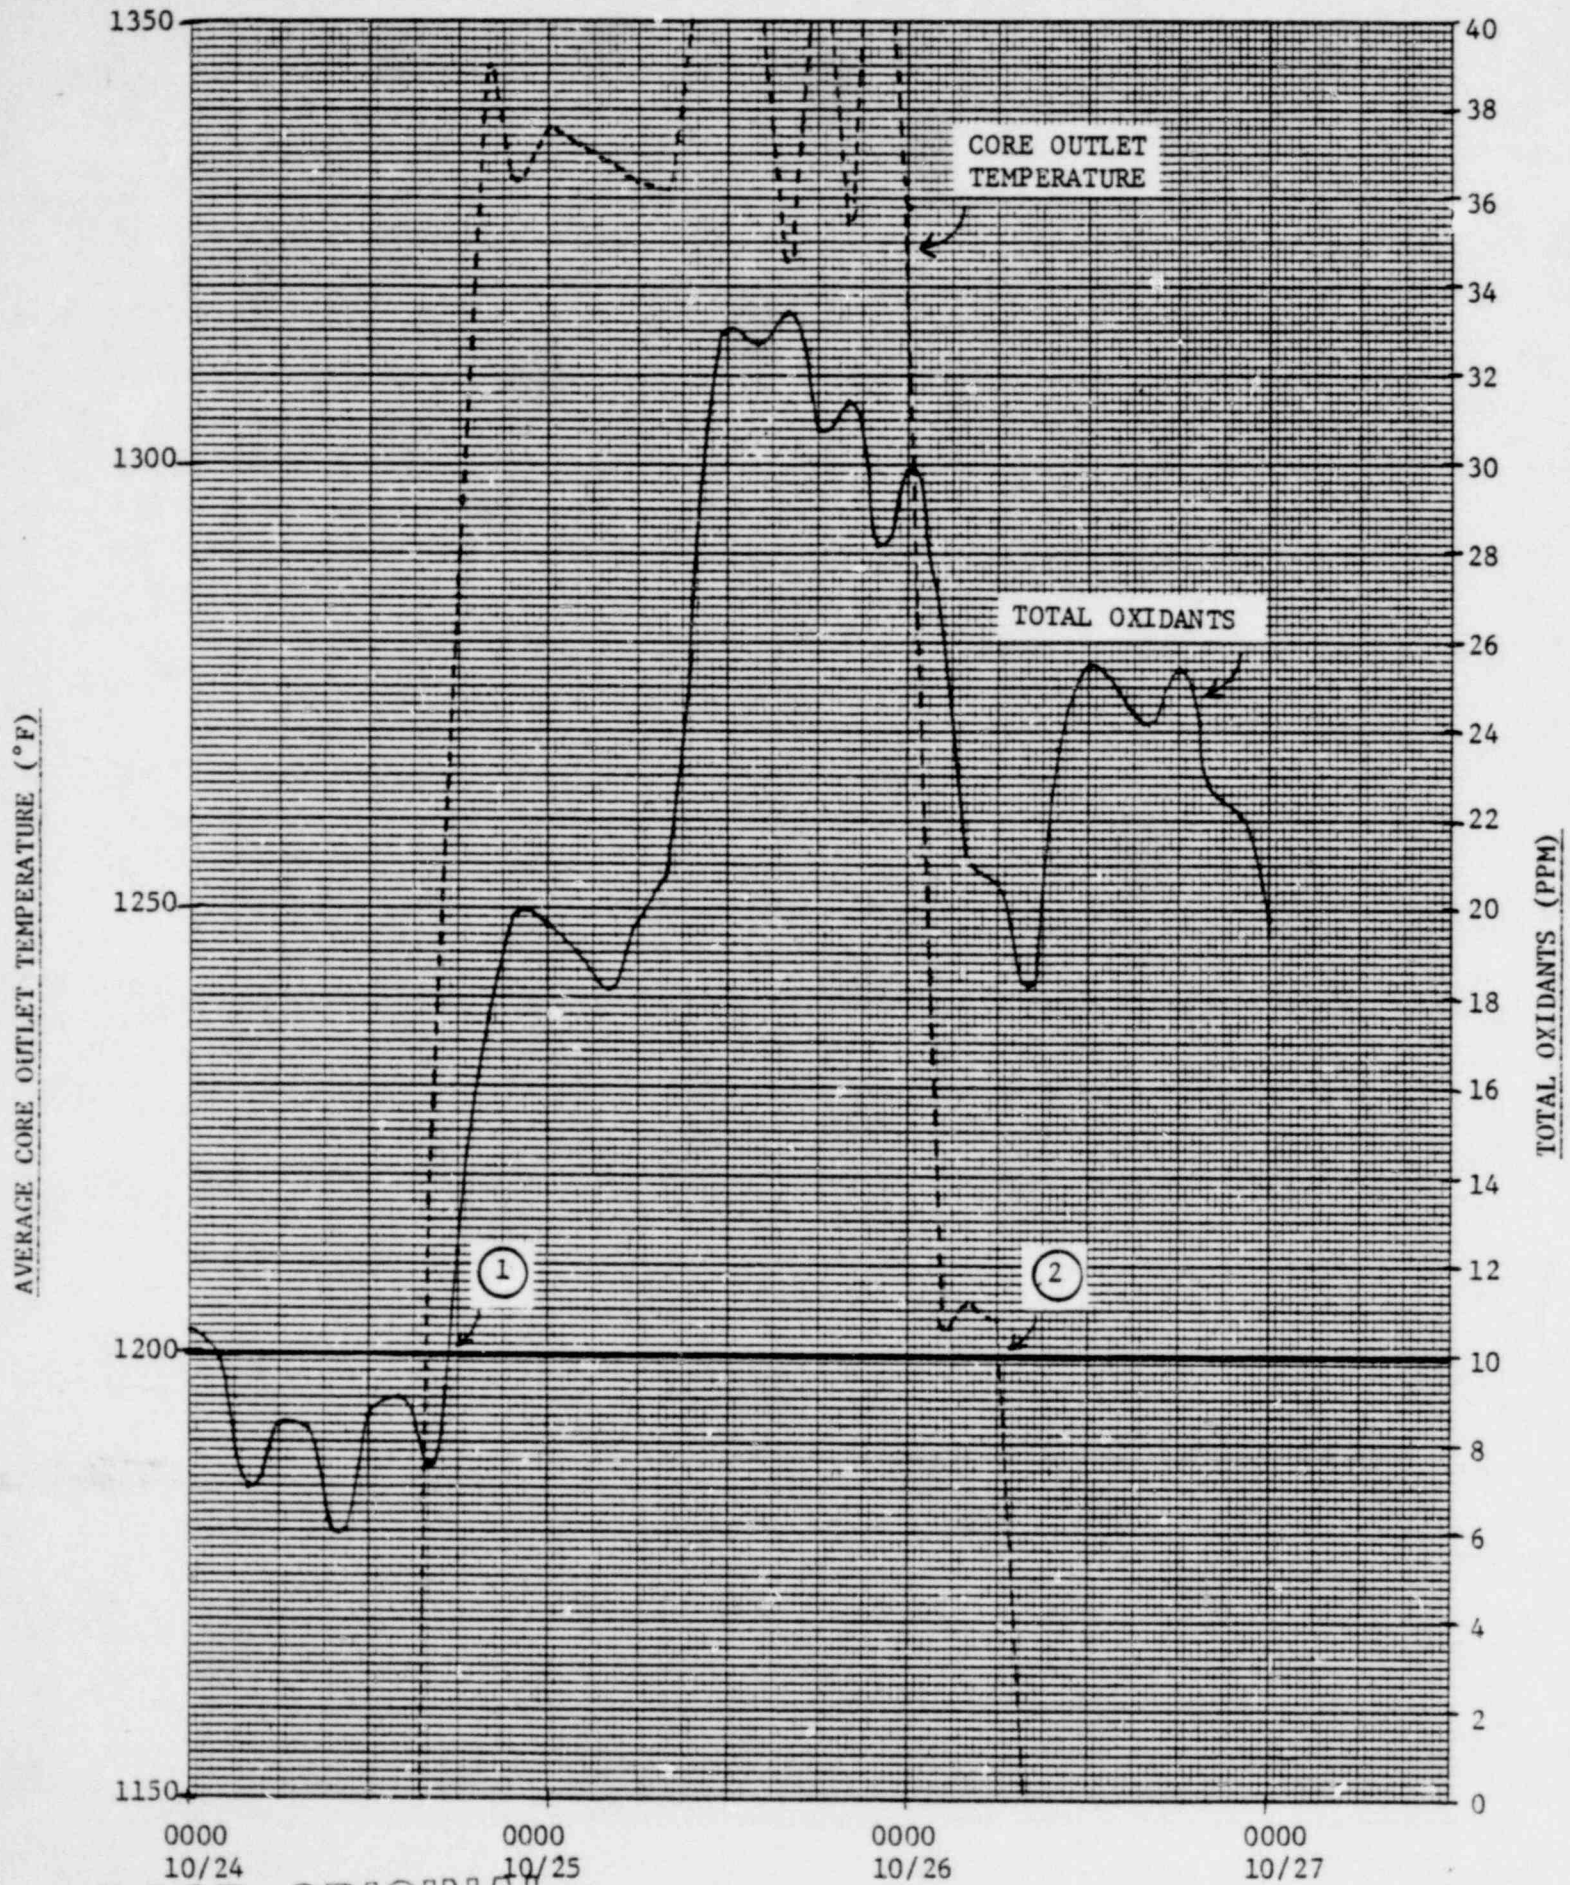
FIGURE 1: AVERAGE CORE OUTLET TEMPERATURE VERSUS PRIMARY COOLANT OXIDANTS

Fluctuation testing was completed at 2230 hours on October 25, 1979, and an orderly shutdown was initiated for plant maintenance. Core outlet temperature was less than 1,200°F by 0600 hours on October 26, 1979, (reference Figure 1, point 2) and no further LCO 4.2.10 degraded mode operation occurred.

The increase in total oxidants is due in part to off-gassing of carbon monoxide and carbon dioxide as residual primary coolant moisture reacted with the core graphite at increased temperatures.

Following completion of fluctuation testing at approximately 2230 hours on October 25, 1979, orderly reactor shutdown was initiated. Core outlet temperature was less than 1,200 ° F. by approximately 0600 hours on October 26, 1979, and no further degraded mode operation was observed.
