November 16, 1979  
Fort St. Vrain  
Unit No. 1  
P-79274

REPORTABLE OCCURRENCE 79-51

FORT ST. VRAIN NUCLEAR GENERATING STATION  
PUBLIC SERVICE COMPANY OF COLORADO  
16805 WELD COUNTY ROAD 19 1/2  
PLATTEVILLE, COLORADO 80651

REPORT NO. 50-267/79-51/03-L-0

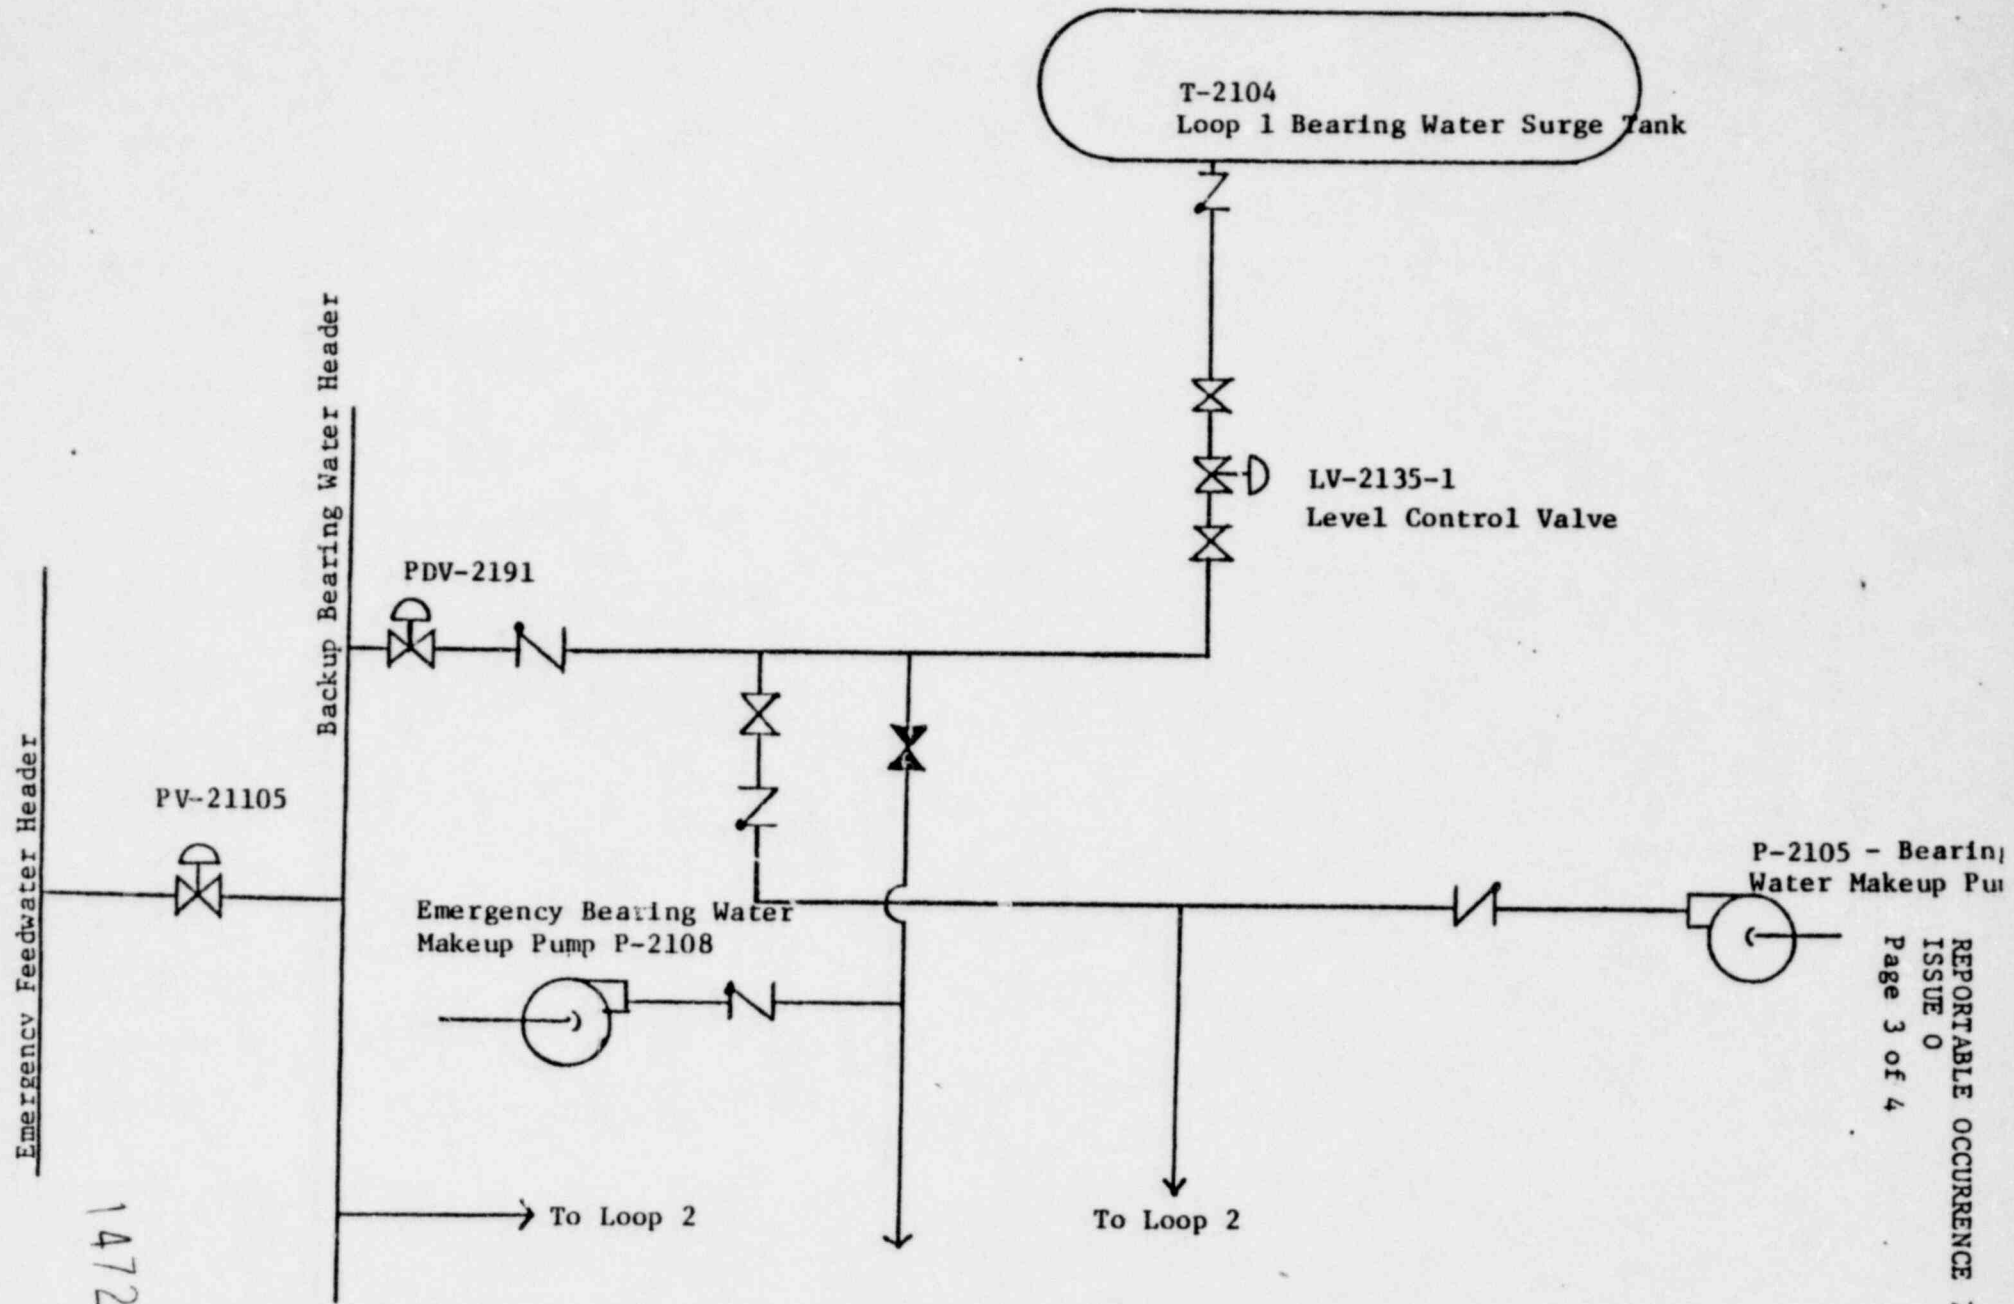
FIGURE 1

See Figure 1. With the backup bearing water system not in service, the makeup water for the bearing water surge tank, T-2104, comes from the bearing water makeup pump, P-2105, which is run intermittently to maintain proper surge tank level.

The reactor operator turned P-2105 off and had become involved in an evolution at control panel I-05, when the surge tank low level alarm was received. It was acknowledged but P-2105 was not started immediately as the reactor operator returned to the evolution at I-05. Before he returned to the surge tank level situation, the level had decreased to the low level trip setpoint and tripped Loop 1 bearing water pumps resulting in Loop 1 being automatically shutdown. The plant protective circuits functioned as expected during this occurrence.

was occupied with another matter. The reactor operator's response to the bearing water surge tank level low alarm was inadequate as the recommended operator action was not carried out after the alarm was acknowledged. This allowed the bearing water surge tank level to decrease to the low level trip setpoint.

The procedure does not adequately address the current operating conditions of System 21 and allows intermittent operation when the bearing water system is required to be operable, and the backup bearing water system is not available to supply makeup.

The surge tank was filled to the proper level and Loop I returned to service. The operating procedure has been revised to use backup bearing water (when available) as the normal surge tank makeup. If the bearing water system is required to be operable and the backup bearing water system is not available, either the bearing water makeup pump, P-2105, or the emergency bearing water makeup pump, P-2108, shall be in continuous operation. Personnel involved have been reinstructed in the proper response to control panel alarms. No further corrective action is anticipated or required.
