NUREG-0090
Vol. 2, No. 2

Report to Congress on Abnormal Occurrences

April - June 1979

U.S. Nuclear Regulatory
Commission

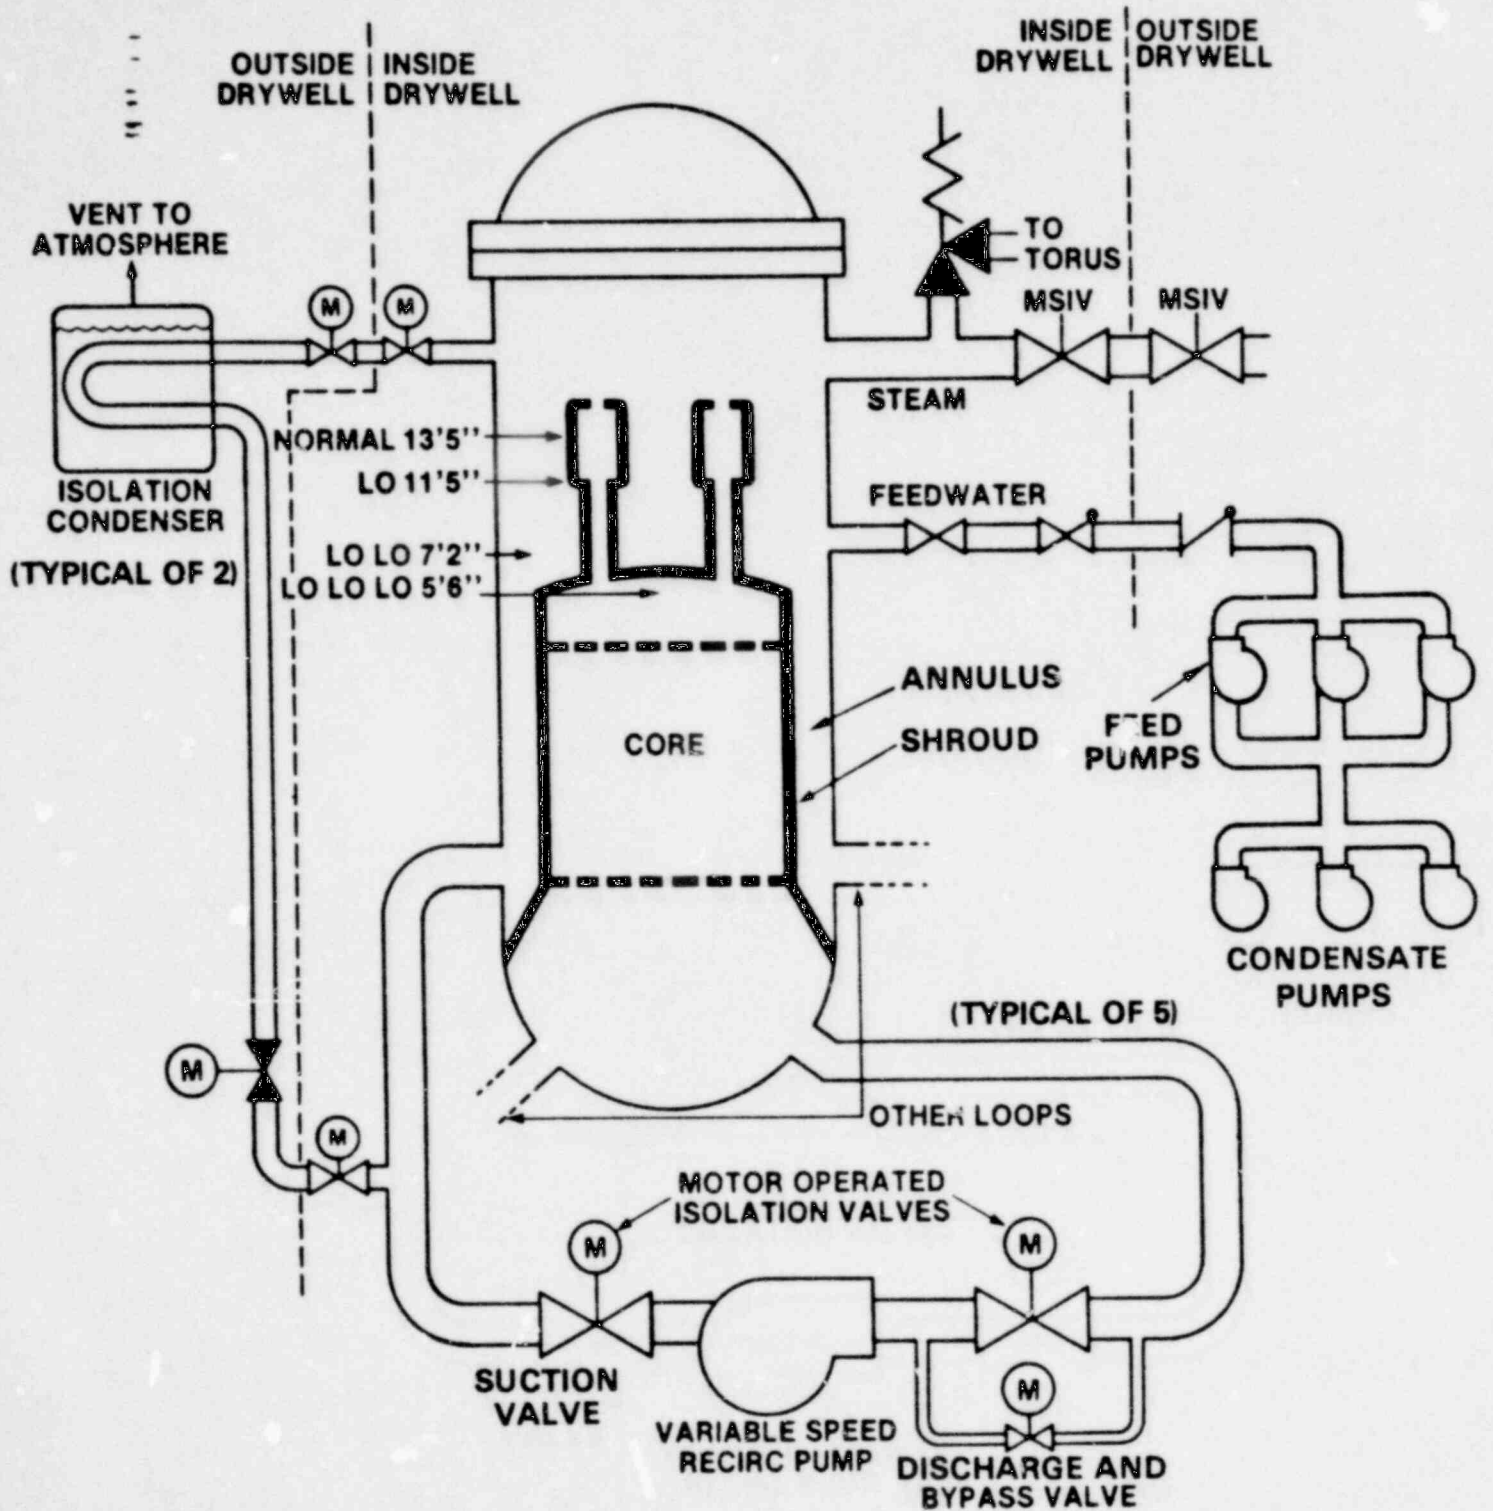
Figure 1. RECIRCULATION, STEAM AND ISOLATION CONDENSER SCHEMATIC

Thirteen seconds after the reactor scram, the turbine tripped at the low load setpoint. The turbine trip initiated a transfer of power from the auxiliary transformers to the startup transformers. Because one startup transformer "SB" was out of service, two feed pumps and two condensate pumps (pumps 1B and 1C) on the associated 4160v bus (2B) lost power. The third feed pump (1A) tripped due to low suction pressure during the feedwater transient. An immediate attempt to restart the 1A feedwater pump, powered by the live 4160v bus (1A), was unsuccessful because of failure of an auxiliary oil pump to start. The lube oil pump is interlocked in the feed pump start sequence. This was the only equipment failure during the transient.

After closure of the MSIV, an isolation condenser was manually placed in service for core decay heat removal. The isolation condenser was condensing steam from the core and returning the condensate to the reactor annulus through a connection to a recirculation loop pump suction line (Figure 1). At approximately a minute and a quarter after the reactor scram, the discharge valves in "A" and "E" recirculation loops were closed in accordance with a Standing Order that was in effect. Closing the "A" and "E" loop discharge valves had in the past been necessary to prevent inadvertent stopping of the isolation condenser due to forced flow from operating recirculation pumps being sensed as if it were flow from an isolation-condenser line break. (This Standing Order was no longer appropriate since an ATWS modification had been made that tripped the recirculation pumps coincident with high-pressure or low-low-level scrams. The necessary procedure change had not been performed following the

Reactor pressure was controlled by intermittent manual operation of the two isolation condensers. At about half an hour into the transient, a recirculation pump was started. The operator tripped the recirculation pump within 2 minutes when he noted a rapid decrease in the annulus level (the recirculation pumps take suction from the annulus). About 5 minutes later, a feed pump was successfully started. At about 40 minutes into the event, a primary recirculation pump and a reactor feed pump were restarted for continued cooldown of the reactor. From about 40 minutes onward, the water level within the core region was normal. The plant attained cold shutdown within 9 hours.

Review of the occurrence by the licensee and NRC established that although the water level in the core shroud area went below the triple low level setpoint, the core remained covered and consequently no fuel damage would be expected.

Cause or Causes - The spurious reactor high pressure scram was initiated by a pressure spike on the reactor high pressure scram switches, caused by an instrument technician while performing surveillance testing. However, the fundamental causes of the resulting sequence of events were:
