Event Date: 12-12-79

Facility: BSEP Unit No. 1

CAROLINA POWER & LIGHT COMPANY
BRUNSWICK STEAM ELECTRIC PLANT
S/RV DISCHARGE LINE INTEGRITY ANALYSIS

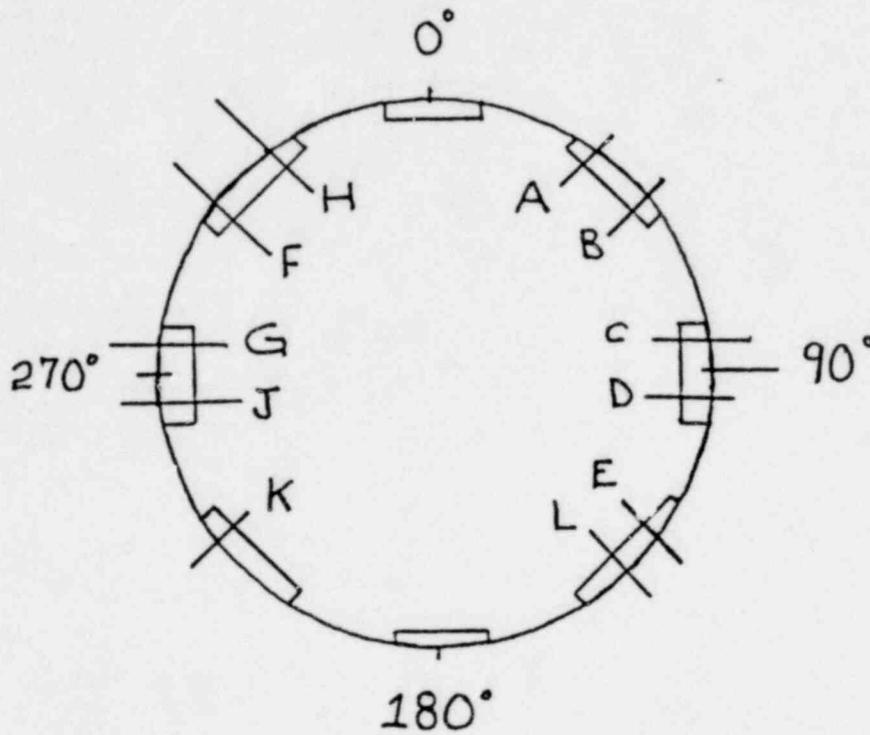
FIGURE 1:

SRV DISCHARGE PIPE LOCATION & SRV SET POINTS

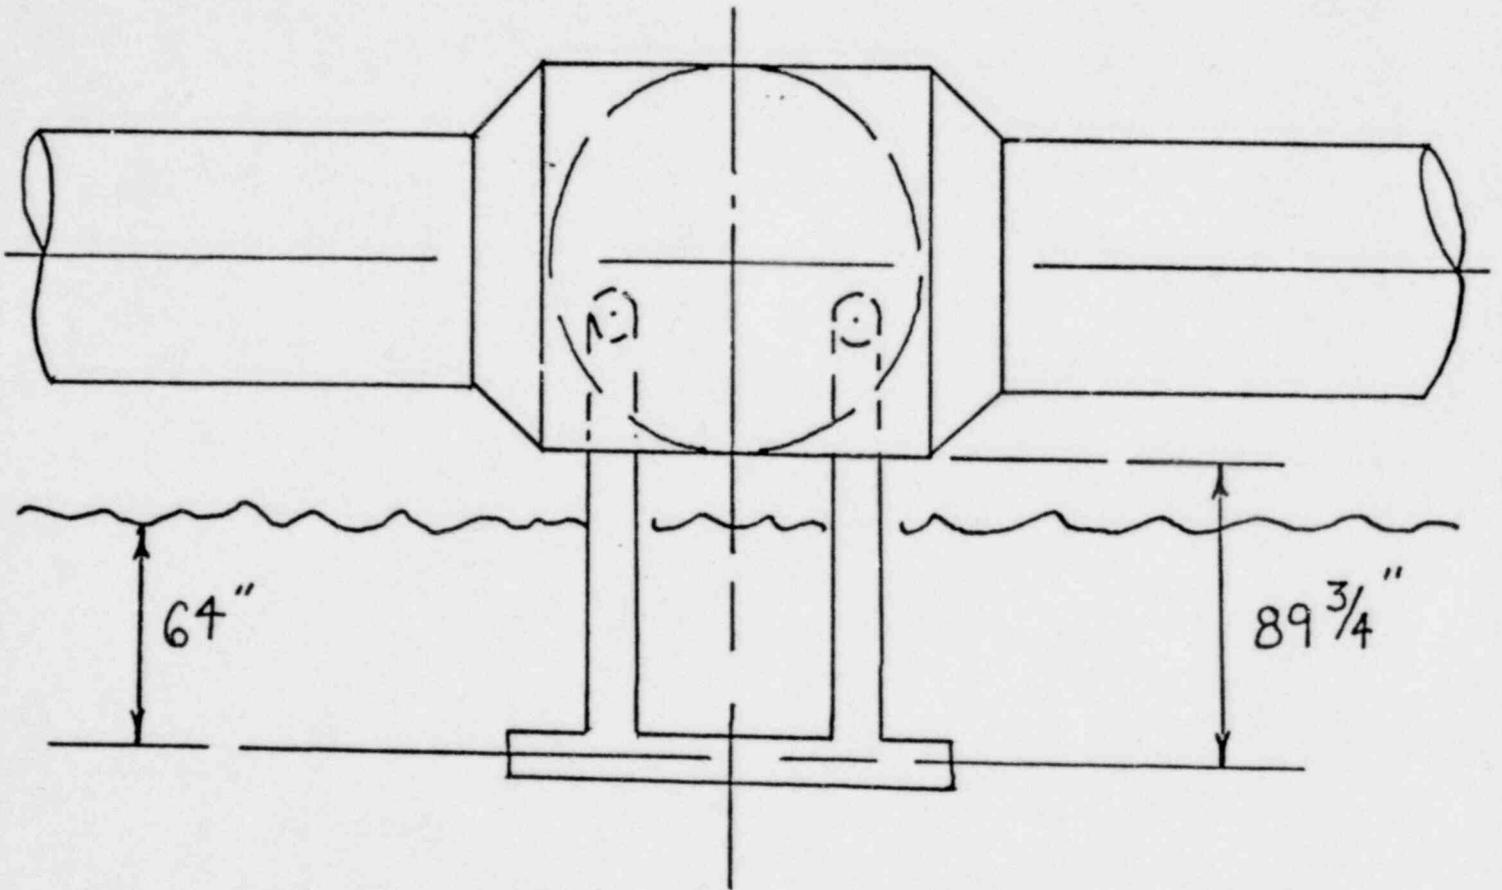
FIGURE 3:

The safety/relief system for the General Electric Mark I boiling water reactor at the Brunswick Steam Electric Plant consists of eleven 3-stage Target Rock safety relief valves attached to the main steam lines. The discharge piping is routed through the containment (drywell) such that two lines are routed through five different vent pipes and one through a sixth vent pipe. See Figure 1. The discharge lines run through the vent pipe to the ring vent header where they penetrate the header in a vertical orientation. The discharge lines run approximately 89" vertically downward to a submergency of approximately 64". See Figure 2. For the design of the two lines in the same vent pipe, the discharge is through a common horizontal header, called the "double-T." See Figure 3. The single line discharges through a "single-T."

The segment of line under investigation is a vertical run of pipe from the penetration of the vent header to the water level in the torus as shown in Figure 3. A break above this penetration allows the discharge of the steam through the normal pressure suppression mode through the vent header downcomers. A break below the water level will still retain pressure suppression by condensation as designed.

SRV "DOUBLE T" ARRANGEMENT

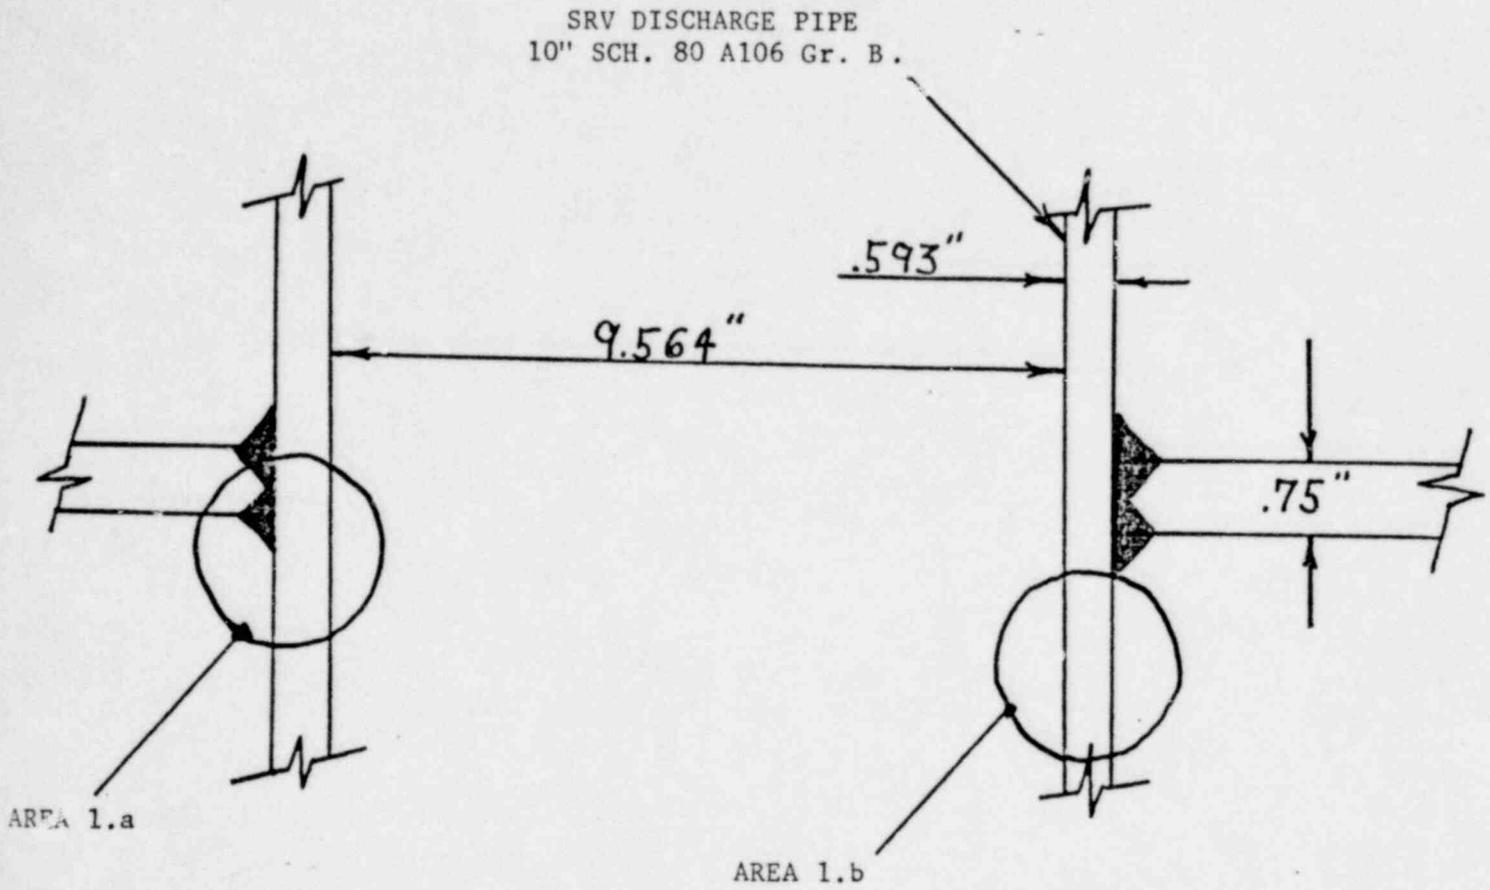
FIGURE 4:

The S/RV discharge line is a 10-inch diameter, schedule 80, A106 Grade B carbon steel pipe. The design of the penetration at the vent header is shown on Figure 4. The discharge line is attached to the vent header by a 3/4-inch full penetration weld. This area around the weld, as well as the normal pipe section, were selected for analysis to determine the location with the lowest allowable load at structural integrity, hence the location with the highest potential for failure.

- a. For Section 1.a of Figure 4, the welded area at the penetration, it was assumed that the load carrying capability was limited by shear in the weld (i.e., fault occurring in the weld heat affected zone propagating into the base metal of the pipe). The maximum load capability in this area is defined as:

- b. For Section 1.b of Figure 4, normal pipe section, the maximum load carrying capability was limited by a tension failure in the base metal. The maximum load capability before structural integrity is defined as:

Therefore, it is concluded that the location having the highest highest potential for failure for the given load condition for the segment of pipe investigated is at the weld of the discharge line to the vent header.

SECTION OF SRV PIPE PENETRATION AT RING HEADER CONNECTION
