Re: St. Lucie Unit 2
Docket No. 50-389
Inservice Inspection Plan
Forth Ten-Year Interval Unit 2 Relief Request 16

Proposed Relief Request RR-16
In Accordance with 10 CFR 50.55a(z)(2)

ASME Code Class: Code Class 2
Reference: ASME XI, IWC-2500
Examination Category: Table IWC-2500-1, Category C-H
Item Number: C7.10
Description: St. Lucie Unit 2 (PSL2) 2B boric acid make-up pump (BAMP). (2998-2229 R2 & 2998-2410 R5)
Component: The BAM PP 2B boric acid makeup pump casing is a casting of type 316 austenitic stainless steel per ASME SA351 CF8M.
Temperature: Design - 250F (CE Spec 13172-PE-404, R1)
Operating - 120F (Discharge)/120F (Suction)
Pressure: Design - 150psig (CE Spec 13172-PE-404, R1)
Operating - Approx. 130psig (Discharge)/0-9psig (Suction)

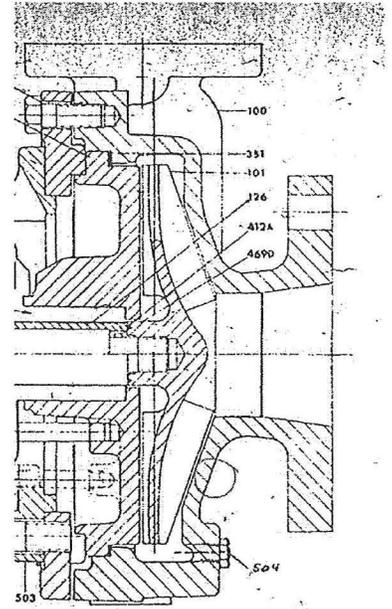
- A dye penetrant (PT) examination was performed on the affected area of the pump casing. As described in Section 4, this examination was inconclusive.
- Leakage was confirmed visually following a pump run, and the location was visually examined with 10X magnification. The flaw was determined to be a rounded indication approximately 1/32" in diameter, with no crack-like characteristics.

Based on the results of the above inspections, the pressure boundary leakage is likely due to small casting void defects or porosity that enabled a through-wall pathway for leakage. This characterization is also supported by the repair attempt on the 2A pump casing, as the flaw was observed to have characteristics of porosity during excavation. Alternate explanations have been considered, but determined to be unlikely, as discussed below.

The figure at the right shows the configuration of the BAMP and the general location of the flaw. The boric acid makeup pump has been in service since initial plant operation. The pump casing is made from cast type 316 austenitic stainless steel per specification ASTM A351-CF8M. Type 316 stainless steel has excellent general corrosion resistance to the boric acid solution that is the process fluid for this pump. Based on testing done for Electric Power Research Institute (Reference 8.2), the general corrosion rate in the process fluid is too small to measure. The other internal parts of the pump are made from cast or wrought type 316 stainless steel. Type 316 stainless steel, either cast or wrought, is not susceptible to pitting or stress corrosion cracking in this environment. The cast version of type 316 stainless steel is not susceptible to thermal aging at the low temperature at which this pump operates. Additionally, mechanical loads due to normal operation, include pump vibration, are low and would not be anticipated to result in service induced flaw growth. With these considerations, it is concluded that there are no active aging degradation mechanisms for this component that would cause initiation and through-wall growth of a planar flaw. The remaining reasonable explanation for leakage is that there is a leakage pathway via small voids, or porosity, originally present in the cast material. Other instances of this phenomenon in the industry are referenced in section 7, Precedents. As discussed below, such small imperfections do not significantly affect the structural integrity of the component.

Structural Integrity - Ultrasonic thickness measurements of the pump casing in the area of the leak resulted in thickness readings of 0.282", 0.289" and 0.292". Per the vendor technical manual this exceeds the design required minimum wall thickness of 0.25". Also, observation of the disassembled 2A BAMP casing did not identify any appreciable general corrosion or "wash-out" in the area of the flaw.

Referencing ASME XI Code subparagraph IWB-3142.4, "Acceptance by Analytical Evaluation," FPL proposes to temporarily accept the as-found relevant condition (through-wall flaw) to allow continued service instead of performing immediate flaw correction by a repair/replacement activity described in Code subparagraph IWC-3142.3, "Acceptance by Repair/Replacement Activity." This proposed alternative is based on FPL actions similar to those required by ASME XI Code Case N-513-3 for flaws without a growth rate analysis. These actions are:
