REFERENCE: Docket No. 50-186
University of Missouri-Columbia Research Reactor
Renewed Facility Operating License No. R-103

SUBJECT: Written communication as required by University of Missouri Research Reactor
Technical Specification 6.6.c(3) regarding a deviation from Technical Specifications
3.2.a and 3.2.f.8.

Licensee Event Report No. 19-05 – July 29, 2019
University of Missouri Research Reactor

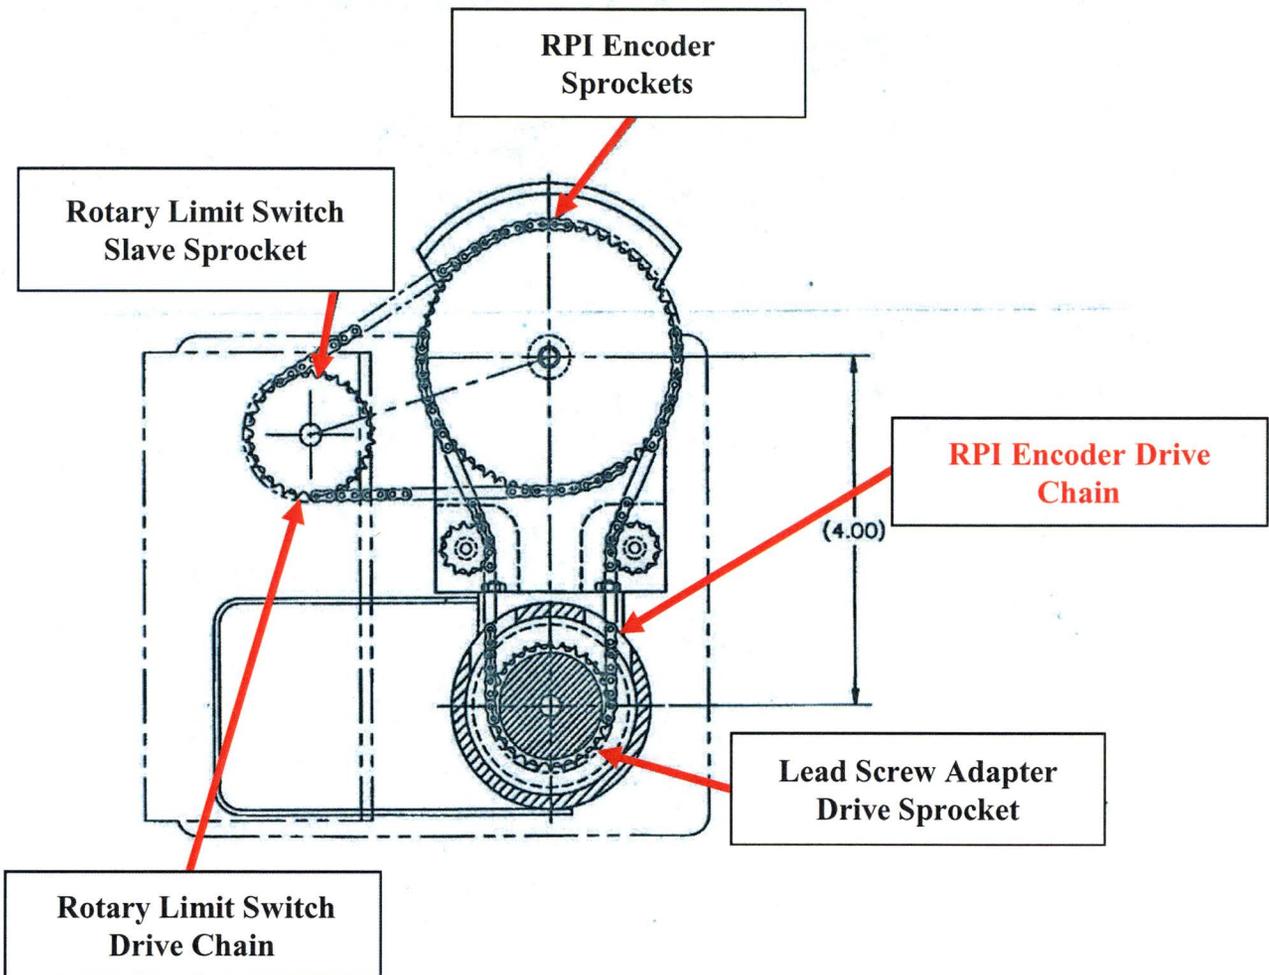
Regulating Blade Drive Assembly Diagram

After a normally scheduled shut down and maintenance day, the reactor was started up and placed in the automatic control mode at 18:57 on July 29, 2019. The regulating blade was observed to move in the inward direction by RPI when the reactor was placed in the automatic control mode. Therefore, the RPI encoder drive chain was engaged and the regulating blade was operable at 18:57. Just after 19:02, the control room operators noted that the NI power range monitors (PRMs) indicated a reactor power level of 90%. These same PRMs indicated a power level of approximately 103% less than a minute earlier. At 19:03, a reactor operator on the reactor pool bridge found that the regulating blade drive mechanism was not moving in response to the console operator inserting the shim control blades while in the automatic control mode. The console operator immediately initiated a manual reactor scram, and all immediate and subsequent actions of reactor emergency procedures REP-2, "Reactor Scram," and REP-7, "Rod Position Indication System Failure," were completed. The drive chain for the RPI encoder on the regulating blade drive mechanism had disengaged and prevented the regulating blade from moving in the outward direction.

The regulating blade drive mechanism was removed for inspection and troubleshooting. After placing the RPI encoder drive chain back on its associated sprockets, the chain alignment and tension seemed to be normal and satisfactory. After further inspection, it was noted that one (1) of the idler sprocket shafts was not quite perpendicular to the chain. The idler sprocket shaft connection was tightened which corrected this very slight misalignment of the idler sprocket and chain.

The idler sprocket shaft connection was tightened which corrected this very slight misalignment of the idler sprocket and chain. In addition, this action tightened the chain tension which helps ensure the chain will stay on the sprockets.

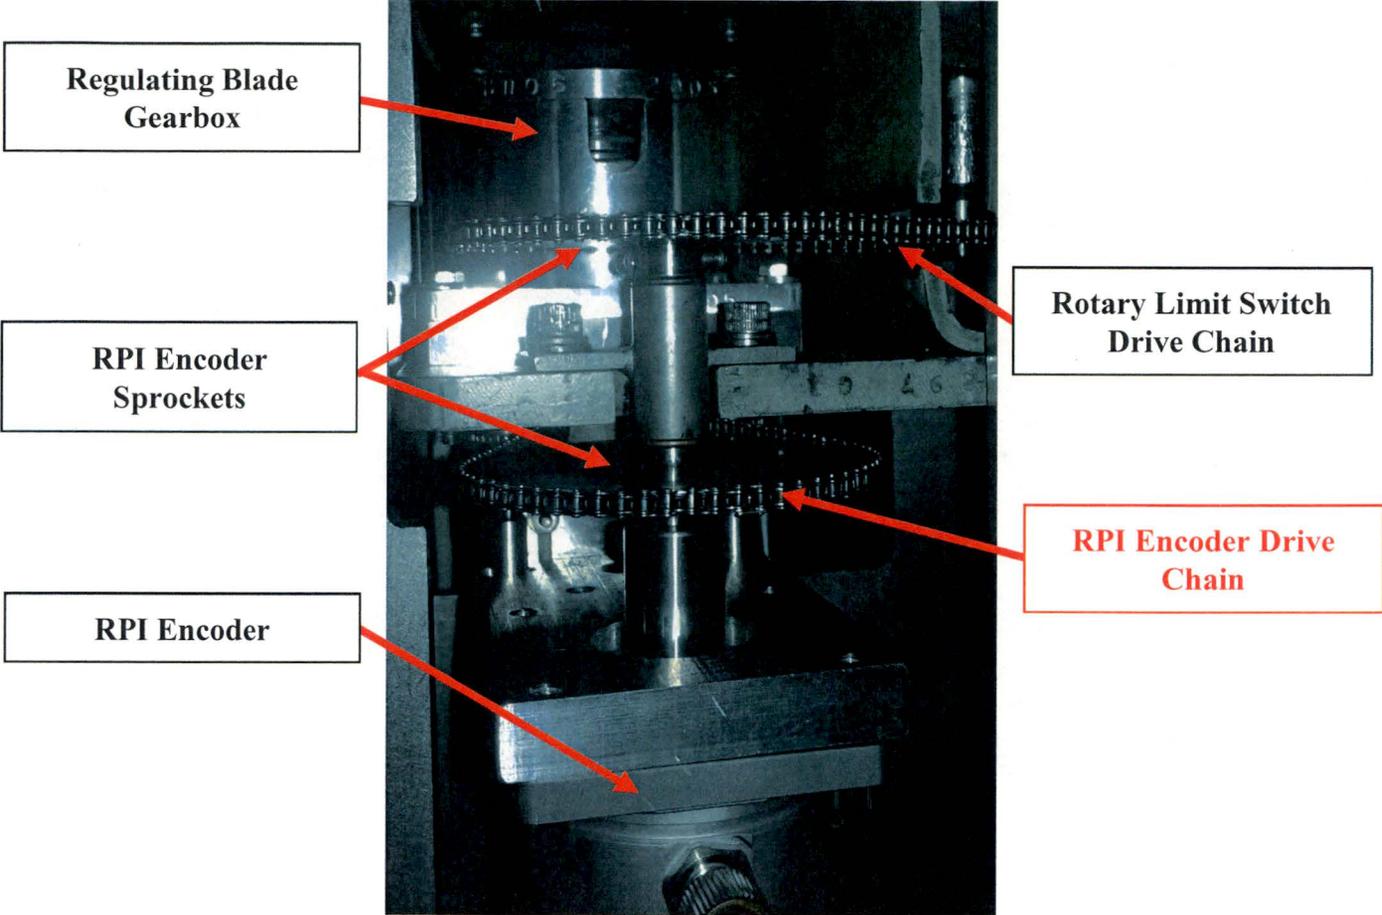
Regulating Blade Drive Assembly

Initial investigation revealed that the drive chain for the RPI encoder on the regulating blade drive mechanism had disengaged and prevented the regulating blade from moving in the outward direction. After the reactor was shut down, the Lead Senior Reactor Operator used manual regulating blade control to successfully move the regulating blade in the inward direction. However, the chain bound the regulating blade from moving outward.

The reactor was shut down by manual scram when it was determined that the regulating blade was inoperable. The regulating blade drive mechanism was removed for inspection and troubleshooting. After placing the RPI encoder drive chain back on its associated sprockets, the chain alignment and tension seemed to be normal and satisfactory. After further inspection, it was noted that one (1) of the idler sprocket shafts was not quite perpendicular to the chain.
