Homestake Mining Company of California

05 August 2019

RE: Homestake Mining Company, Grants Reclamation Project, License Source Materials License SUA-1471, Docket Number 40-8903; NMED Discharge Permit DP-200: NMED 15-Day/NRC 30-Day Corrective Action Report for the Unauthorized Discharge from Evaporation Pond EP-1

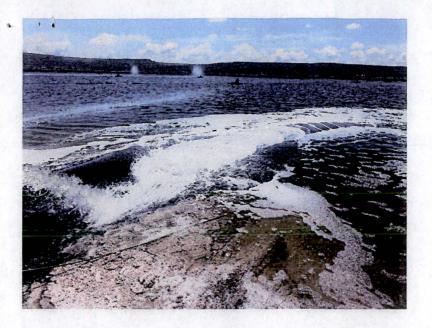
In anticipation of the EP-1 re-lining project, the water level in EP-1 had been lowered during the spring. Since the re-lining project was deferred to 2020 and residual salts were exposed in EP-1, HMC commenced transferring water from Evaporation Pond #2 (EP-2) on July 11, 2019. The discharge stream into EP-1 tore a hole in the liner on July 23, 2019 and the transfer was stopped that afternoon, leaving an approximate six-inch hole in the liner slightly above the water line. An estimated volume of up to 12,000 gallons of brine was released through the tear. A photograph of the tear area is attached.

Photograph 1: View showing water discharge causing water/air to infiltrate below liner

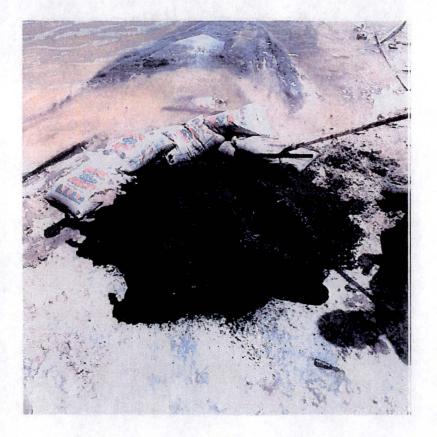
Photograph 2: View showing liner after repair with fabric patch and sealed with Deery Oil #6

Repairs were performed on July 31, 2019. Sandbags were used to isolate the tear and then a fabric patch was used to cover the tear prior to application of Deery Oil #6 to seal the tear. A photograph showing the final patch is attached.
