SUBJECT: OPERATING REACTOR EVENT MEMORANDUM NO. 81- 31:
LOSS OF DIRECT CURRENT (DC) BUS AT MILLSTONE UNIT 2

LOSS OF DC BUS AT MILLSTONE 2SEQUENCE OF EVENTS

LOSS OF DC BUS AT MILLSTONE 2

ANALYSIS AND CONCERNS

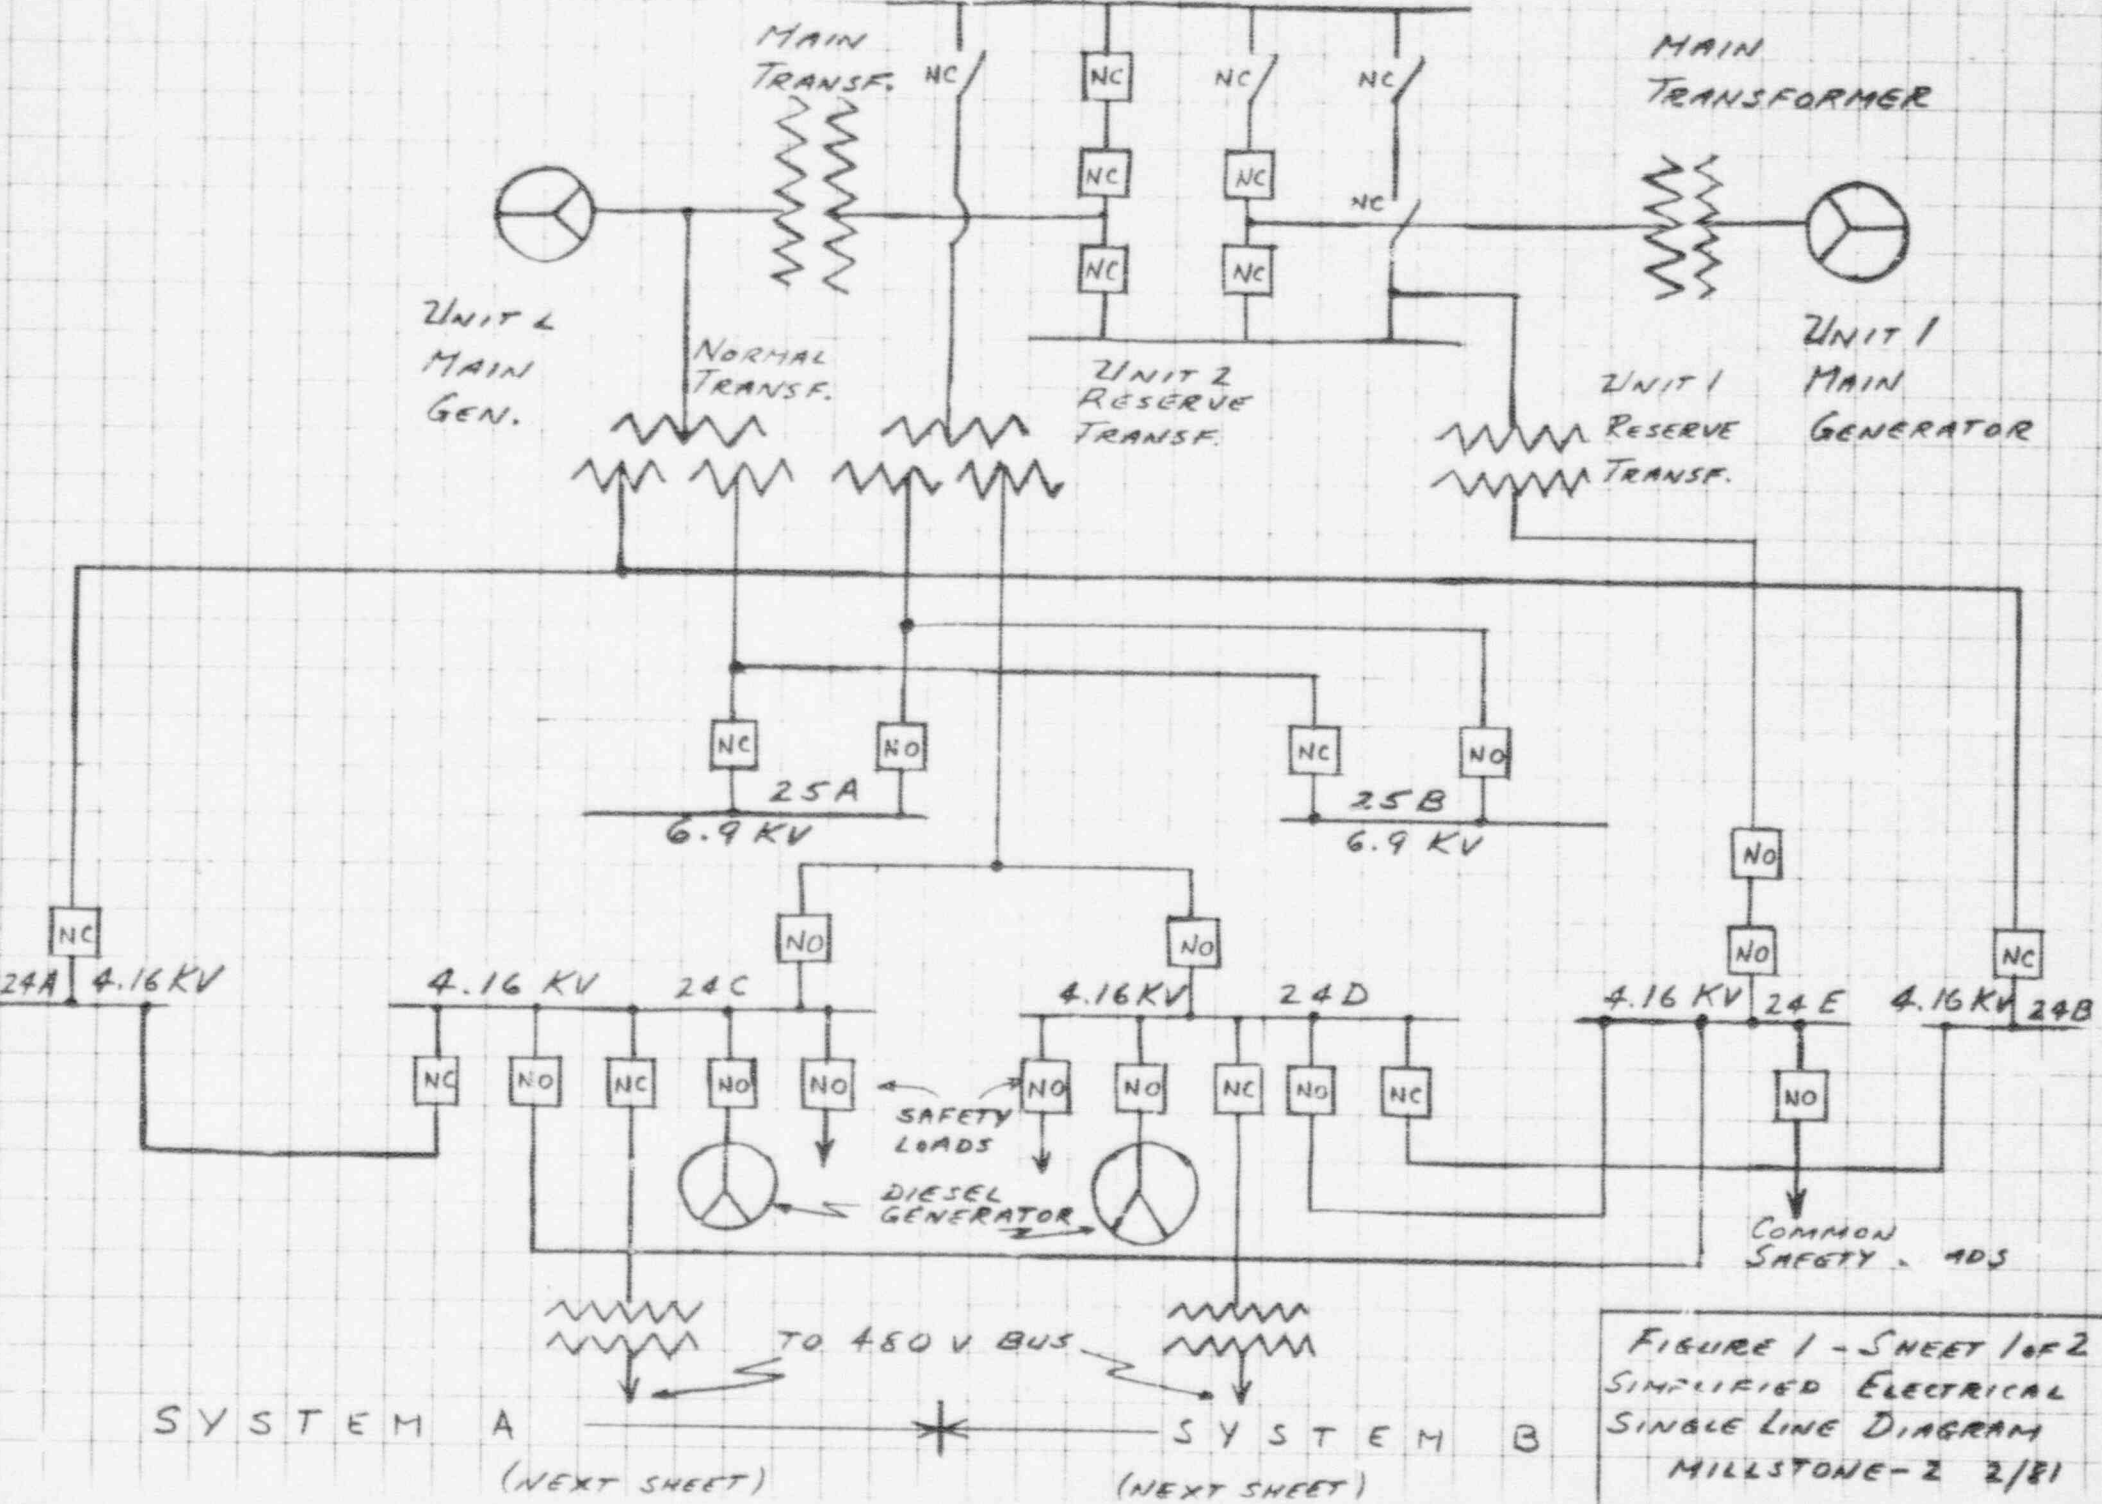
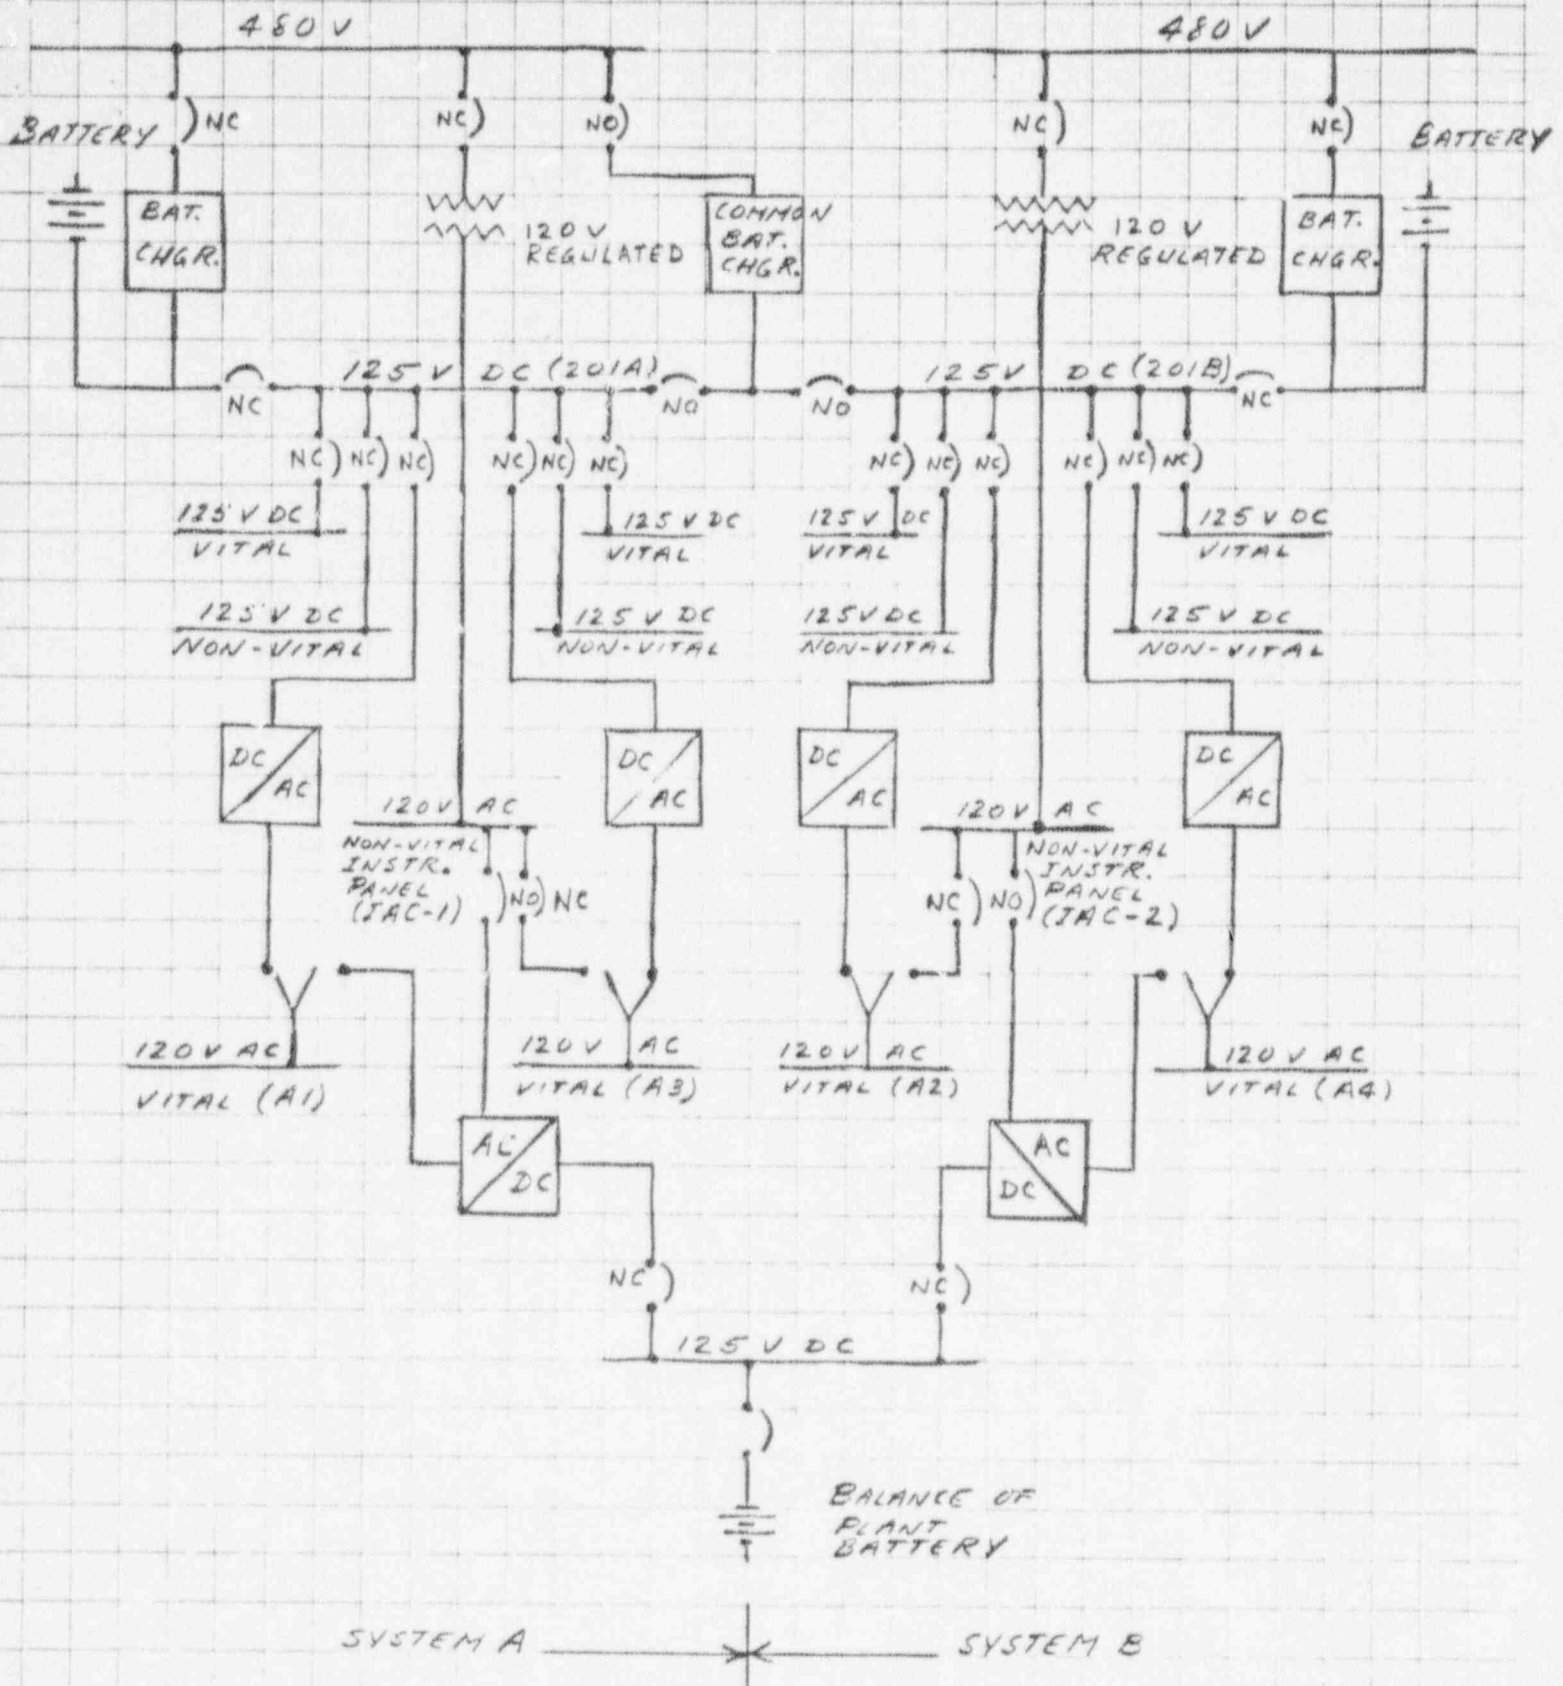
FIGURE 1 - SHEET 1 OF 2
SIMPLIFIED ELECTRICAL
SINGLE LINE DIAGRAM
MILLSTONE-2 2/81

Ten minutes after the initiating event occurred, System B diesel generator experienced a malfunction caused by a water leak which sprayed the speed controller. This resulted in an underspeed condition followed by a low oil pressure trip of the diesel generator. The low oil pressure trip corresponded to a electrical frequency of approximately 45 hertz. At approximately the same time, several fuses were blown in the instrumentation loops being powered from a 120 V ac non-vital instrument panel associated with system B. This panel has been identified in the enclosed Figure 1 as IAC-2.

As a result of evaluating the effects of this event, it was noted that the independence between the two redundant electrical systems could possibly be compromised at the 120 V ac level. As shown in the enclosed Figure 1, each system has two vital 120 V ac buses and one non-vital bus. One vital bus of each system is fed automatically, upon loss of the normal source, from a dc/ac inverter for which the source of dc is the balance of the plant battery (referred as the turbine battery). The other vital bus of each system is fed automatically from the non-vital bus upon the loss of the normal supply. Each non-vital bus can also be supplied from the same dc/ac inverter connected to the balance of the plant battery and used as mentioned before as an automatic alternate source for one of the vital buses. Thus, the design provisions to assure continuity of power to the vital buses from the common balance of the plant battery could also result in the compromising of the required independence between redundant electrical systems.

- o The Operating Reactors Branch #3 should convey the following to the licensee:
 - g To examine the design and recommend modifications (including technical specification changes) that will preclude supplying either manually or automatically vital buses in supposedly independent systems from a single non-safety related bus of the plant battery at the same time. The ORAB will evaluate the licensee's recommendations in this regard.
