NUCLEAR REGULATORY COMMISSION

IN THE MATTER OF:  
STATUS OF MAY 2 EVENT AT OYSTER CREEK

Place - Washington, D. C.  
Date - Wednesday, May 30, 1979  
Pages 1 - 32

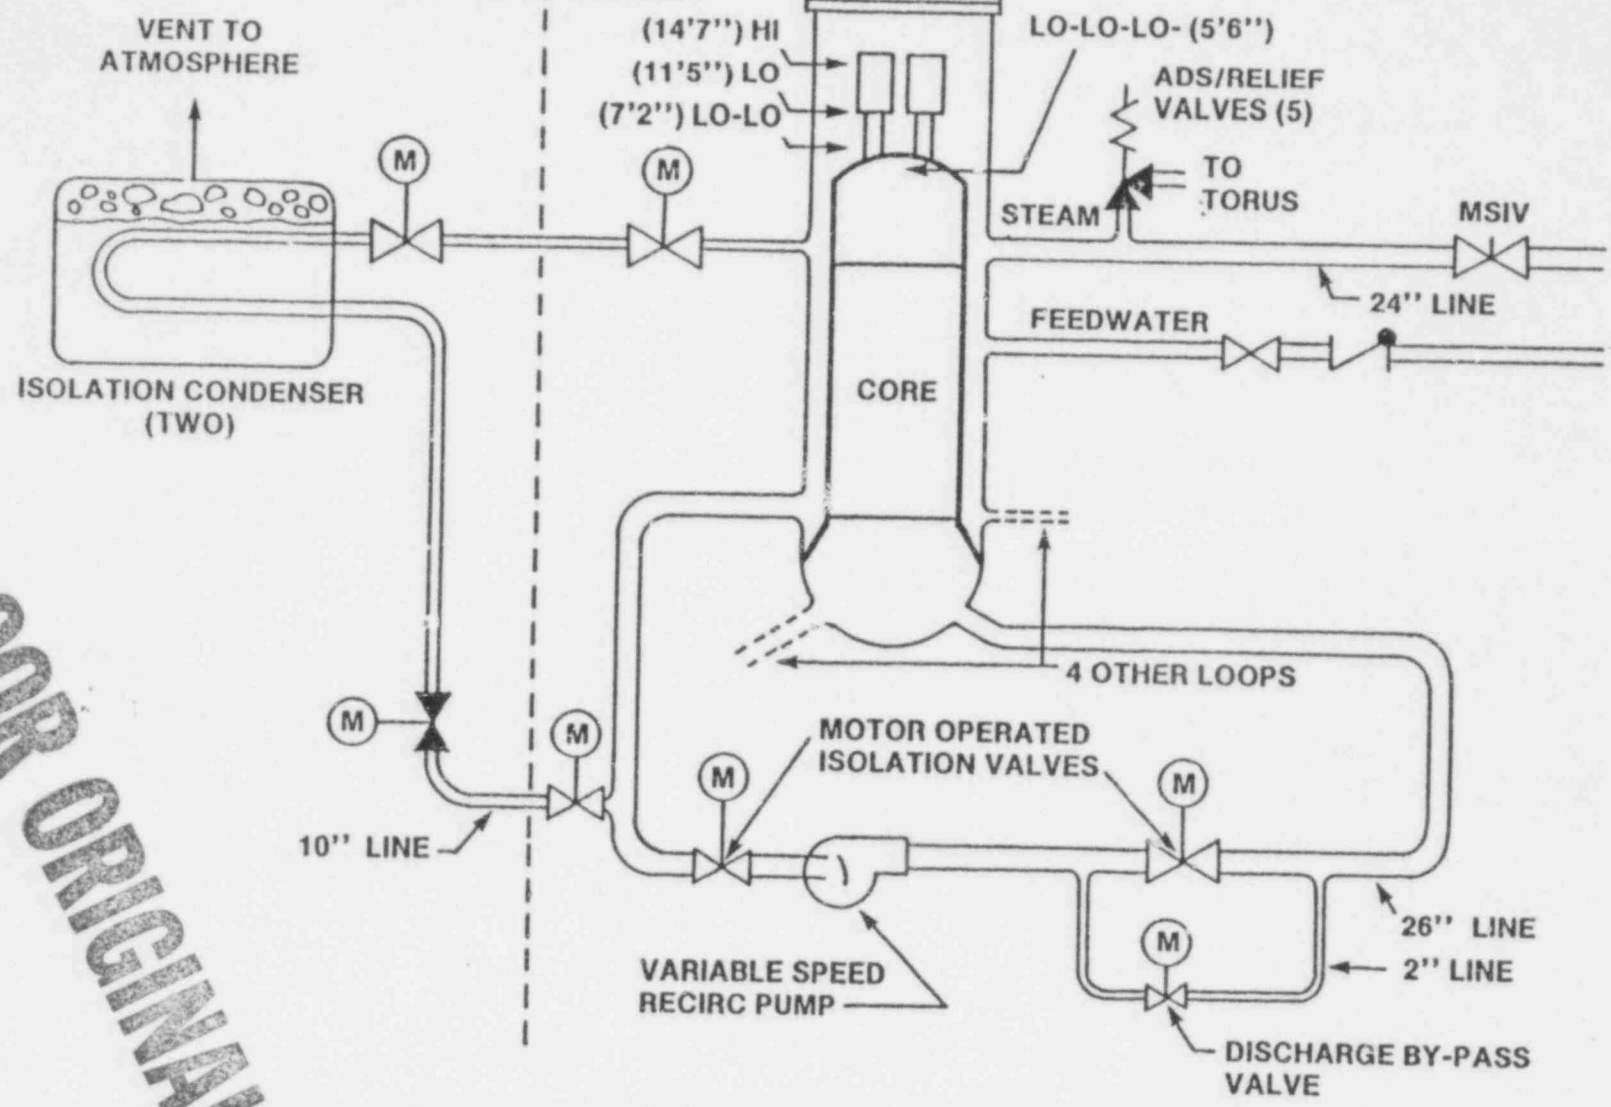
OYSTER CREEK RECIRCULATION, STEAM AND ISOLATION CONDENSER SCHEMATIC

6 The steam supply system. The reactor, with five  
7 recirculation loops. Only one is shown explicitly here. It's  
8 typical, of course. There are four others. There is main  
9 steam piping and there is feedwater piping.

7 At the time of the May 2nd event, one of these  
8 recirculation loops, Loop D, was out of service awaiting  
9 replacement parts for a pump seal. Two of the recirculation  
10 loops, A and E, have ten-inch connections on the suction side  
11 of the recirculation pump, upstream of the isolation valve.  
12 These connections are the return lines from the isolation  
13 condensers.

21 The discharge valve was closed, the suction valve  
22 open, the discharge bypass valve open, and a plate was  
23 discharged over the opening in the pump housing, so there was  
24 continuity in the loop.

6 Now, here is an important point: The procedures  
7 governing isolation condenser operation instruct the operator to  
8 close the discharge valves on recirculation loops A and E, the  
9 two loops to which the isolation condensers are connected. This  
10 is to protect against an excessive flow condition in the con-  
11 denser piping that would actuate the break-sensing automatic  
12 isolation provisions of the isolation condenser. High-flow con-  
13 ditions in the isolation condenser are sensed automatically as  
14 a break in that system, and automatically then the reactor takes  
15 steps to isolate itself to isolate the break.

8           In a minute and a half, then, we have not an isolation  
9 condition, but certainly a choked-flow condition. It's not true  
10 of isolation. A choked-flow condition between the annulus and  
11 the core, the only path being through the bypass lines around  
12 each of the discharge valves and each of the five loops.

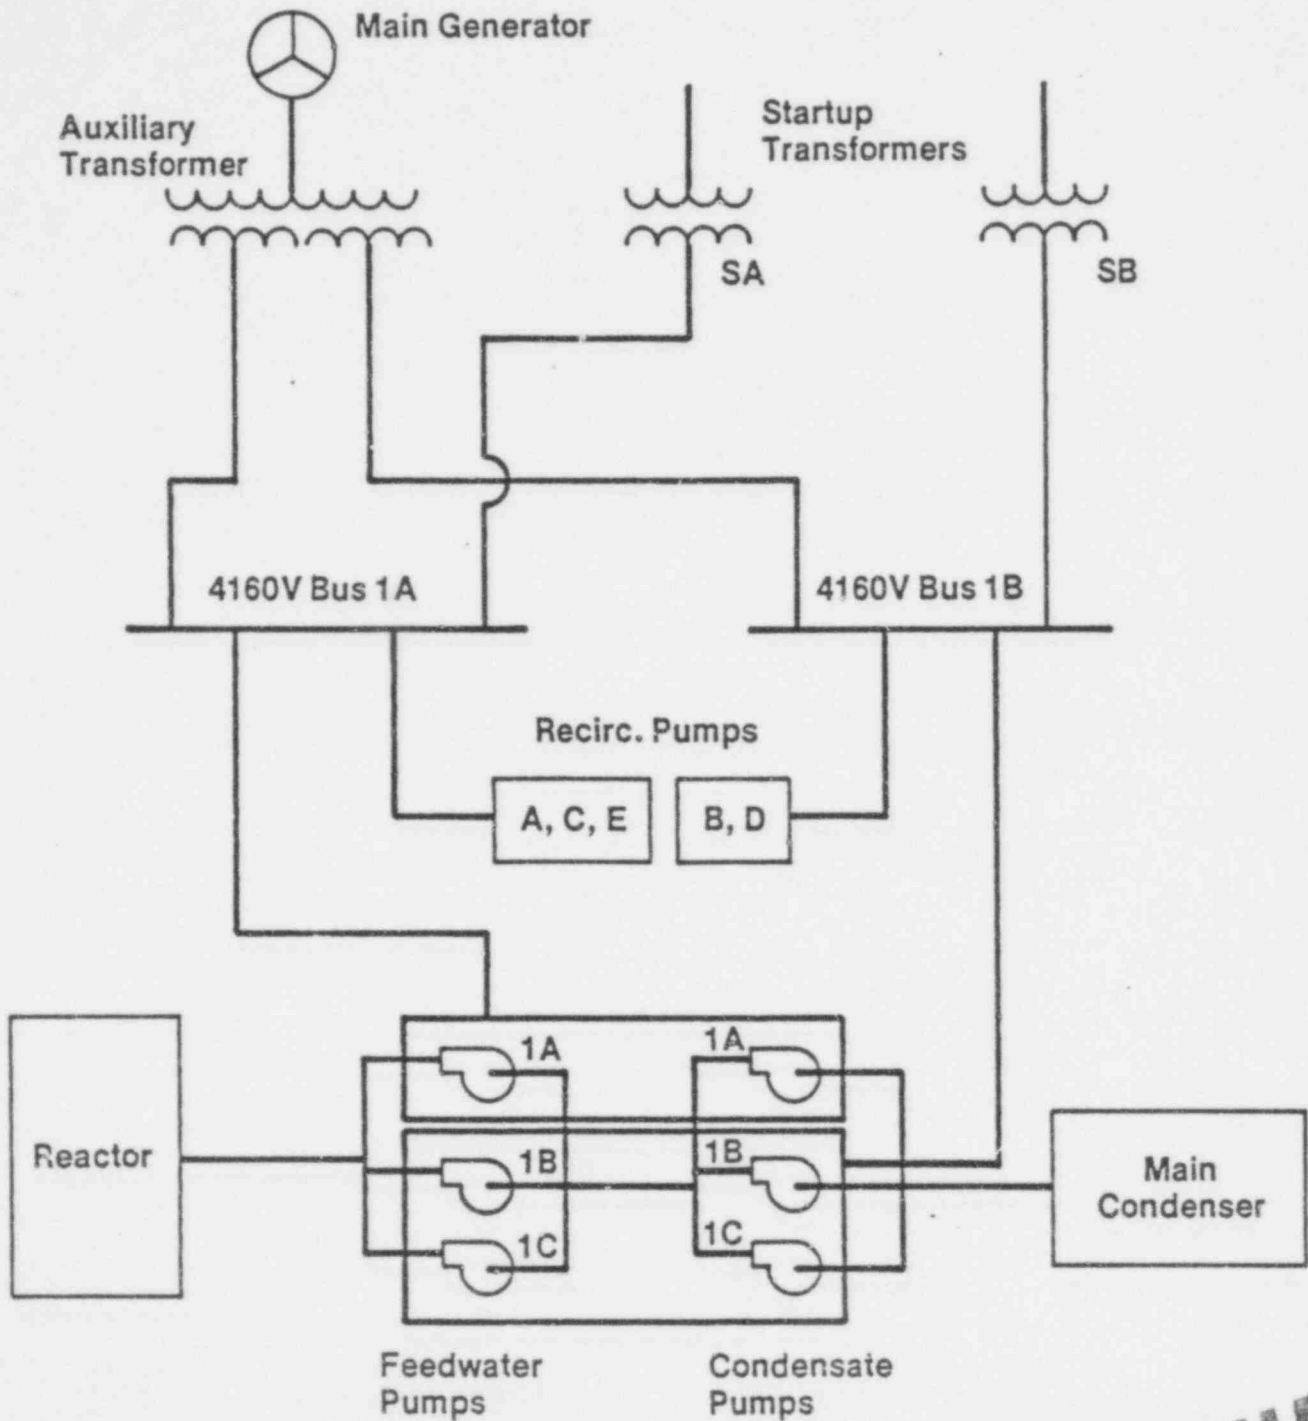
# Feedwater & Electrical Supply Systems

11 Start-up transformers SA and SB provide power to  
12 buses 1A and 1B during plant shutdown. Condensate pump 1A,  
13 feed pump 1A, recirculation pumps A, C and E all receive power  
14 from nonvital bus 1A. Condensate pumps 1B and C, feedwater  
15 pumps 1B and C, and recirculation pumps B and D receive power  
16 from bus 1B.

17 The point here is that at the time of the May 2nd  
18 event, start-up transformer SB was out of service, as permitted  
19 by technical specifications, to perform a routine inspection  
20 of its associated 4160 Volt cabling. This point may have  
21 been the subject of some confusion at the previous briefing.  
22 I want to make the point here that that transformer was out  
23 per technical specifications, for routine surveillance. It  
24 had been out for approximately two hours before the event.

20 Automatic transfer of loads from the auxiliary  
21 transformer to the start-up transformers was successful for  
22 start-up transformer SA, but failed, of course, for SB, because  
23 it was out of service. This left feed and condensate pumps  
24 1B and 1C without power, and they tripped temporarily.

25 Condensate pump 1A alone could not meet the suction

1 pressure requirements of feedwater pump 1A. So feedwater pump  
2 tripped. This is a known characteristic of the feedwater  
3 system.
