UNITED STATES
NUCLEAR REGULATORY COMMISSION
OFFICE OF INSPECTION AND ENFORCEMENT
WASHINGTON, D.C. 20555

IE Information Notice No. 79-13

INDICATION OF LOW WATER LEVEL IN THE OYSTER CREEK REACTOR

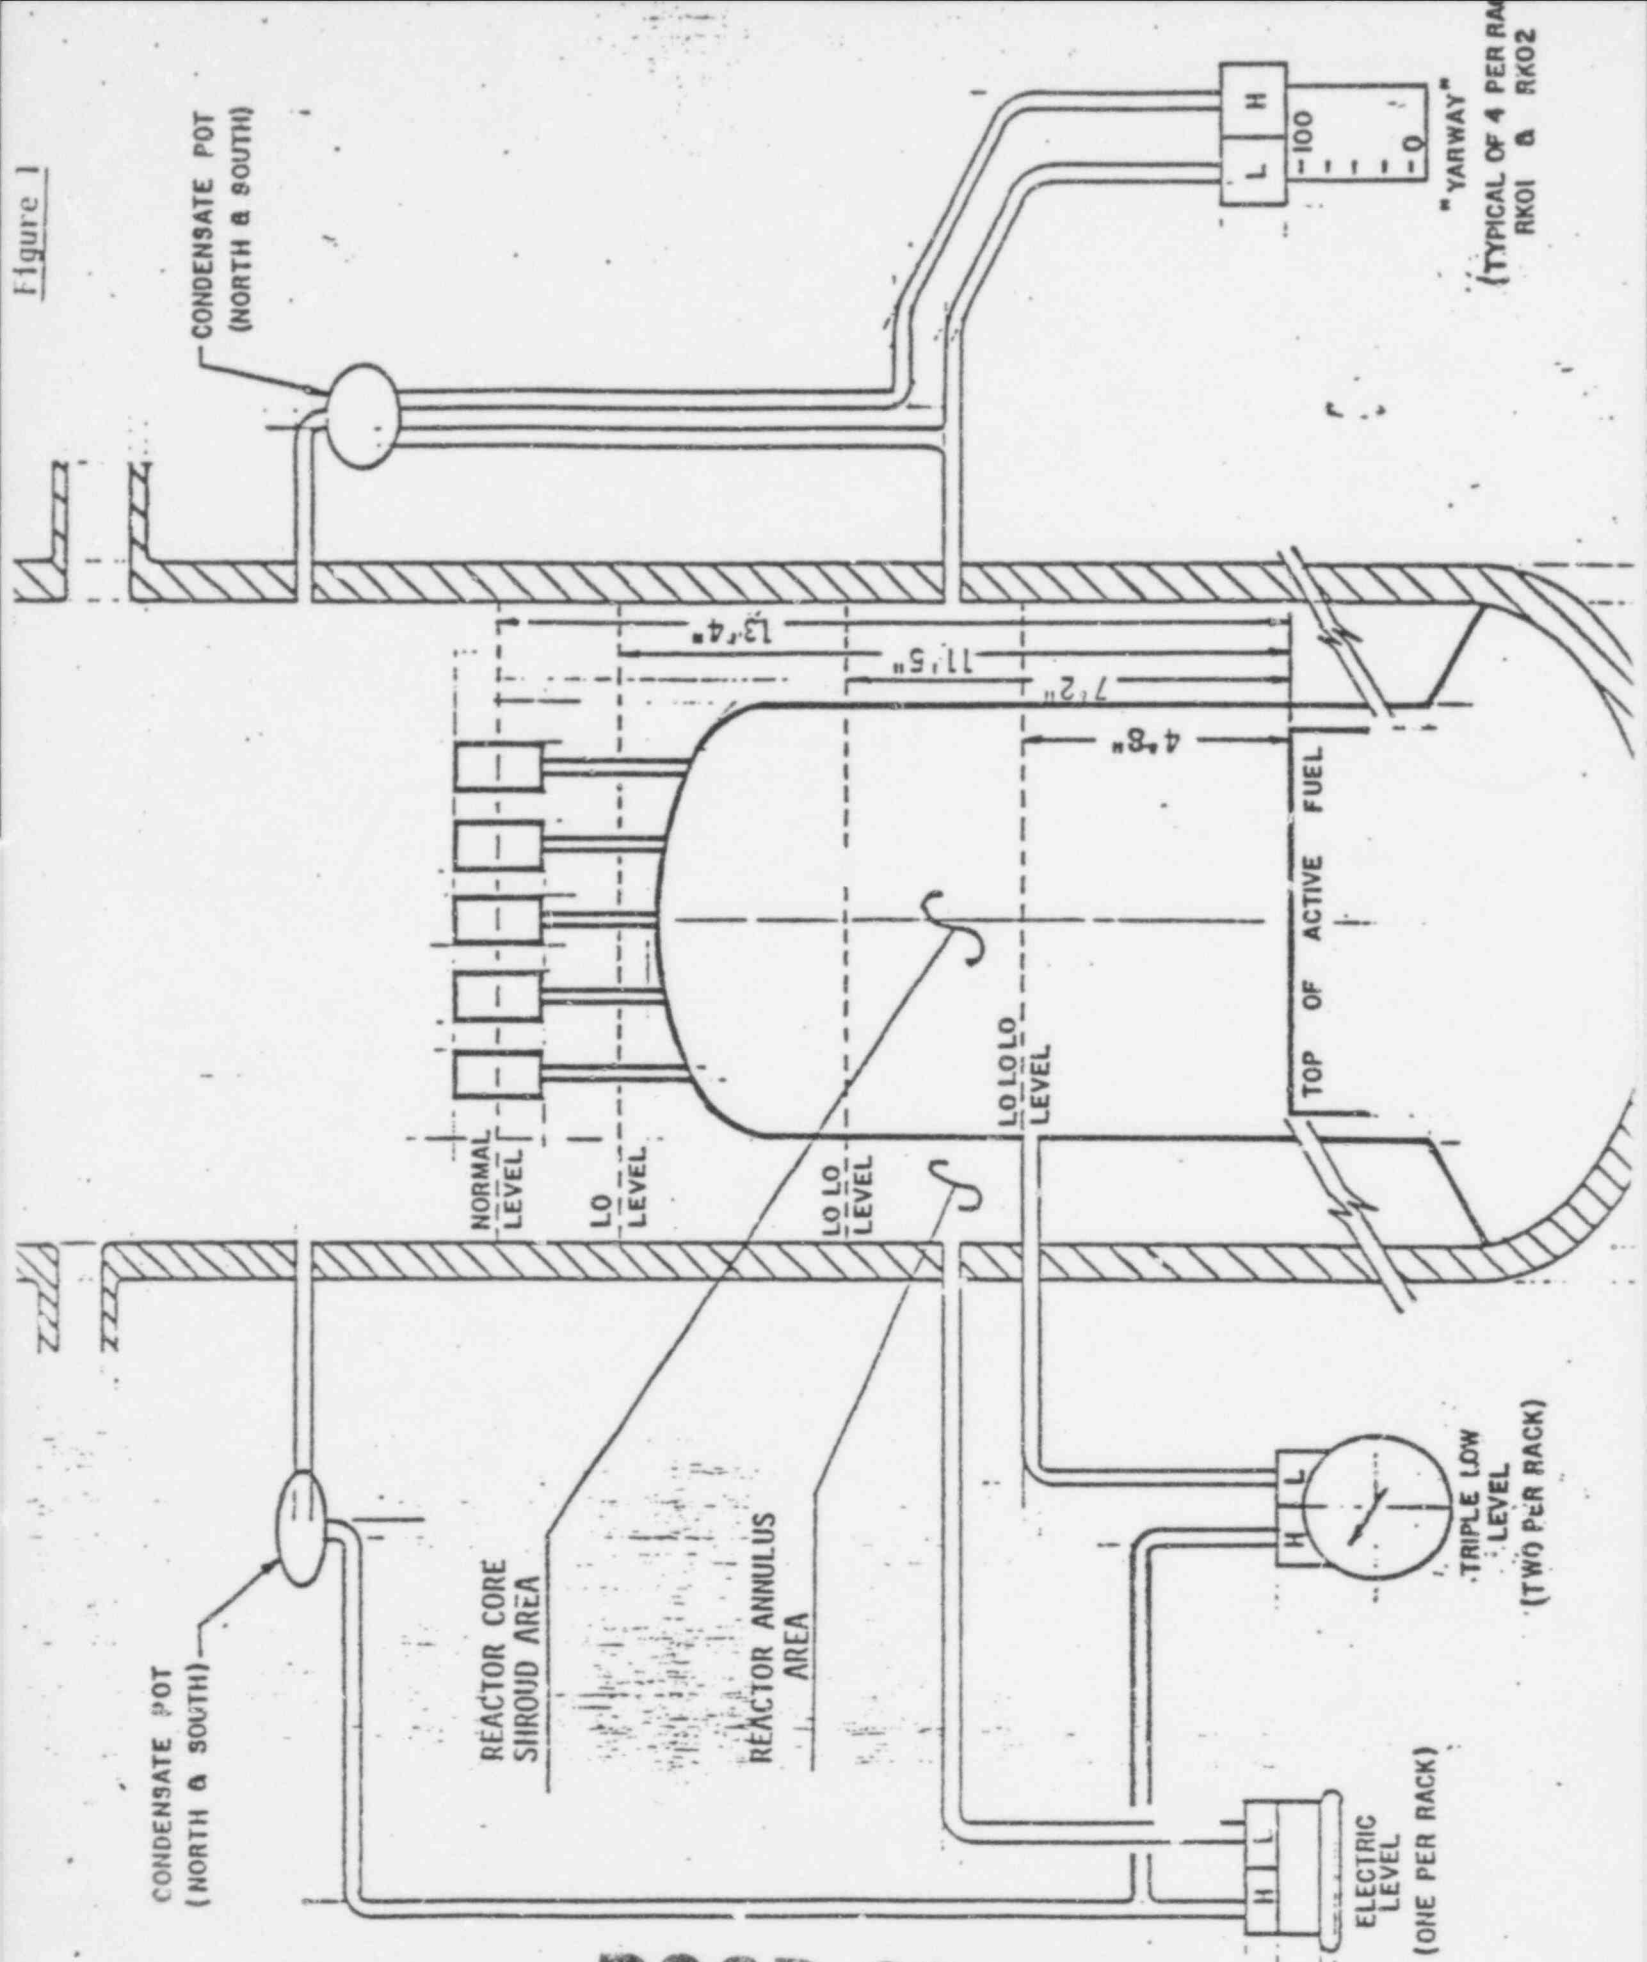
Figure 1

A loss of feedwater transient at the Oyster Creek facility on May 2, 1979, resulted in a significant reduction in water inventory within the reactor core shroud area as measured by one set of water level instruments (triple low level), while the remaining level instruments, sensing from the reactor annulus area indicated water levels above any protective feature setpoint (Figure 1). The water level within the core shroud area was reduced below the "triple low level" setpoint of 4-feet, 8-inches above the top of the fuel.

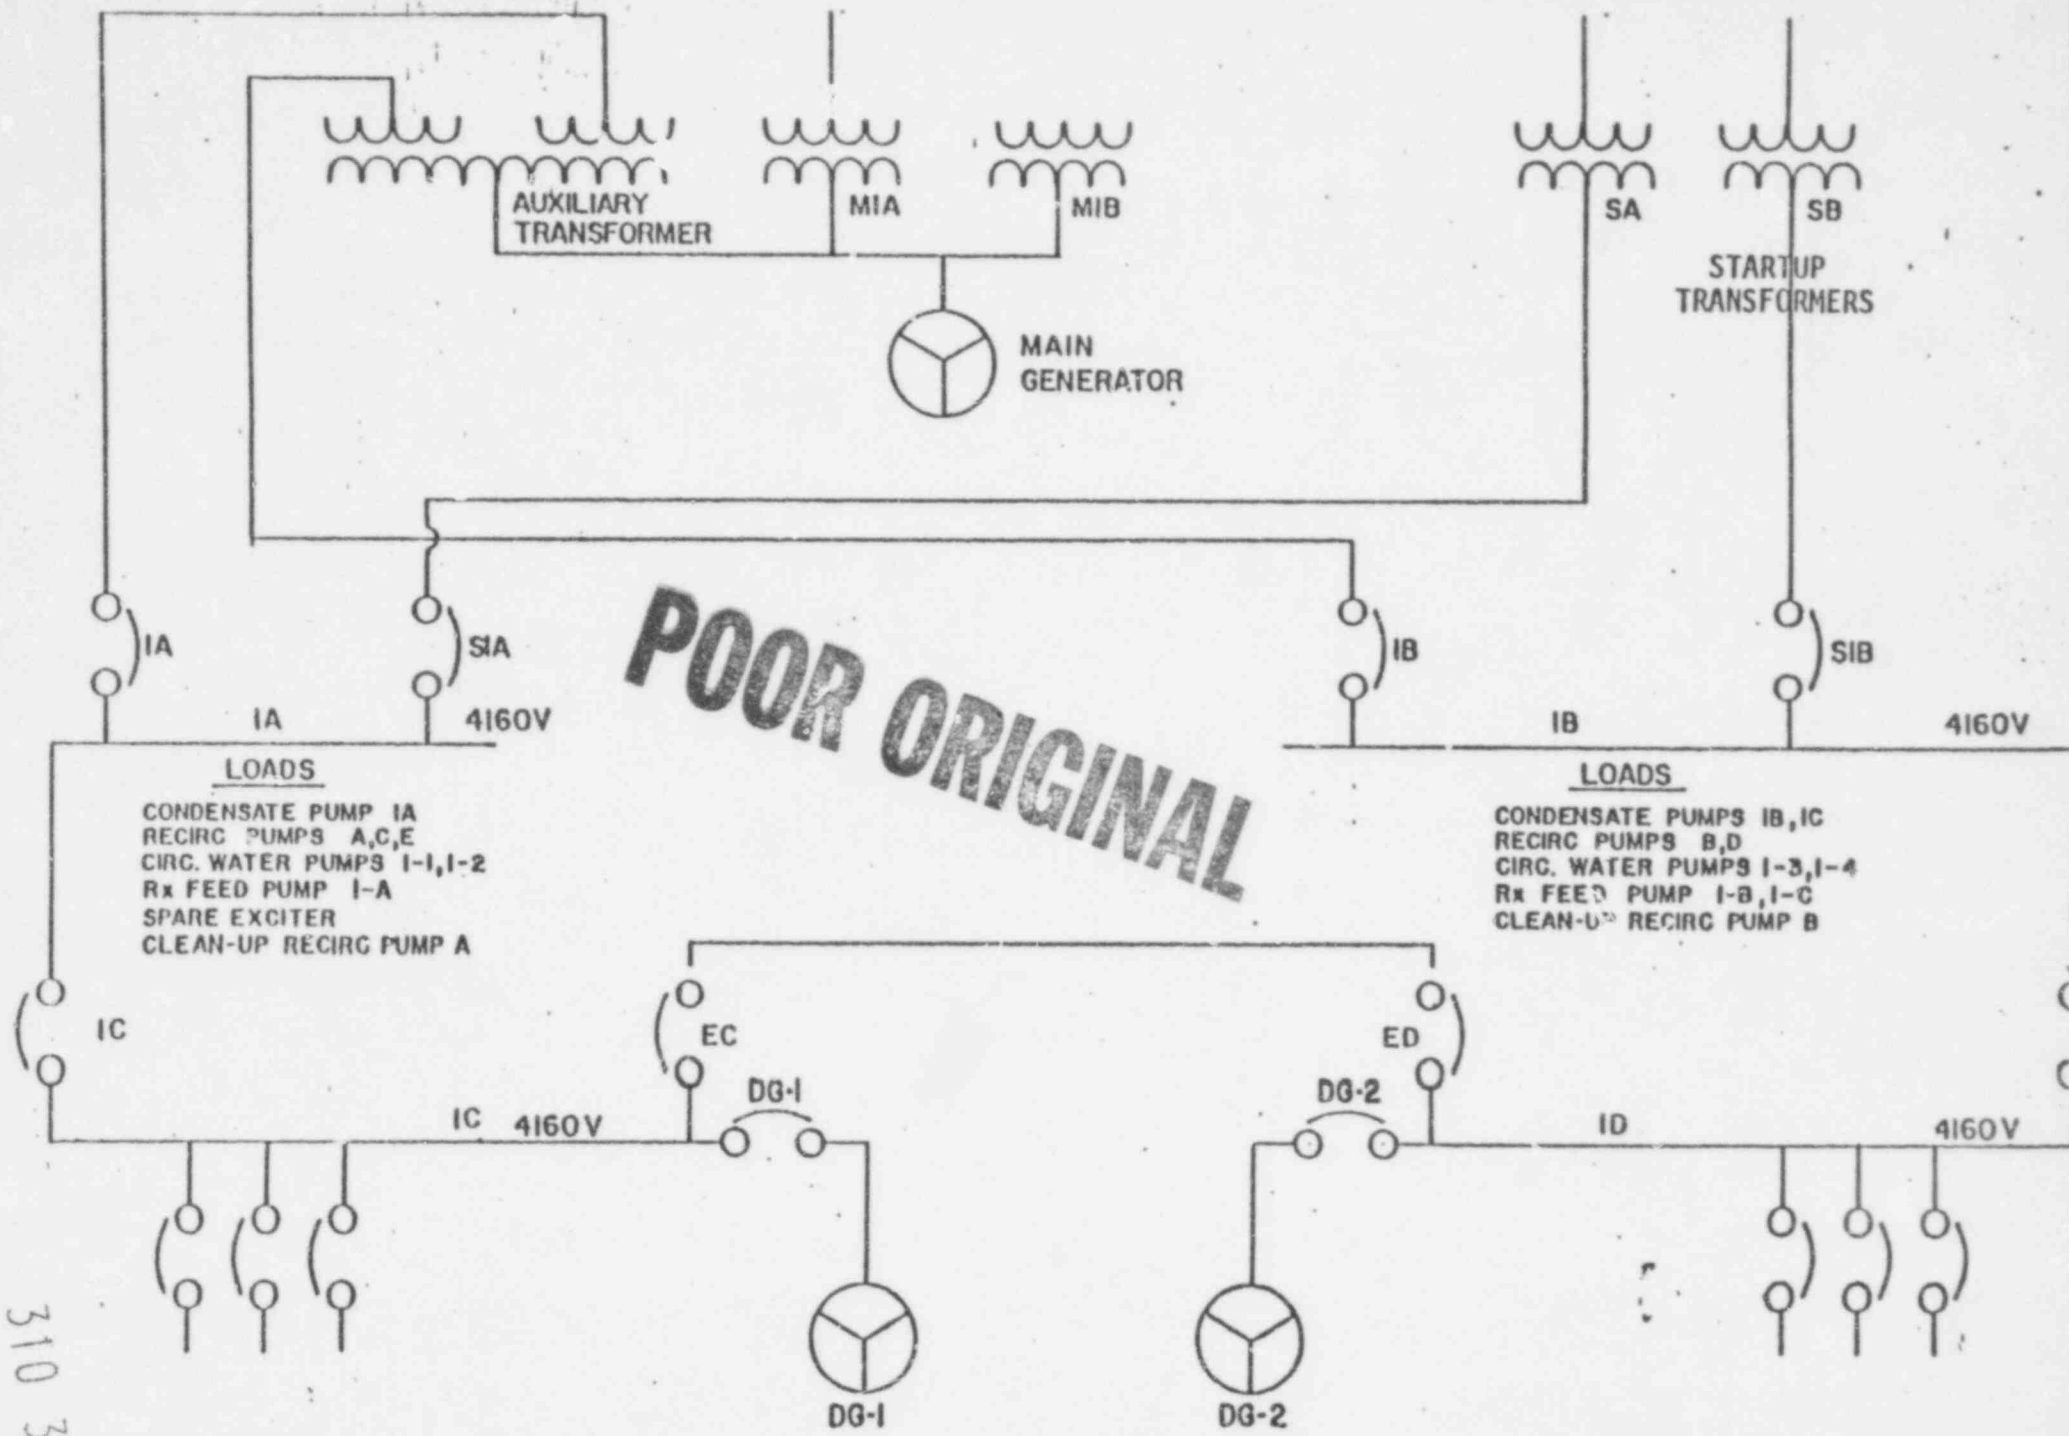
FIGURE 2

Thirteen seconds after the reactor scram on a false high reactor pressure signal, the turbine tripped at 25% low load setpoint. The turbine trip initiated a transfer of power from the auxiliary transformers to the startup transformers (Figure 2). Because one startup transformer (SB) was out of service, two feedpumps and two condensate pumps on that 4160v bus (IB) lost power (pumps 1B and 1C). The third feedpump (1A) tripped due to low suction pressure resulting from the feedwater transient. An immediate attempt to restart 1A was unsuccessful because of failure of an auxiliary oil pump to start. The oil pump is interlocked in the feedpump start sequence.

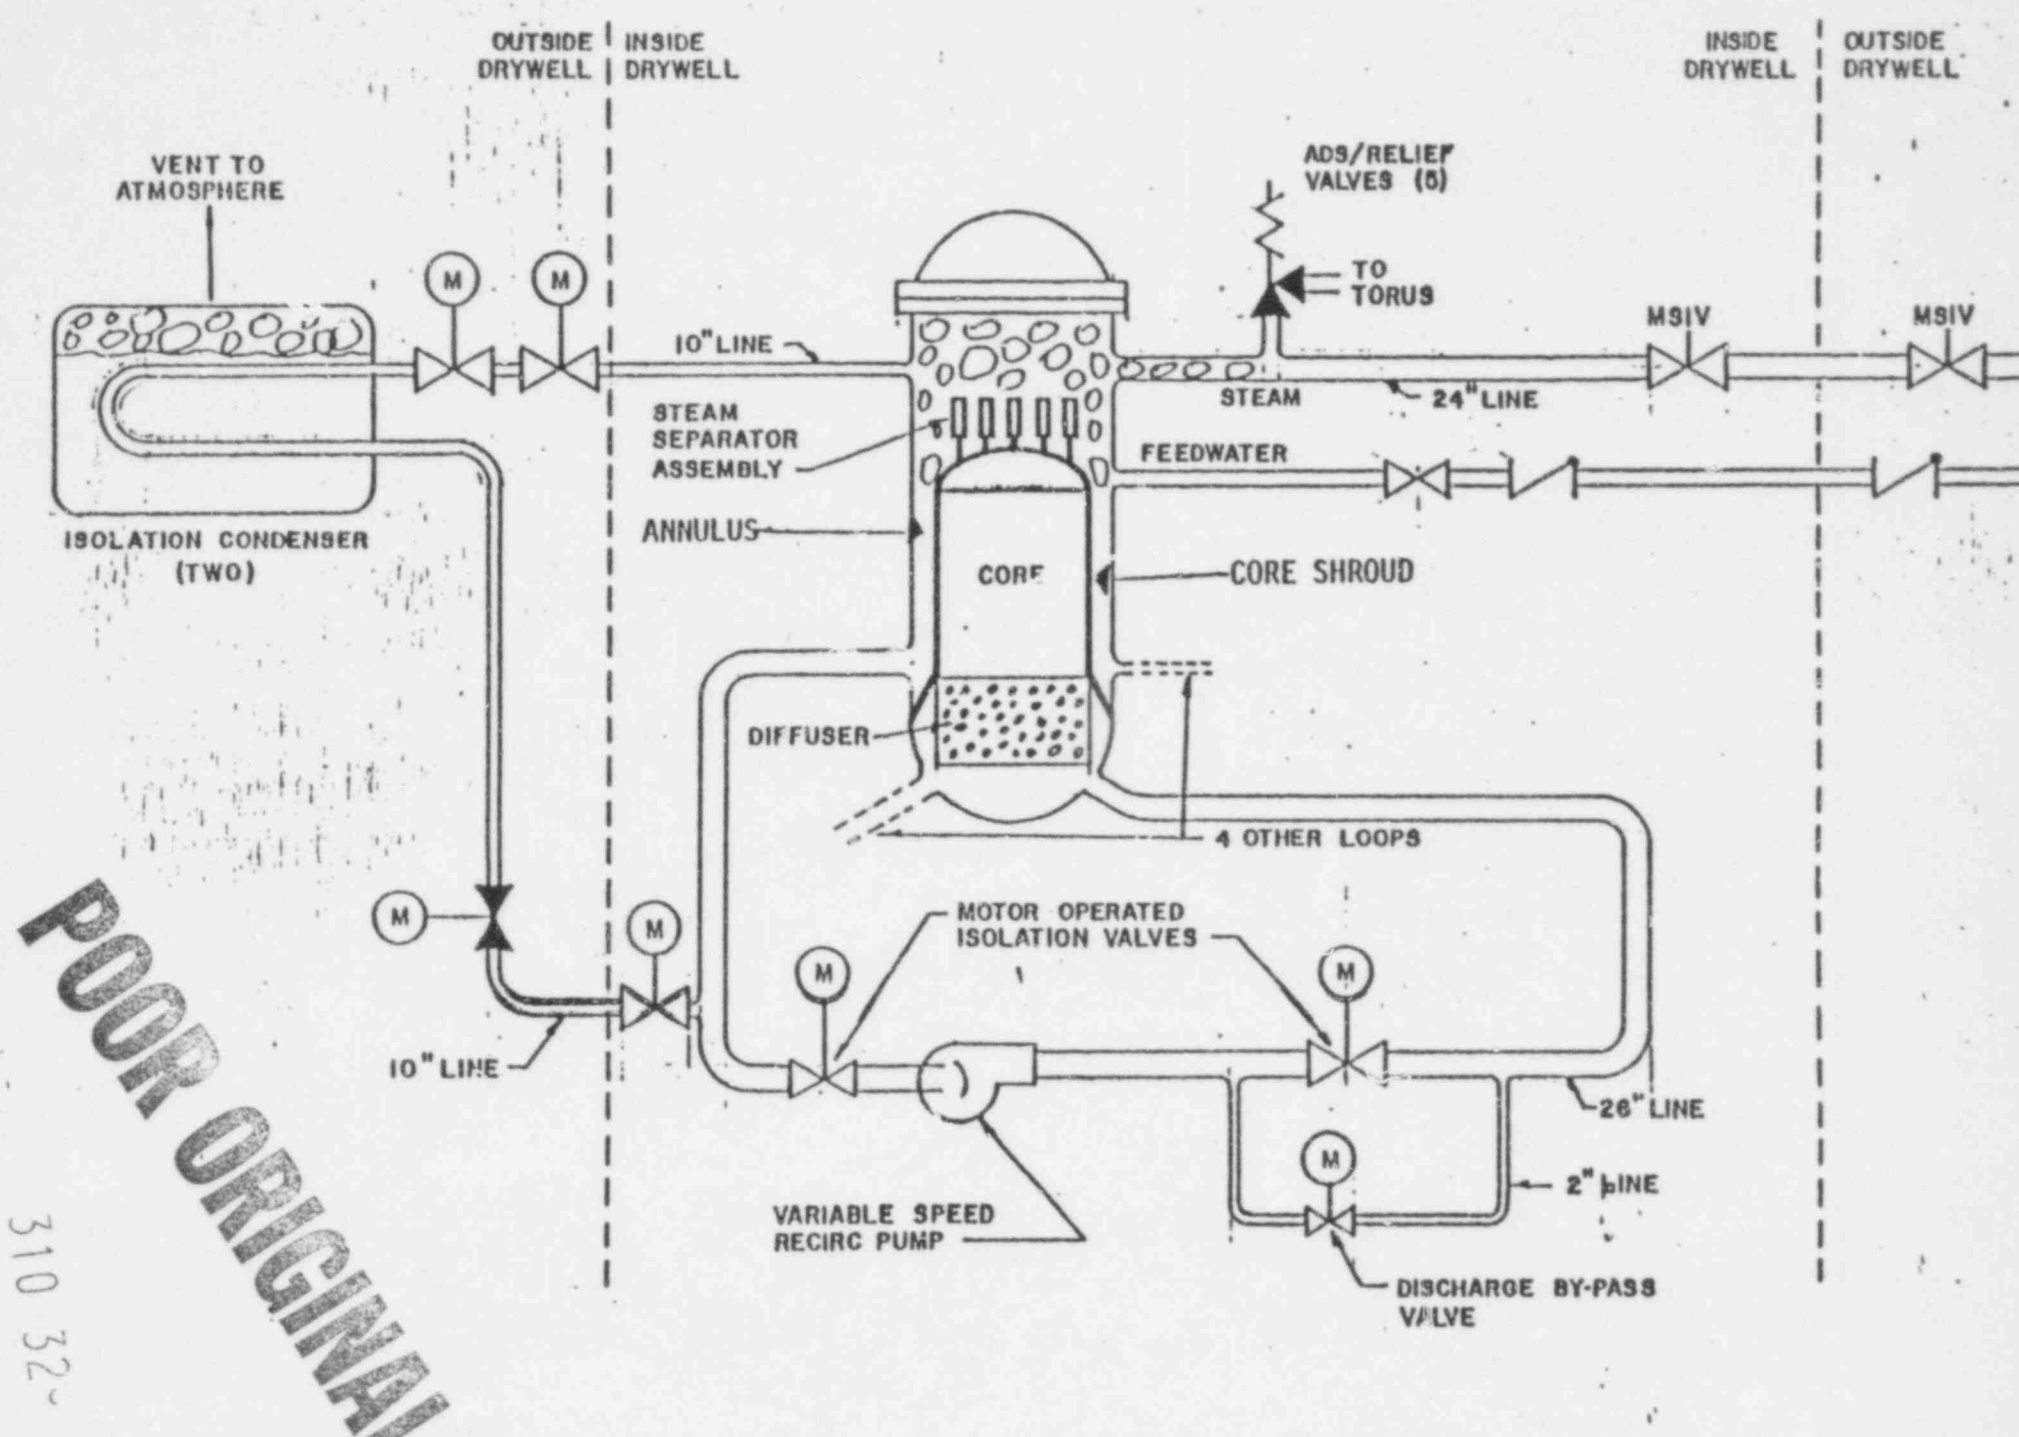
Initially, water inventory was decreasing due to steam flow through the turbine bypass valves to the main condenser. This loss together with the void collapse associated with decreased feedwater temperature and the subsequent loss of feed flow, resulted in a rapid reactor water level reduction to the low water level alarm setpoint of 11-feet, 5-inches above the top of the fuel at 13.6 seconds. At 25 seconds, an emergency diesel generator (DG-2) had automatically fast-started following the power loss to bus 1D and picked up emergency loads as designed. This loading included the second control rod drive (CRD) pump which with the other CRD pump (powered through the retained startup transformer) provided the only coolant makeup during this time. The operator manually initiated a main steam line isolation valve (MSIV) closure at about 43 seconds into the transient to conserve water inventory. The minimum indicated water level in the annulus area was 9-feet, 8-inches above the top of the fuel (the low low setpoint is 7-feet, 2-inches above the top of the fuel). After closure of the MSIV the isolation condenser was condensing steam from the core and returning the condensate to the reactor annulus (down-comer) region through connection to a recirculation loop pump suction line (Figure 3). Reactor water level began to increase shortly after MSIV closure.

The triple low level in the core shroud area resulted from restriction of the isolation condenser return flow path to the core region due to closure of the recirculation pump discharge valves. With the recirculation pump discharge valves closed, the flow path back to the core shroud was via the 2-inch bypass lines around the discharge valves. The effect was to reduce the water level in the core shroud area and to increase the level in the reactor annulus area.

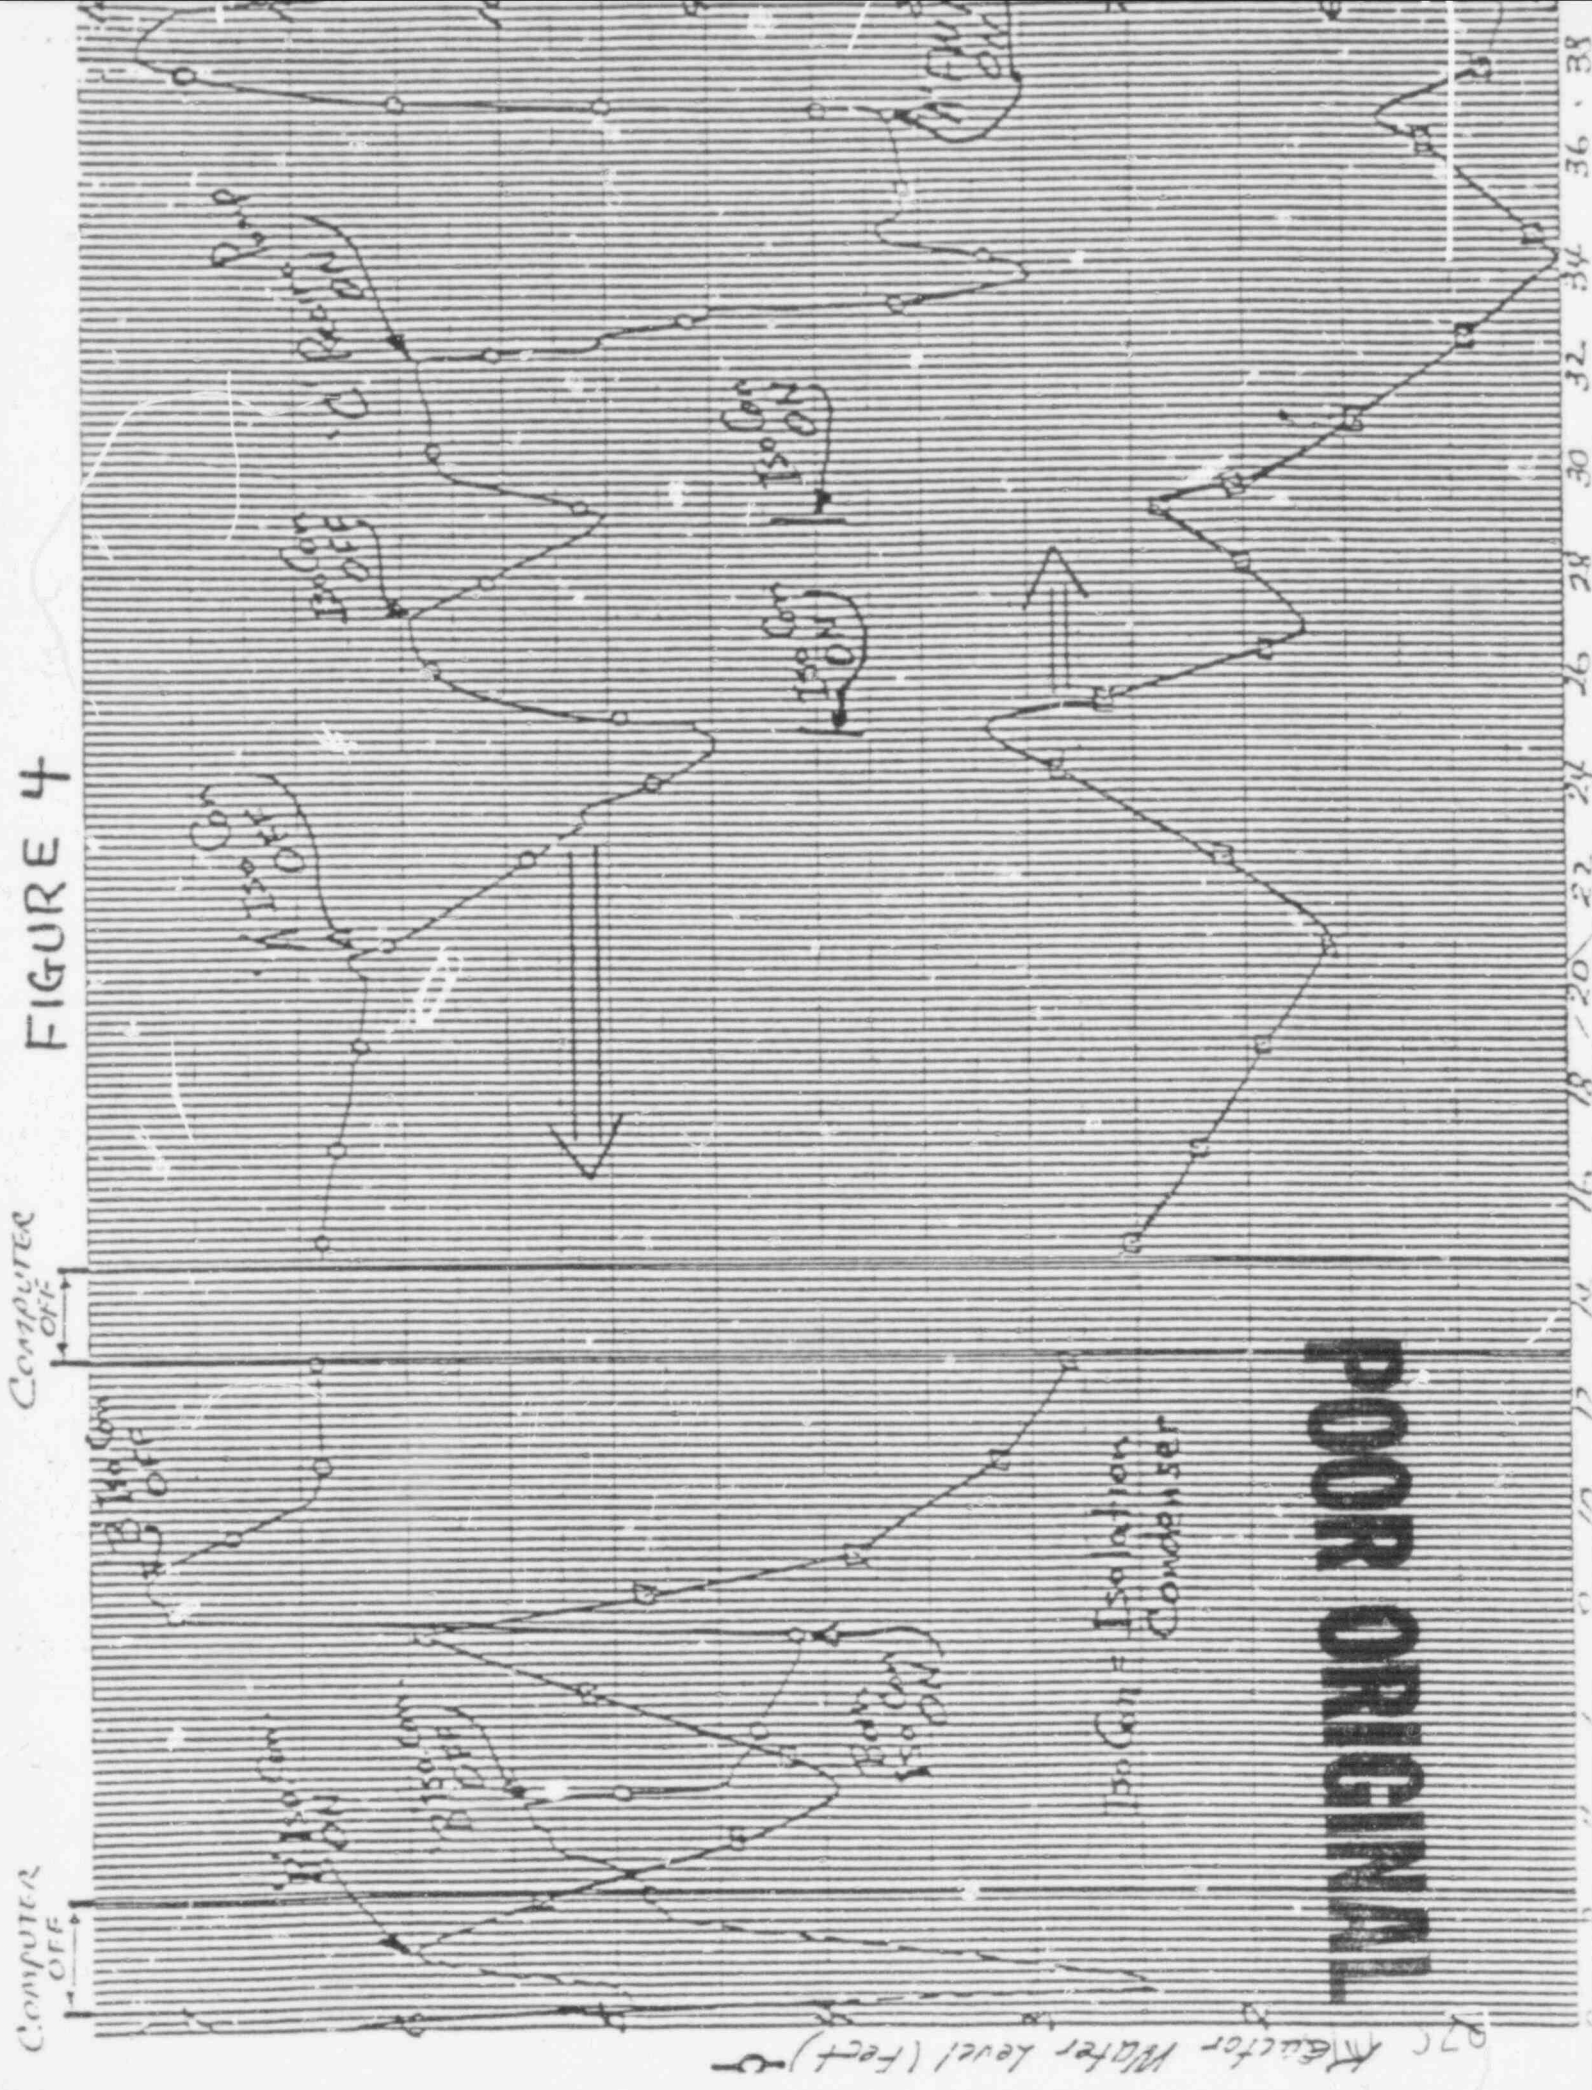
FIGURE 4

Reactor pressure was controlled during the transient by intermittent manual operation of the two isolation condensers. Reactor pressure and reactor annulus water level variations with time are shown on Figure 4.
