U.S. NUCLEAR REGULATORY COMMISSION
OFFICE OF INSPECTION AND ENFORCEMENT

IE Bulletin No. 79-13

CRACKING IN FEEDWATER SYSTEM PIPING

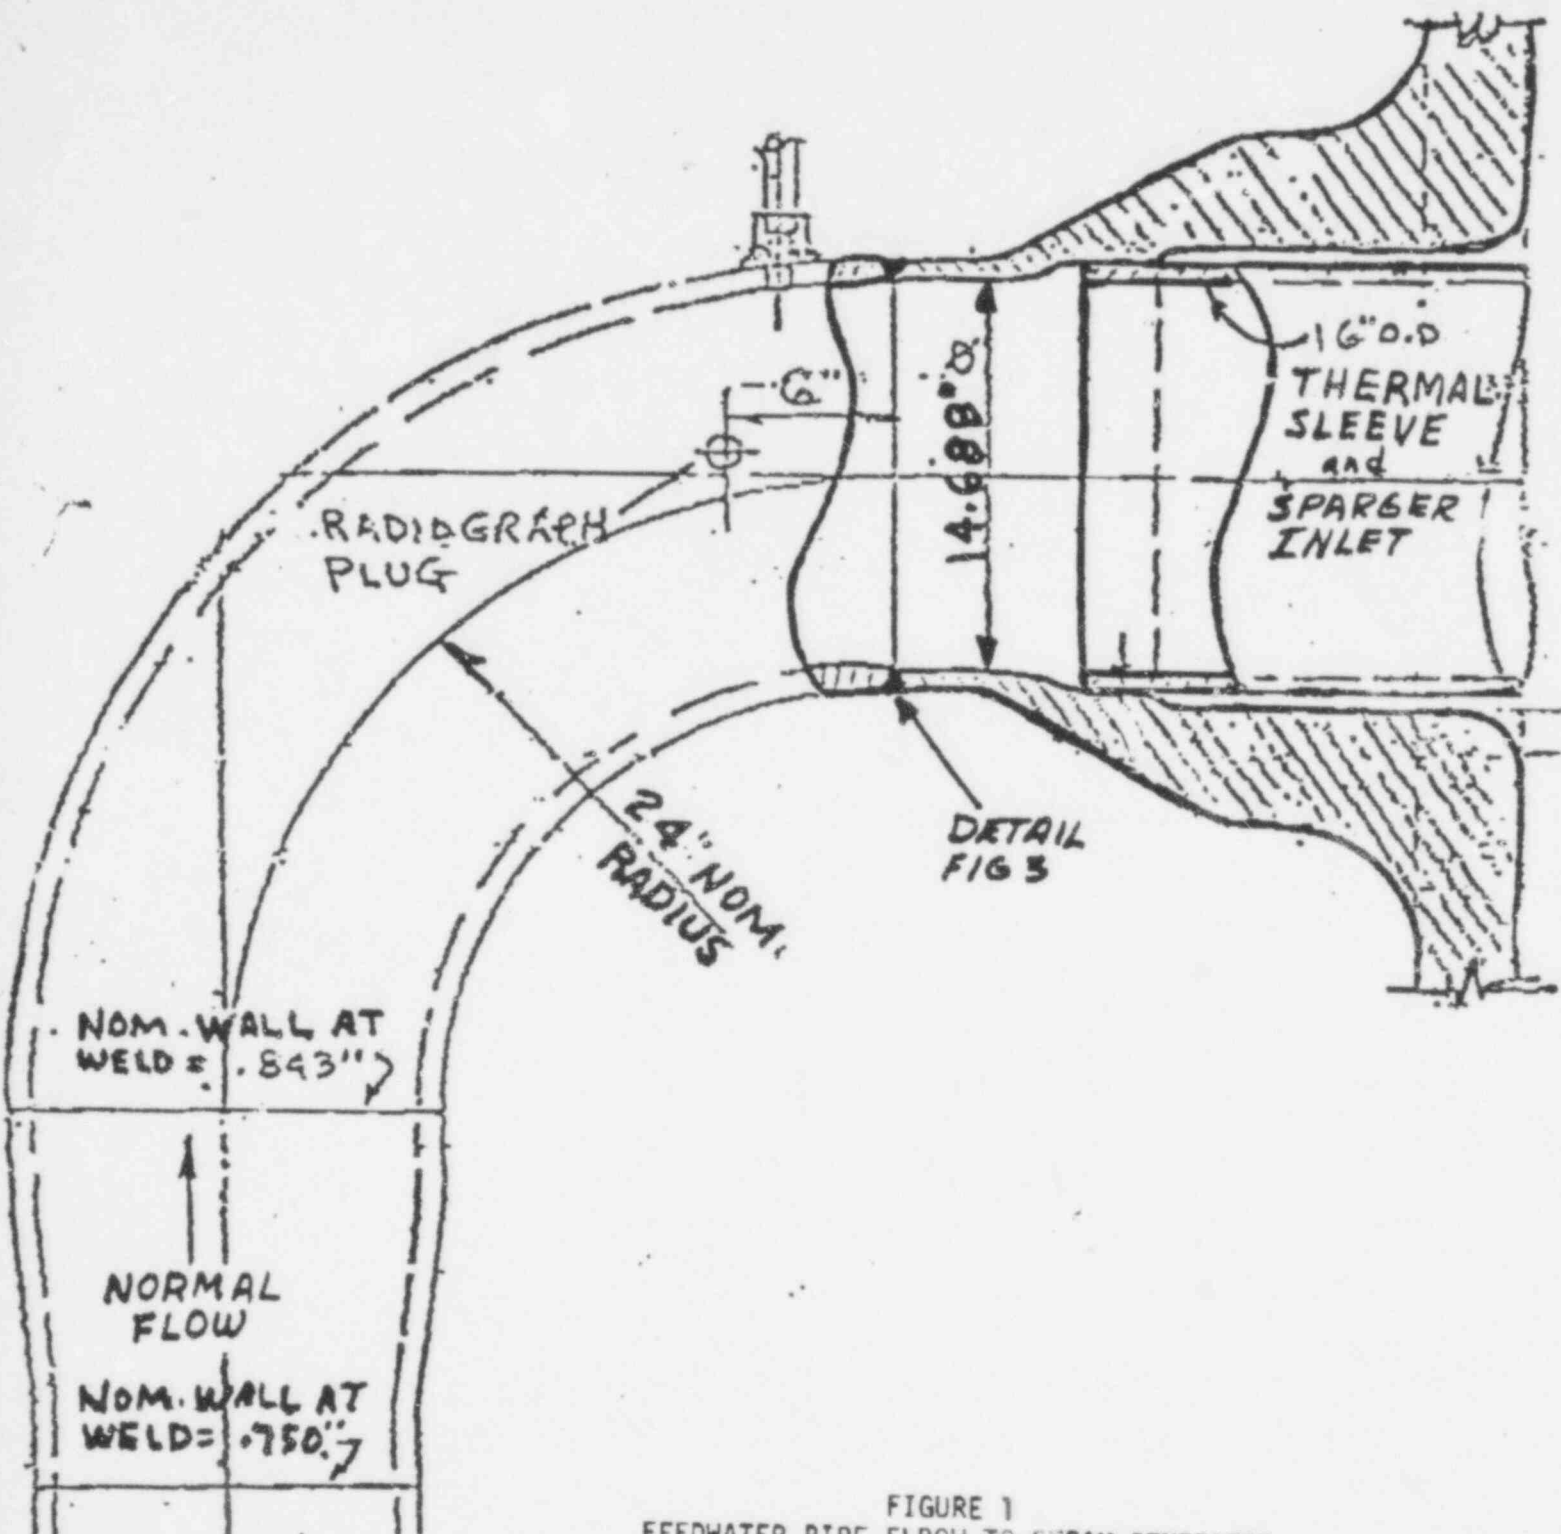
FIGURE 1
 FEEDWATER PIPE ELBOW TO STEAM GENERATOR
 NOZZLE INSTALLATION (DC COOK)

On May 20, 1979, Indiana and Michigan Power Company notified the NRC of cracking in two feedwater lines at their D. C. Cook Unit 2 facility. The cracking was discovered following a shutdown on May 19 to investigate leakage inside containment. Leaking circumferential cracks were identified in the 16-inch feedwater elbows adjacent to two steam generator nozzle elbow welds. Subsequent radiographic examination revealed crack indications in all eight steam generator feedwater lines at this location on both Units 1 and 2.

The feedwater nozzle-to-pipe configurations for D.C. Cook and for San Onofre are shown on the attached figures 1 and 2. A typical feedwater pipe-to-nozzle weld joint detail showing the principal crack locations for D.C. Cook and San Onofre are shown on the attached figure 3.

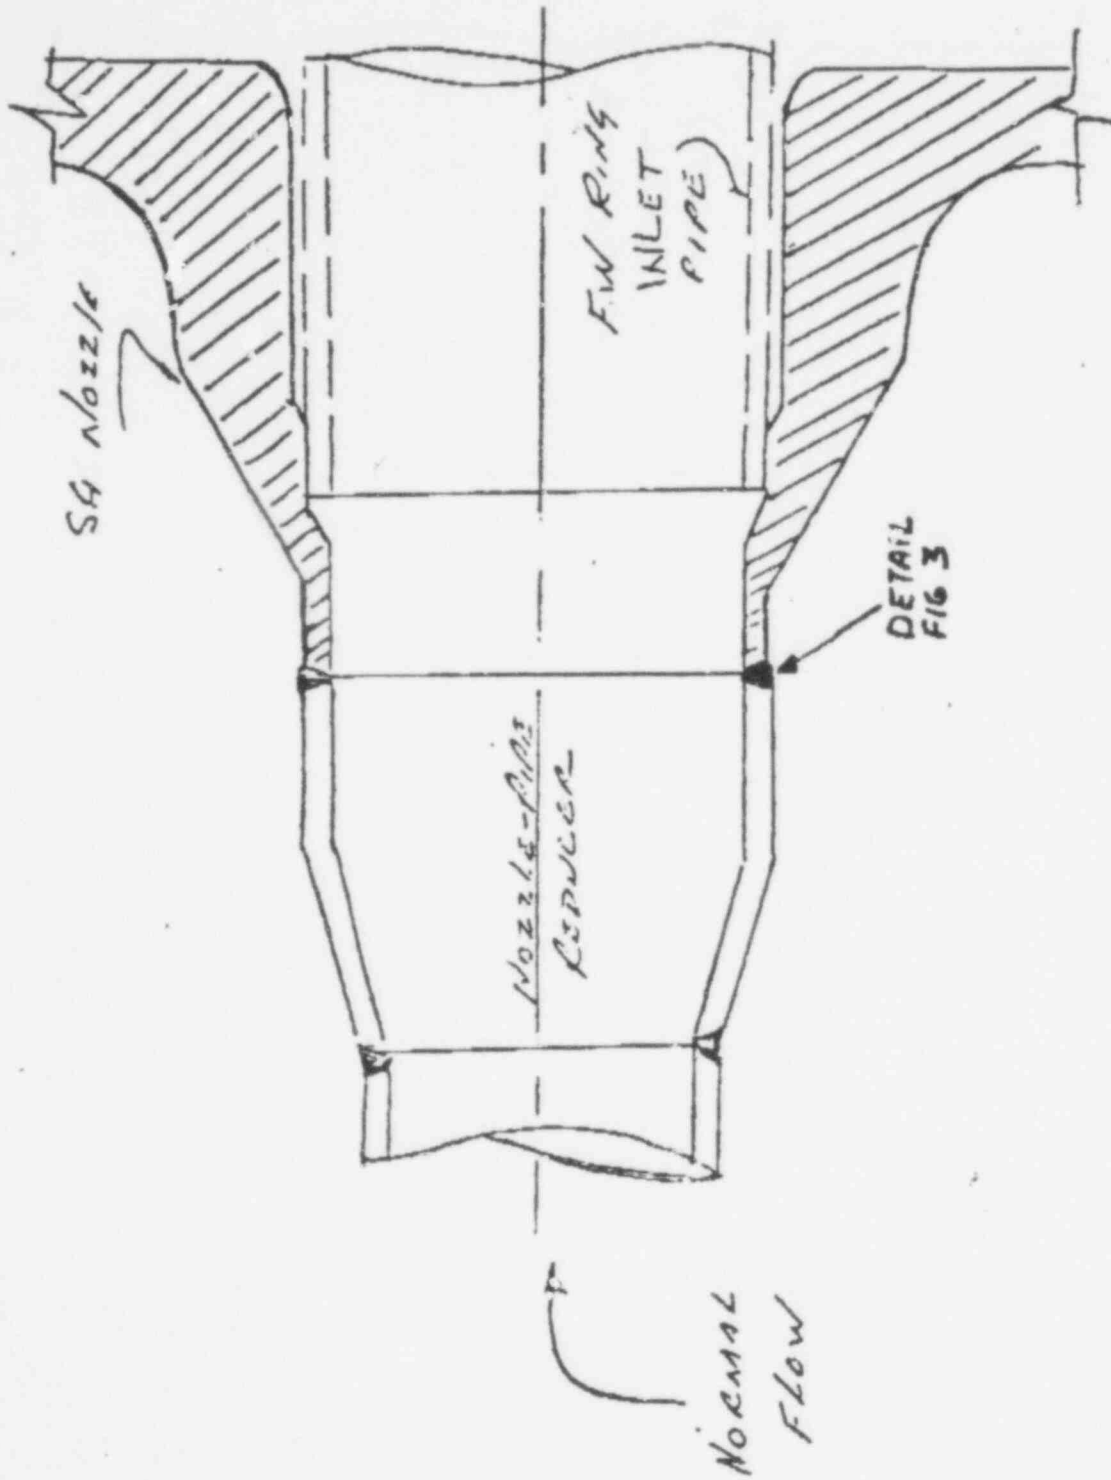
FIGURE 2
FEEDWATER PIPE REDUCER TO STEAM GENERATOR
NOZZLE INSTALLATION (SAN ONOFRE)

As a result of these actions, several other licensees with Westinghouse steam generators reported crack indications. Southern California Edison reported on June 5, 1979, that radiographic examination revealed indications of cracking in feedwater nozzle-to-piping welds on two of three steam generators of San Onofre Unit 1. On June 15, 1979, Carolina Power and Light reported that radiography showed crack indications in similar locations at their H. B. Robinson Unit 2. Duquesne Power and Light confirmed on June 18, 1979, that radiography has shown cracking in their Beaver Valley Unit 1 feedwater piping to vessel nozzle weld. Public Service Electric and Gas Company reported on June 20, 1979 that Salem Unit 1 also has crack indications. Wisconsin Public Service company decided on June 20, 1979 to cut out a feedwater nozzle-to-pipe weld which contained questionable indication, for metallurgical examination. As of June 22, 1979 and since May 25, 1979 seven other PWR facilities have inspected the feedwater nozzle-to-pipe welds without finding cracking indications.

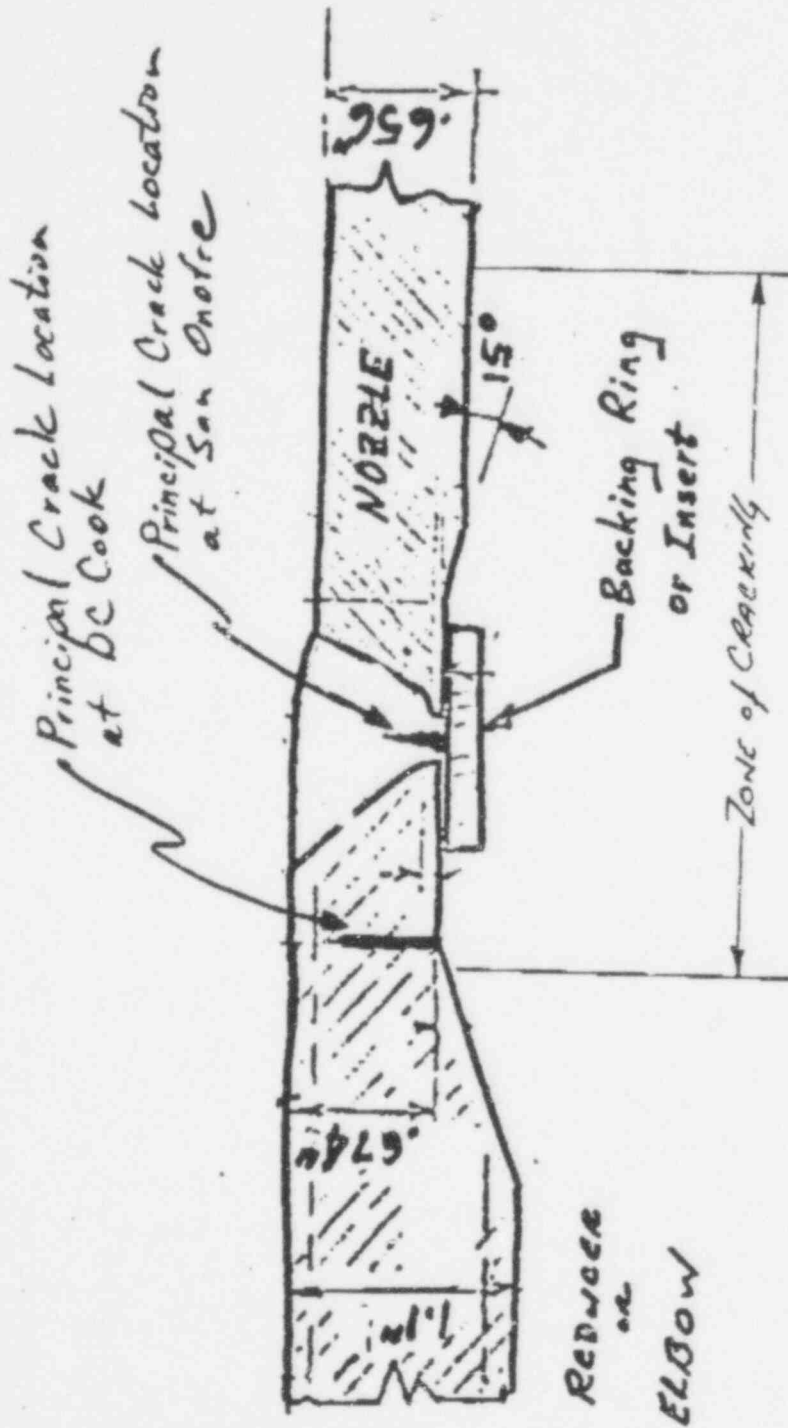
FIGURE 3
 TYPICAL FEEDWATER PIPE TO NOZZLE
 WELD JOINT DETAIL
 (W , CE)

Cracked weldments have been removed from the D. C. Cook Units 1 and 2 and San Onofre Unit 1 feedwater systems for extensive metallurgical investigation by Westinghouse. Based on preliminary analysis, Westinghouse stated the D. C. Cook failure may be "fatigue assisted by corrosion." The San Onofre cracking was stated to be characteristic of "stress assisted corrosion."
