THE BABCOCK & WILCOX COMPANY  
POWER GENERATION GROUP

CURRENT ASSESSMENT OF CORE CONDITION 4/7/79 (1800)

4-7-79 - 7:48 p.m.

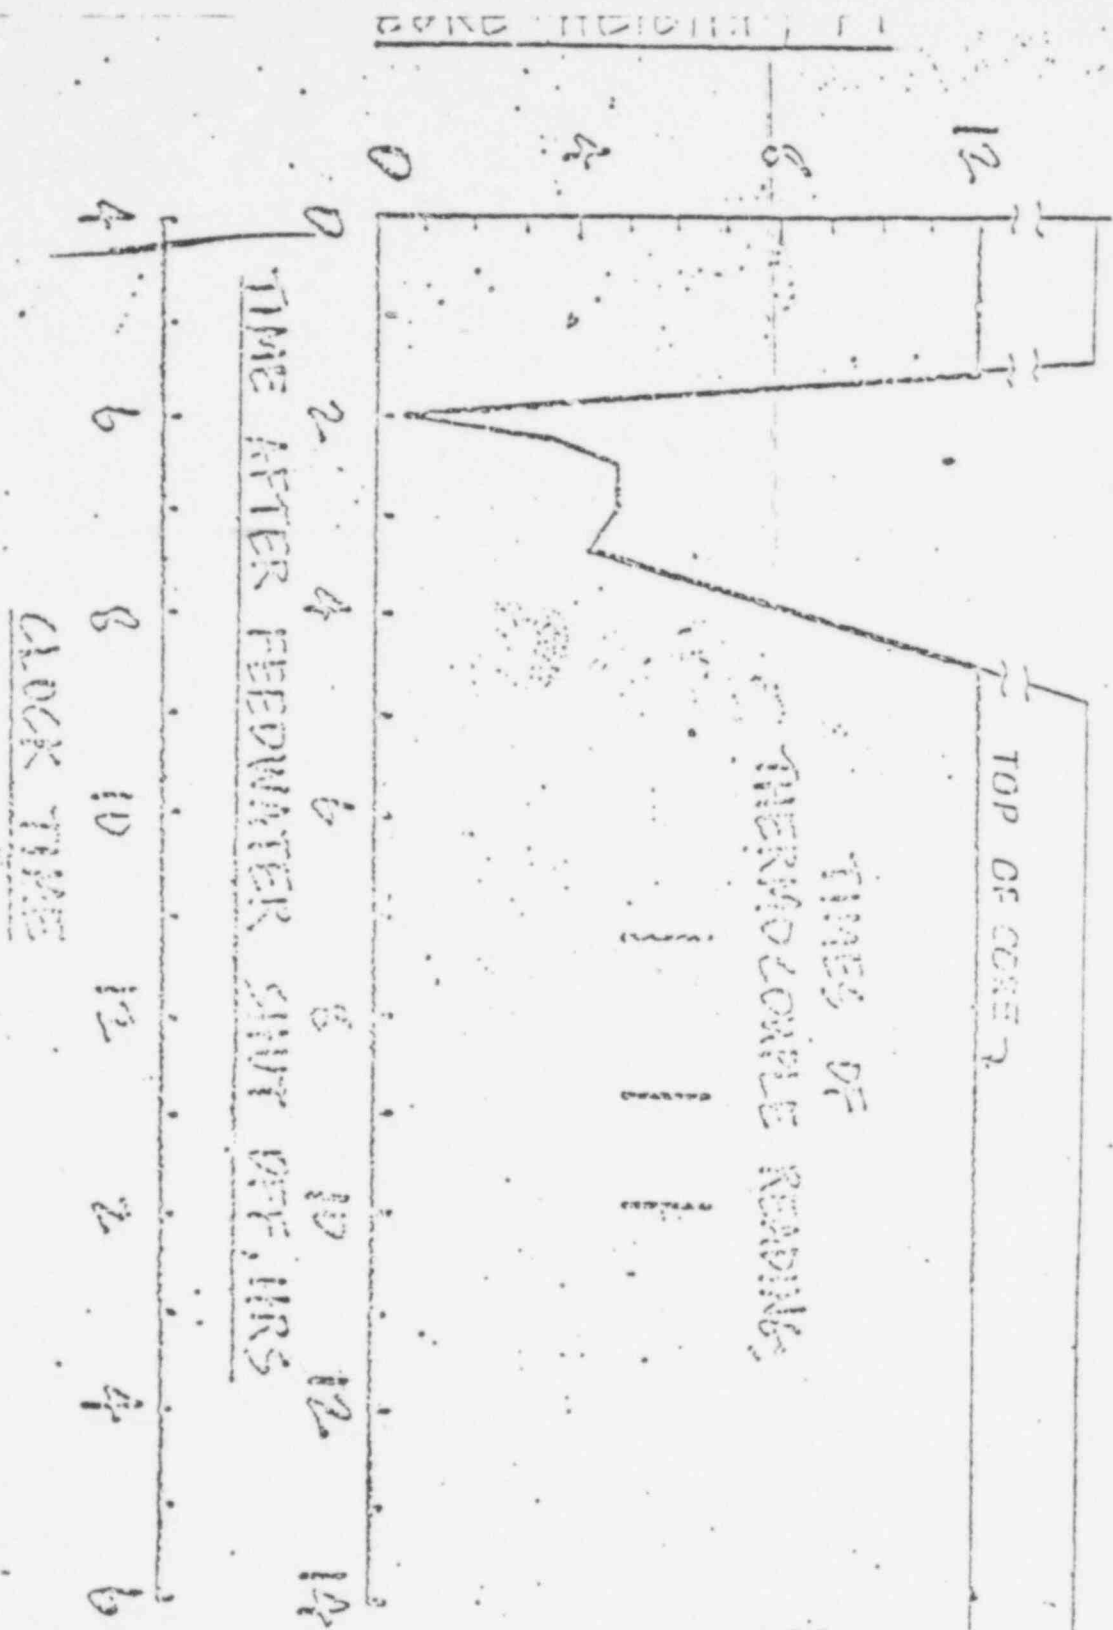
ESTIMATED CORE COOLANT LEVEL

THE PHYSICAL CONDITION OF THE CORE IS BASED ON THE FOLLOWING POSTULATED SEQUENCE OF EVENTS. THE CORE WAS UNCOVERED ~11 FT DURING THE FIRST 15 MINUTES FOLLOWING THE SECOND PUMP TRIP. (SEE FIG. 1) THE CORE WAS THEN UNCOVERED 8 FT FOR 105 MINUTES. FOR THE REMAINDER OF THE TRANSIENT, THE CORE WAS ASSUMED TO BE QUASI-COVERED TO THE POINT THAT NO SIGNIFICANT OXIDATION OCCURRED. DURING THE INITIAL UNCOVERING, THE CLADDING WOULD FAIL NEAR THE TOP OF THE ROD DUE TO STRESS RUPTURE. DEPENDING ON THE HEATING RATES, THESE FAILURES WOULD HAVE OCCURRED BETWEEN ~1200-1650°F. THIS MAY PRECLUDE INITIAL FAILURE BY EUTECTIC FORMATION BETWEEN INCONEL GRID AND ZIRCALOY RODS. CLADDING STRAINS DUE TO HIGH-TEMPERATURE DEFORMATION PRIOR TO RUPTURE COULD APPROACH 35%. DURING THE HOLD TIME SUBSEQUENT TO THE RUPTURE, THE CLADDING OXIDIZED SEVERELY, FORMING ZIRCONIUM OXIDE AND RELEASING HYDROGEN GAS. THE DEGREE OF OXIDATION WILL VARY WITH THE POWER, HAVING BOTH AXIAL AND RADIAL DISTRIBUTION. THE DEGREE OF OXIDATION ALONG THE LENGTH OF A ROD COULD VARY FROM NEGLIGIBLE AT THE BOTTOM TO 100% AT THE HOTTEST REGION NEAR THE TOP OF THE ROD.
