Wisconsin Electric POWER COMPANY

DOCKET NOS. 50-266 AND 50-301
RESPONSE TO IE BULLETIN 79-13
POINT BEACH NUCLEAR PLANT, UNITS 1 AND 2

Response to
IE Bulletin 79-13
July 10, 1979

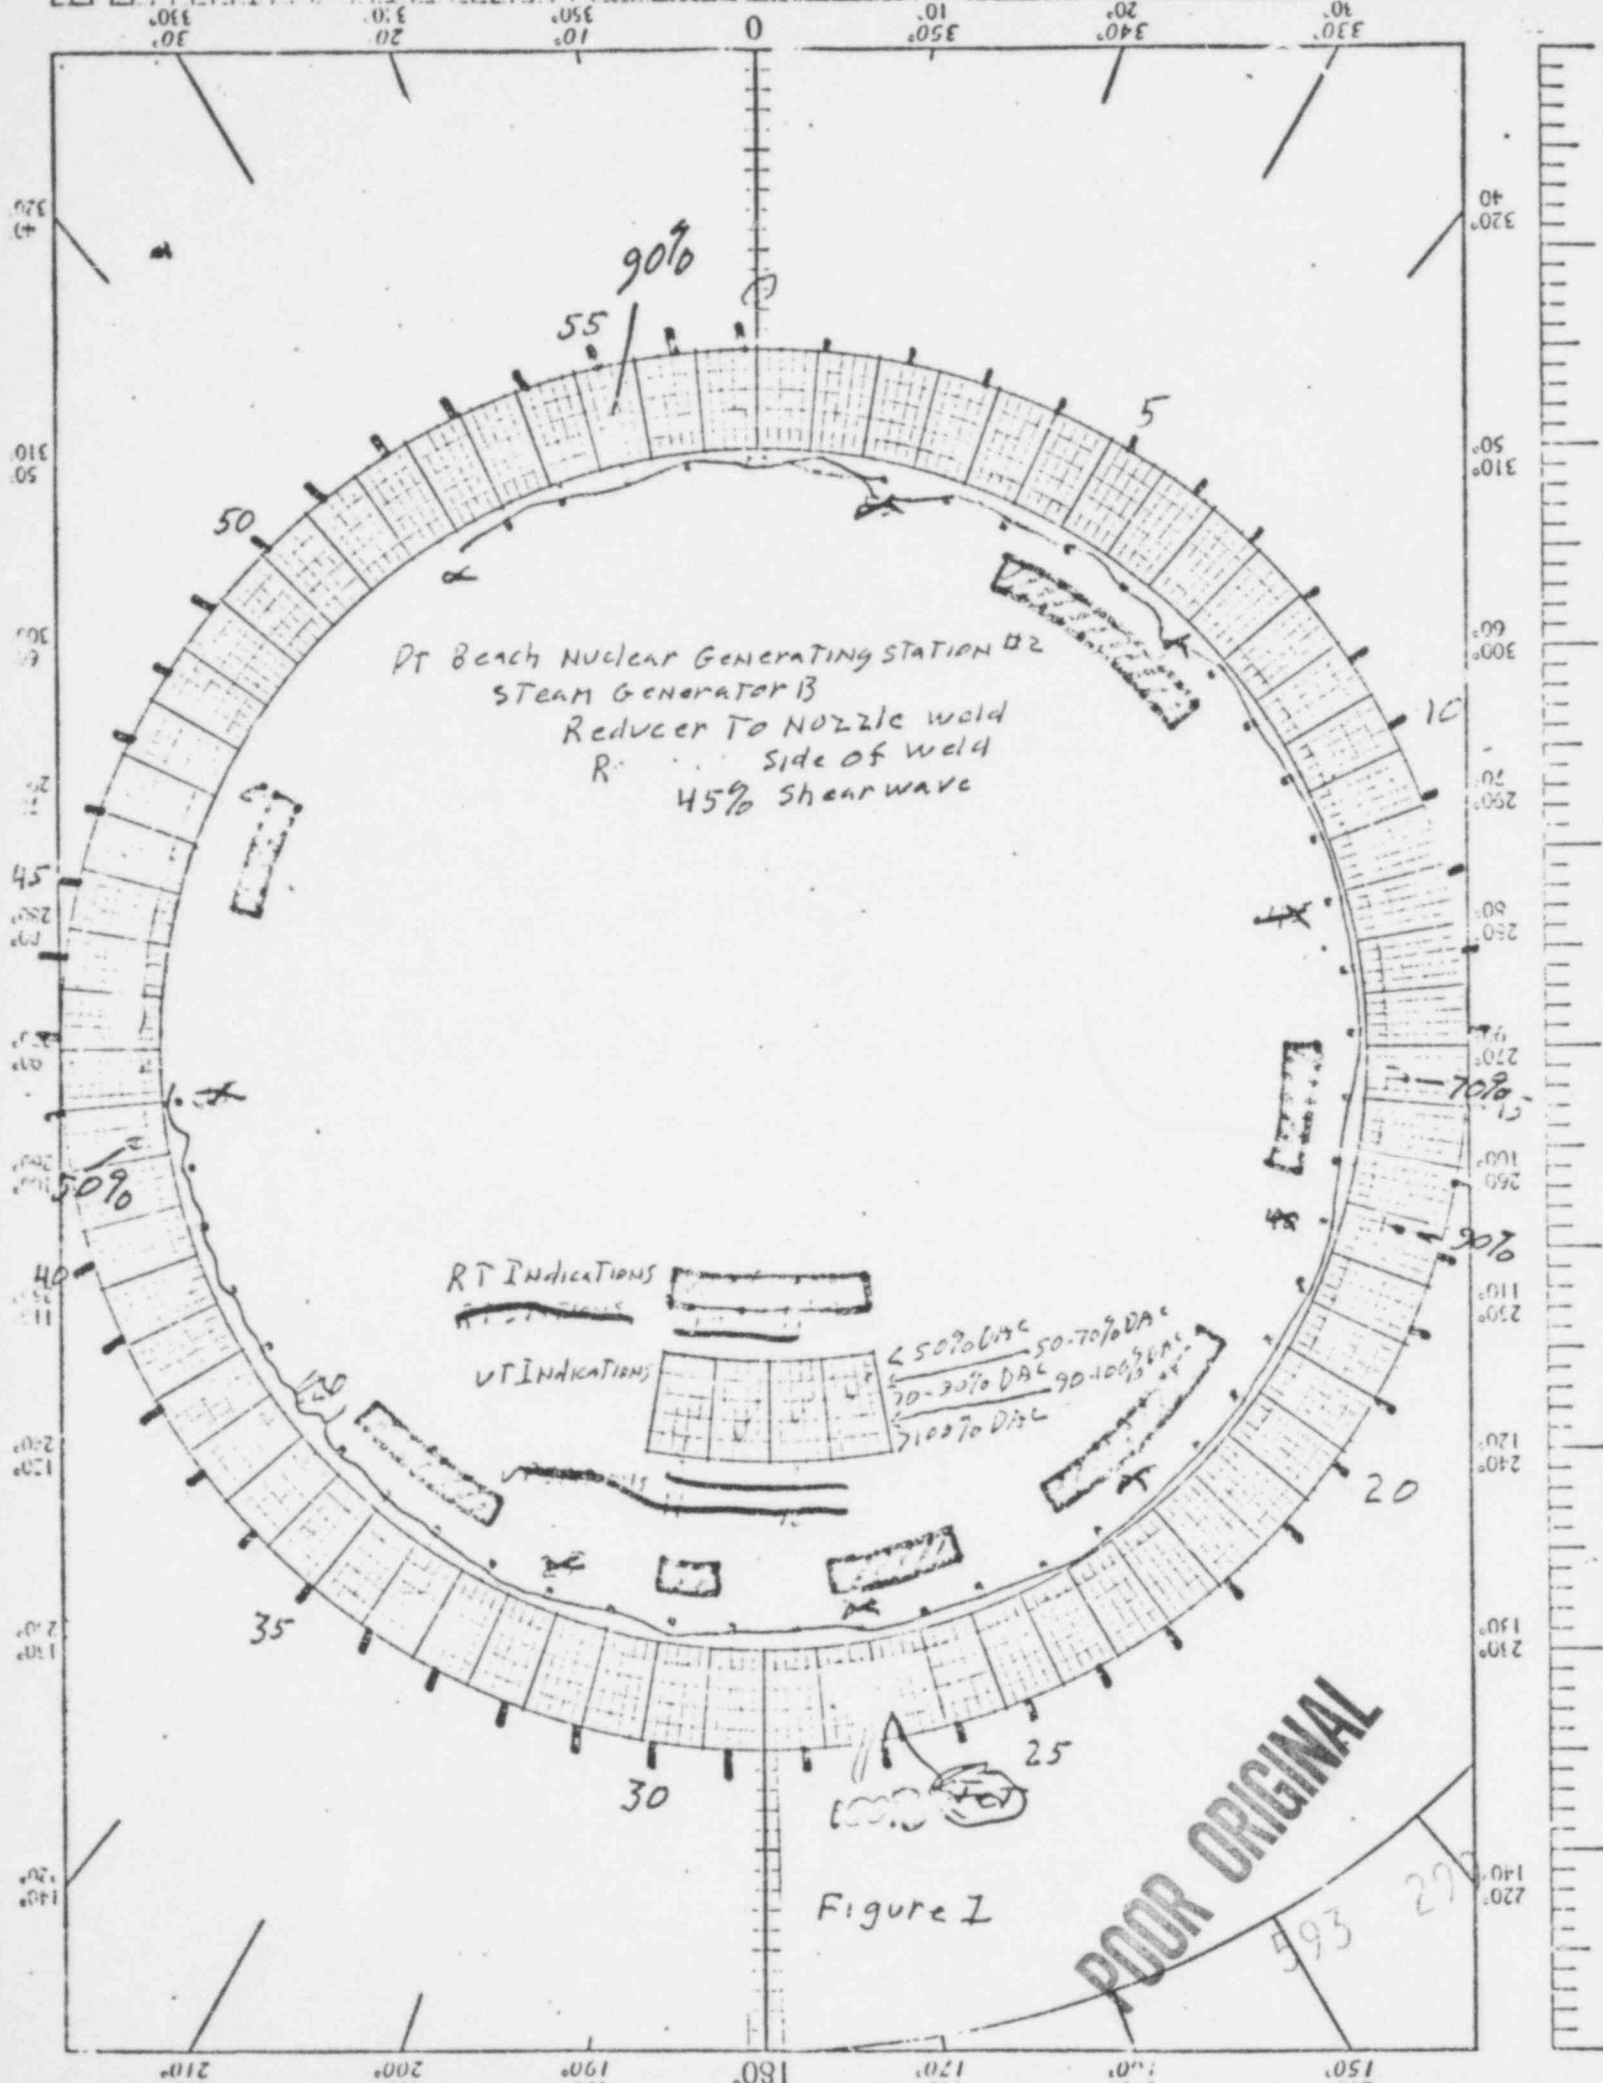
The 45° shear wave examinations from the reducer or upstream side of the weld disclosed a low level signal for 360° of the circumference with several indications exceeding the 50 percent recording level. However, in accordance with Paragraph 8.0 of the ultrasonic procedure used, indications regardless of their amplitude which, in the opinion of the operator, are caused by non-geometric conditions should be recorded. Precise locations of those portions of the signals which exceeded the mandatory 50 percent calibration were duly recorded. Resolution of these indications indicated that they were crack-like in nature not caused by geometry. These signals were also detected from the weld crown with the ultrasonic beam being directed from the nozzle toward the reducer. (This information was utilized in resolving the indications.)

Figure 1 is a polar ordinate plot showing the relative position and amplitude of the ultrasonic signals as well as the reported radiographic indications. It should be noted however, that the ultrasonic stations proceeded clockwise from top dead center when facing the direction of flow and the radiographic station markers proceeded counterclockwise from top dead center facing the director of flow. This difference has been corrected for all plots and the plots are clockwise facing the direction of the flow.

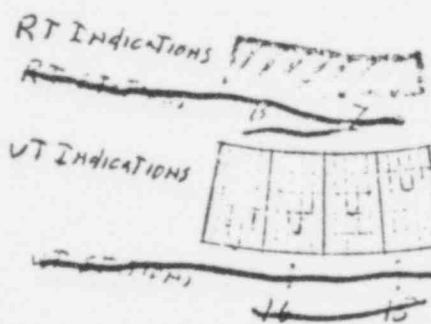
Figure 3

On 3 July 1979 ultrasonic examinations were performed on the elbow-to-pipe weld for both steam generators A and B. During the 45° shear wave examination it was again noted that there was a singular signal trackable for 360° of the pipe circumference. However, in most cases this signal did not exceed 50 percent of the calibration amplitude. The one point at which the signal exceeded 50 percent of the calibration amplitude is clearly indicated in Figure 3. This plot is from the data taken from the pipe side of the weld.

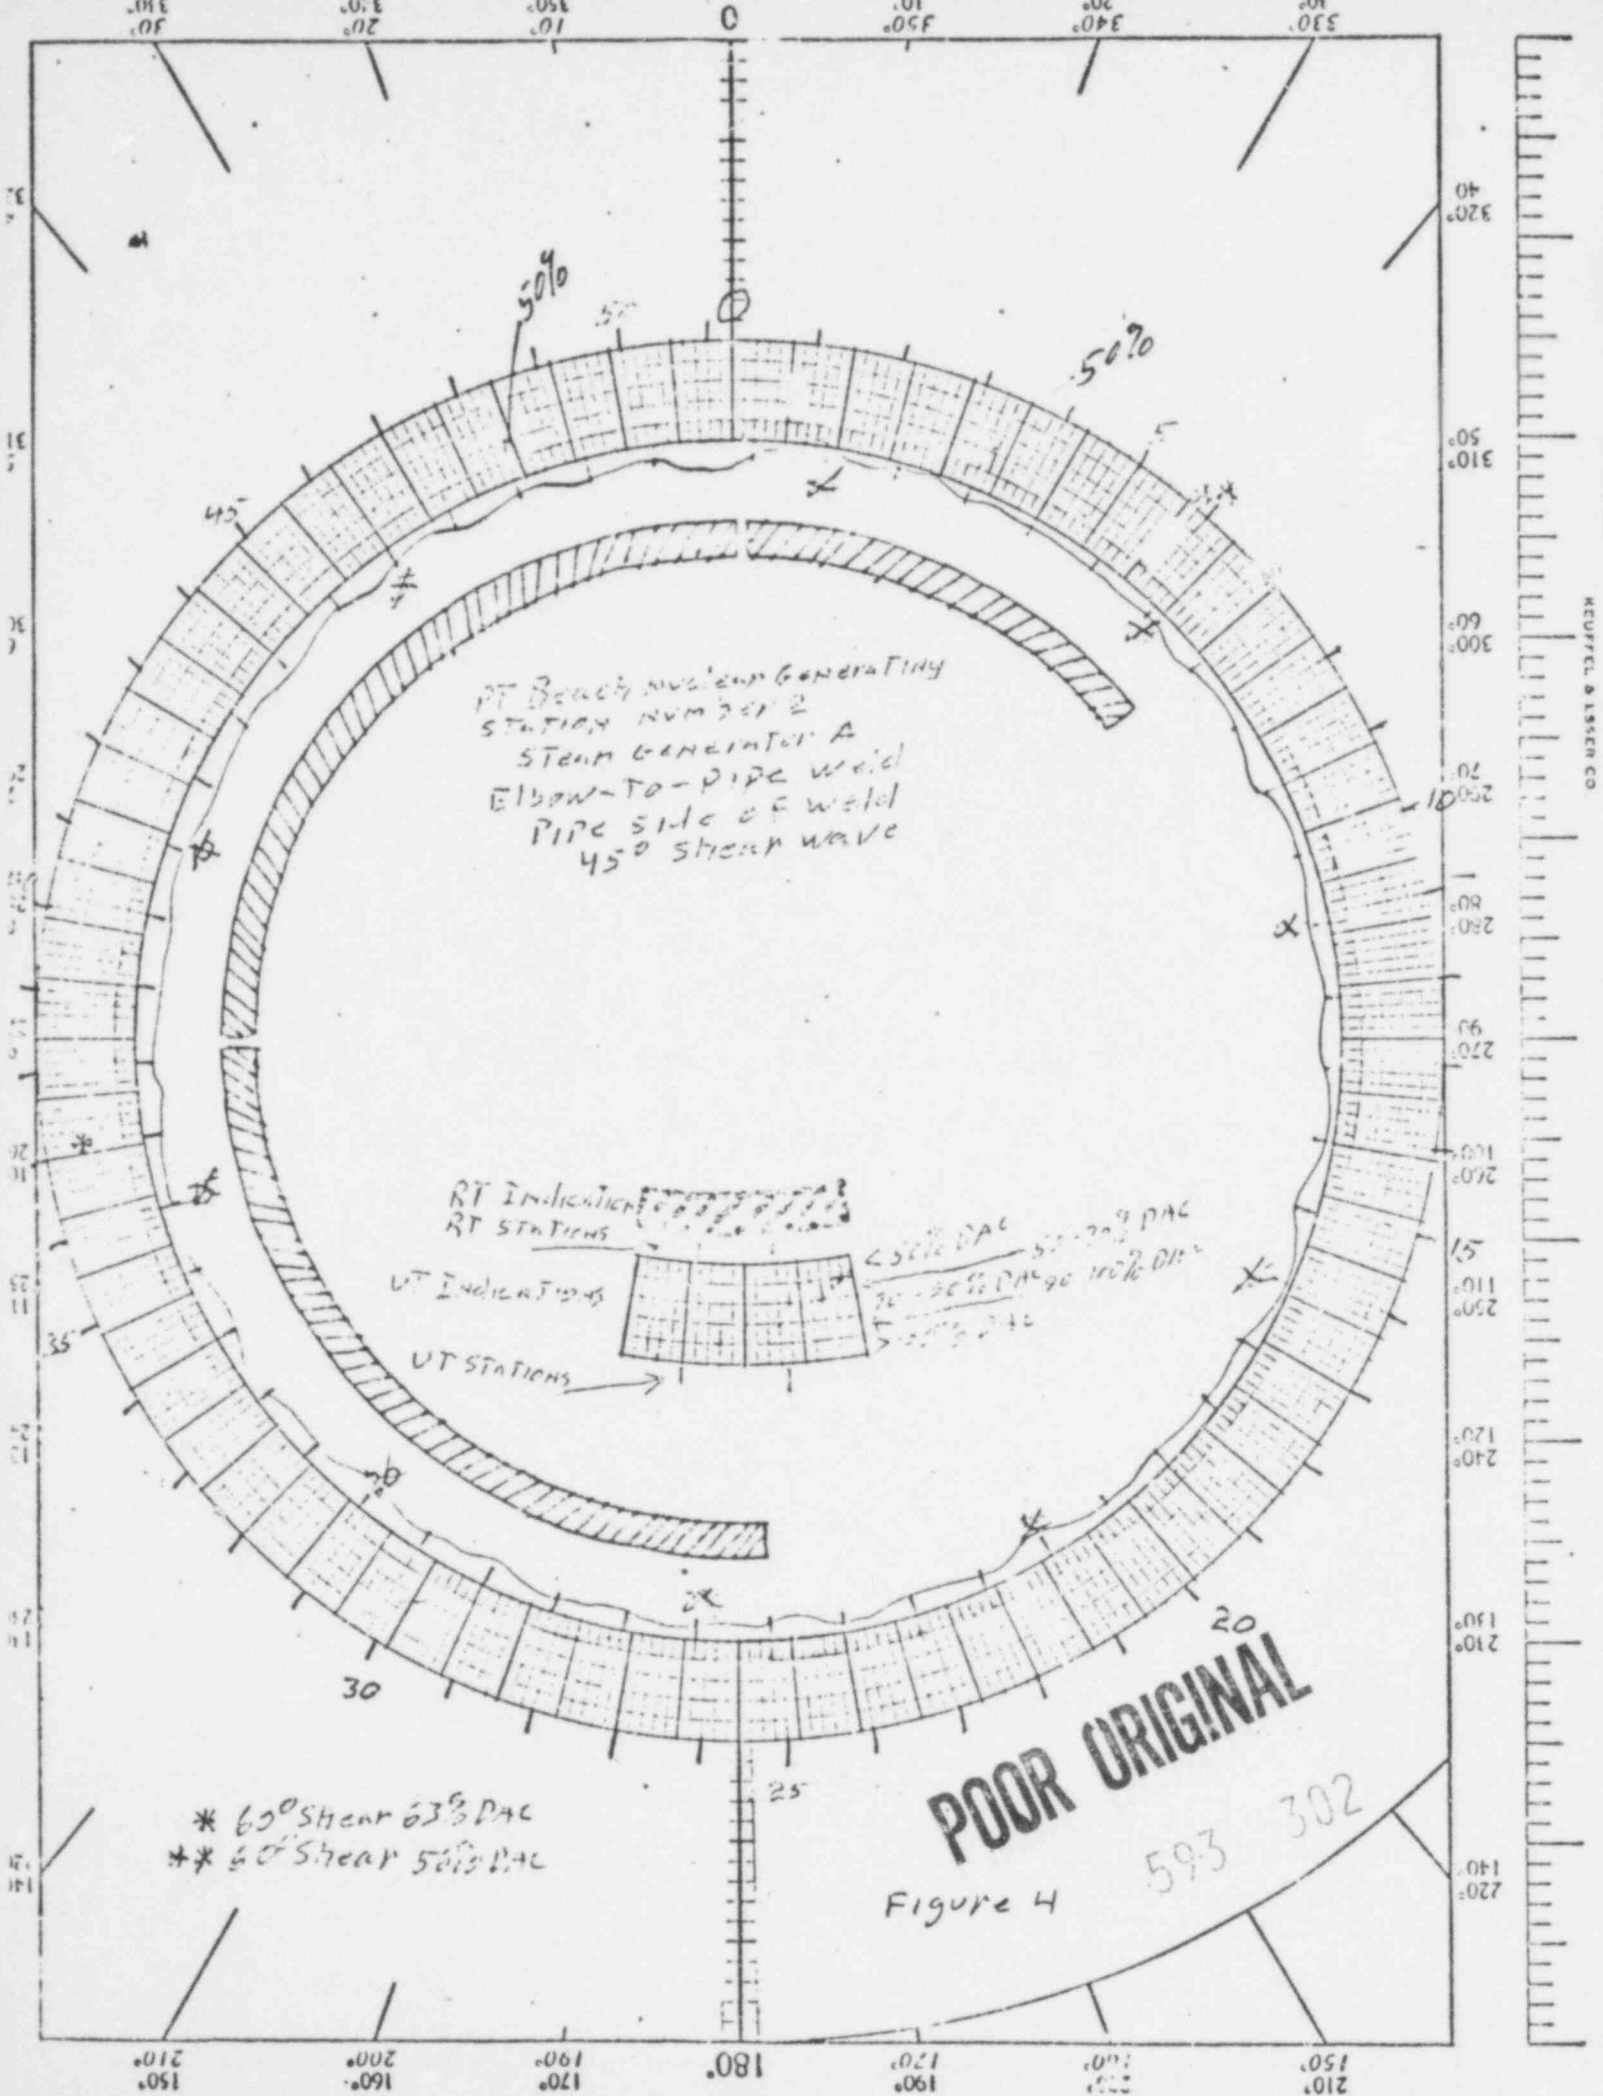
The 45° shear wave examination of the pipe side of the elbow-to-pipe weld disclosed an ultrasonic signal preceding 360° around the circumference of the weld. Figure 4 is a polar ordinate plot showing the position where the ultrasonic signal exceeded 50 percent of the calibration amplitude as well as the positional location of the radiographic indications. 60° shear wave examination from the pipe side of the weld showed 2 places where the signal amplitude exceeded 50 percent of the calibration amplitude. It was noted that the 60° shear wave signal was not trackable through the full 360 degrees. An ultrasonic signal was also detected using 45° shear wave from the top of the weld crown toward the pipe side of the weld. Thus, confirming the absence of geometry as a source for the reflected signal.

RT Beach Nuclear Generating
 Station Number 2
 Steam Generator A
 Elbow-to-pipe weld
 Pipe side of weld
 45° Shear wave

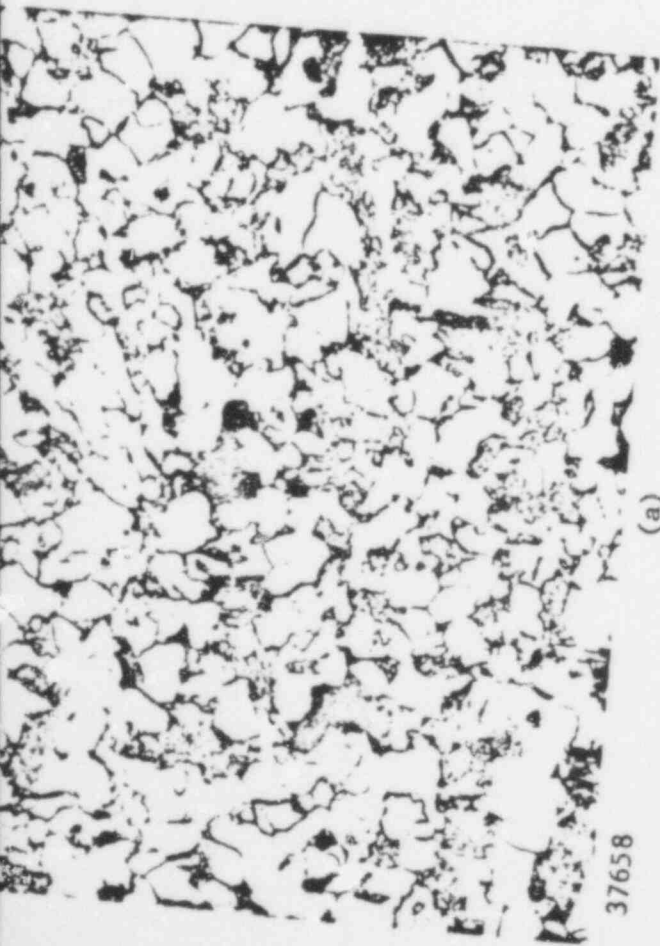
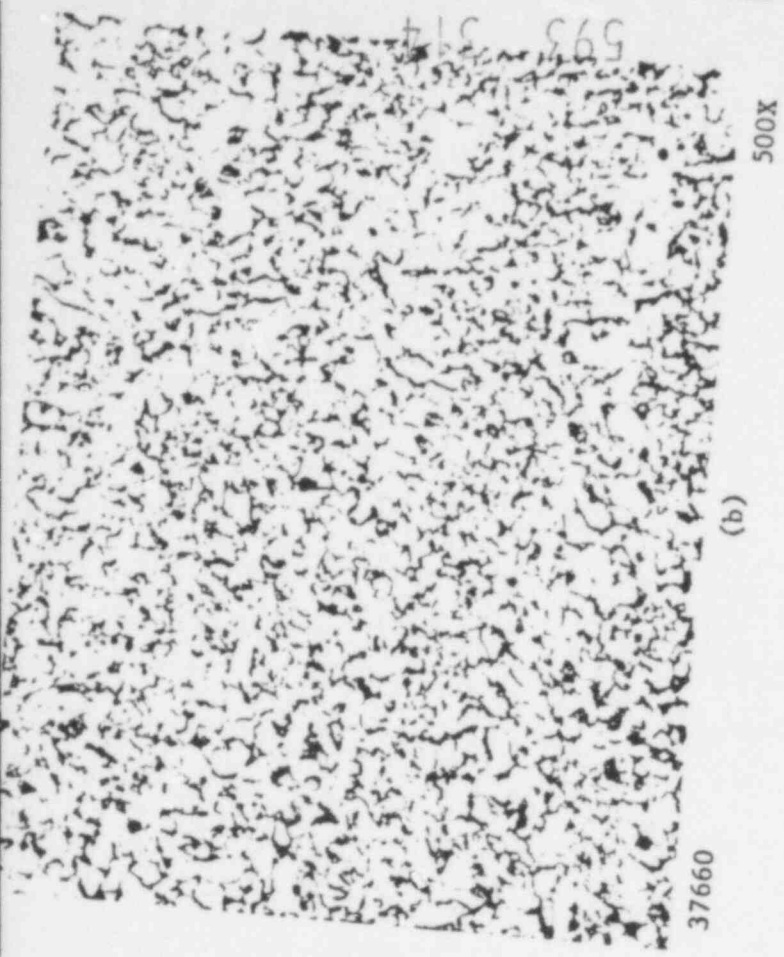
The structure of the reducer in all sections was normal for mild steel, Figure 1. No microstructural abnormalities, such as islands of martensite, weld porosity, or lack of fusion, were evident in the weld or heat-affected zone.

FIGURE 1. TYPICAL MICROSTRUCTURES OF REDUCER AND WELD. Base metal, (a), and heat-affected zone, (b), of reducer; Widmanstätten ferrite in weld bead, (c).

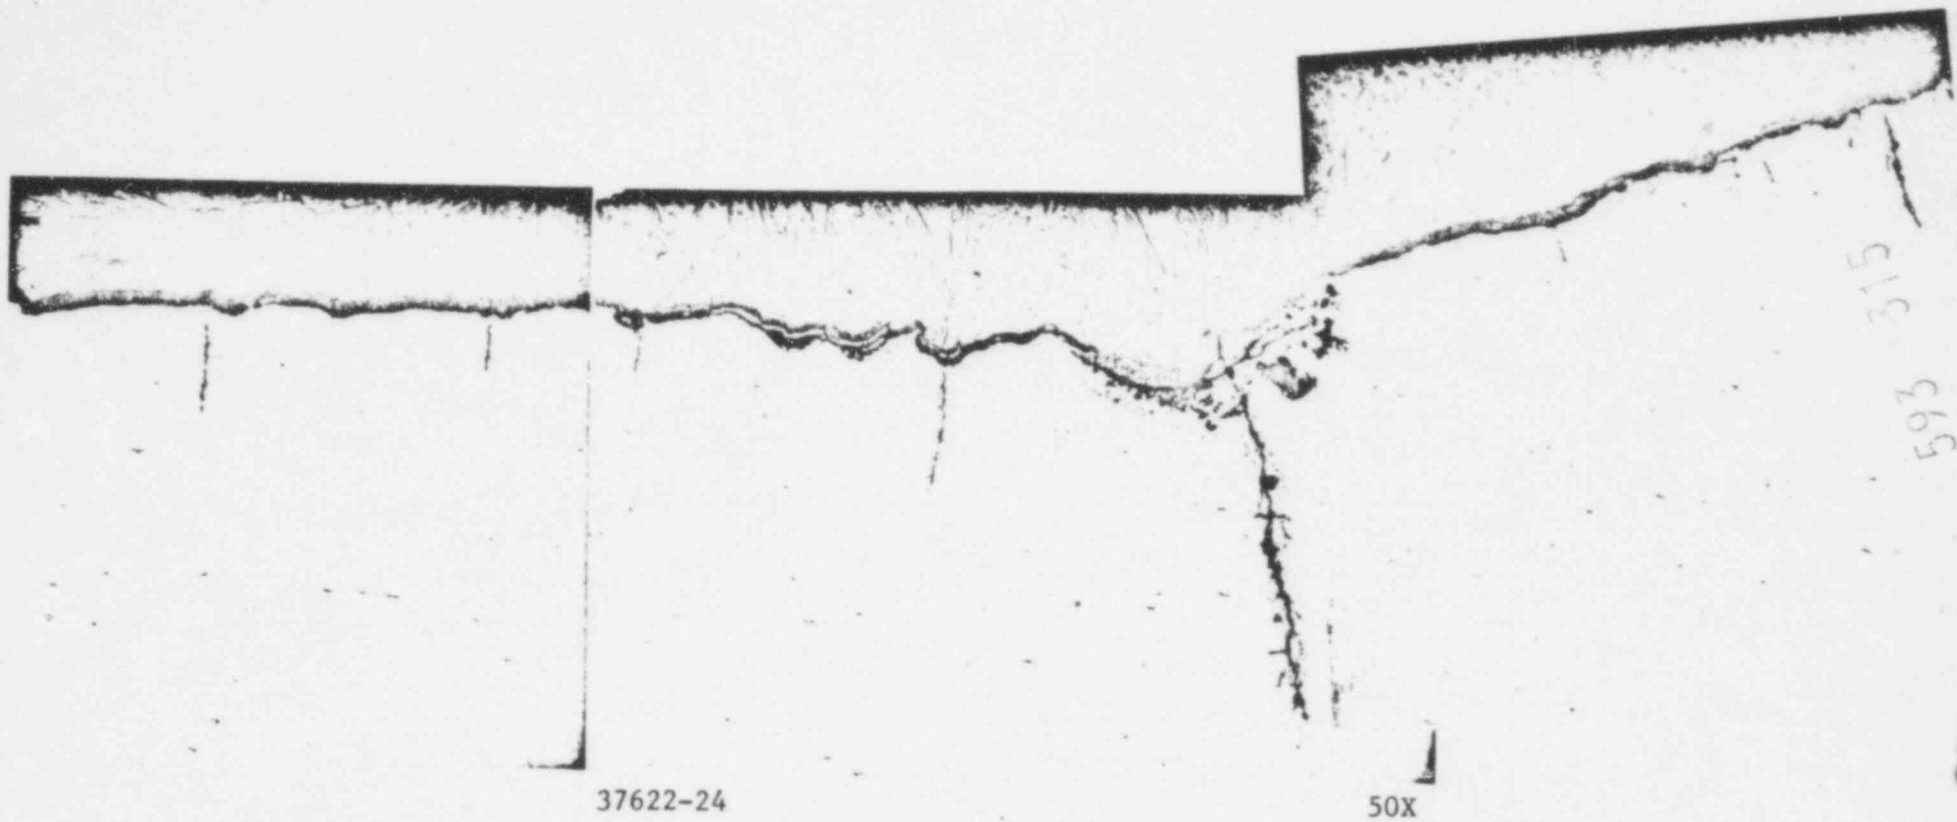
FIGURE 2. LONGITUDINAL SECTION AT STATION #15

Cracking was found in all the sections taken. The depth of the largest crack and the number of cracks in each section are given in Table I. In all cases, multiple cracking was observed, Figures 2 through 4. Although cracks were observed in all areas of the counter-bore, from the weld fusion line to the original reducer I.D., cracking with depths greater than 0.015 in. was restricted to the weld fusion line and counter-bore transition region. Of the two, the counter-bore transition zone contained the deeper cracks, Figure 3.

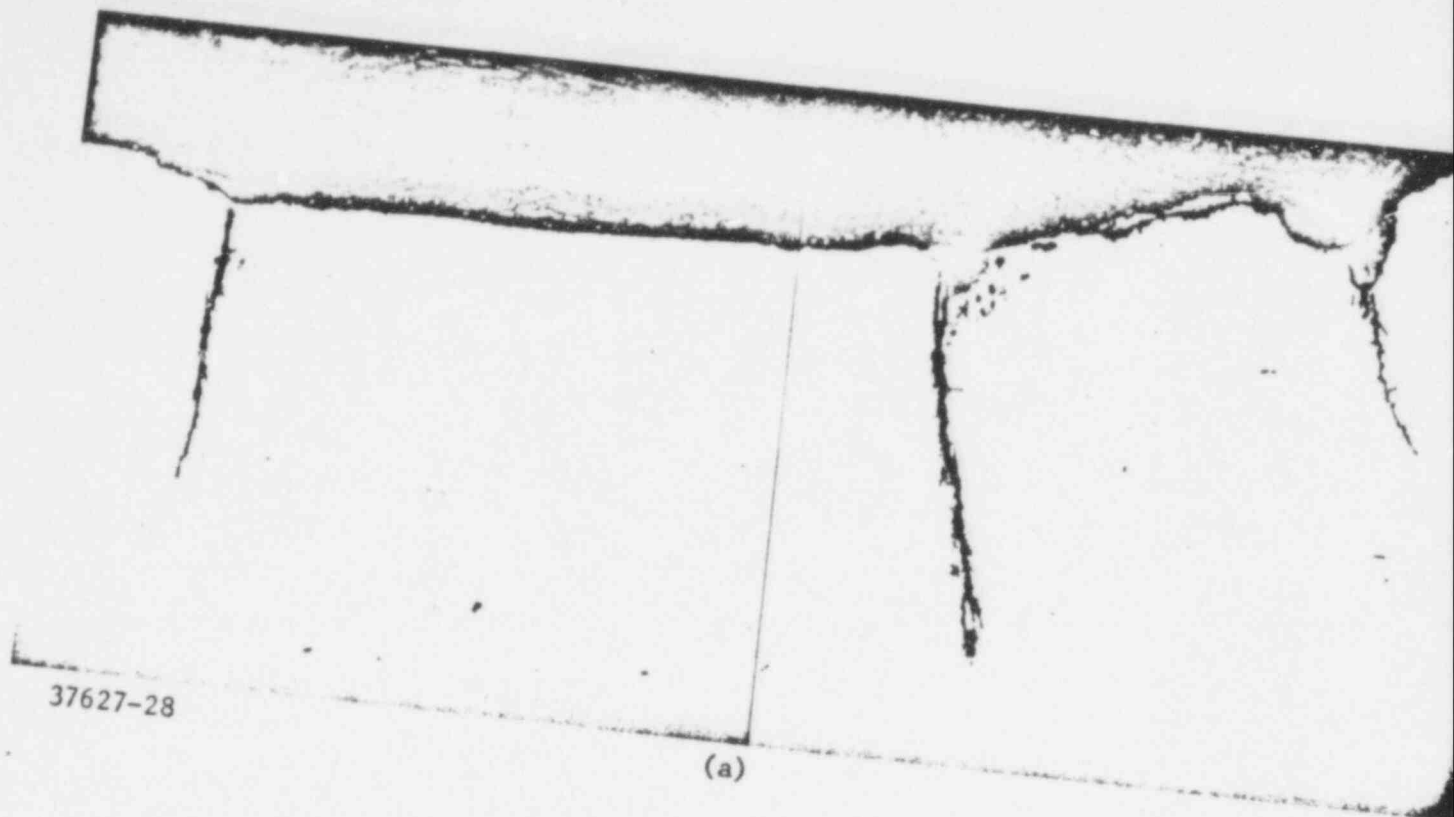
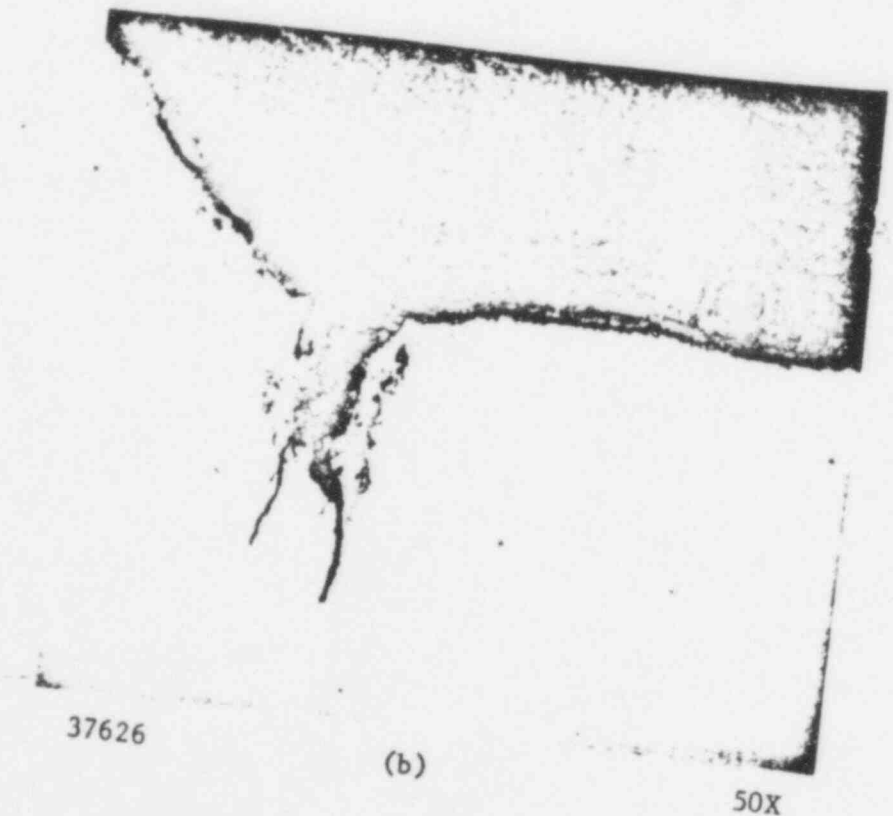
FIGURE 3. LONGITUDINAL SECTION AT STATION #43. Cracking occurred at the counter-bore transition zone, (a), and at the weld fusion line, (b).

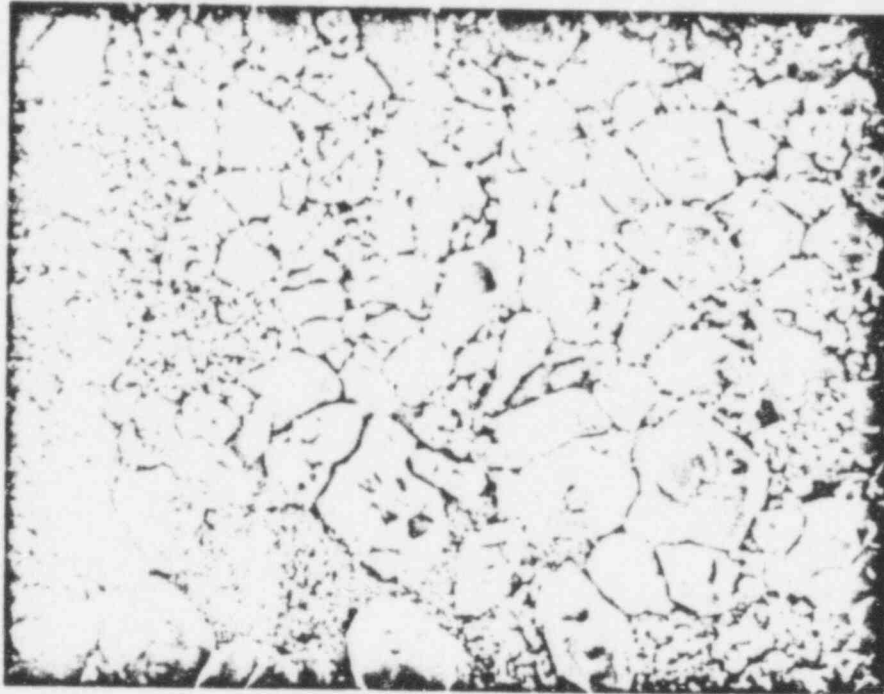
FIGURE 6. TYPICAL FRACTOGRAPH OF CRACK TIP OF #15 SEGMENT

Fractography has only been performed on specimens in the as-fractured condition. No cleaning or oxide removal has yet been attempted. Figure 6 shows a typical region near the crack tip. The surface is intergranular in appearance, with grain size comparable to that of the base metal, Figures 1 and 7. This suggests that the mode of cracking is intergranular. This observation should not be interpreted as definitive since the possibility remains that the grains imaged are of the thick oxide often present near the crack tip, Figure 7, rather than of base metal. This point will be clarified
