Subject: Zion Station Units 1 and 2
Response to IE Bulletin No. 79-13
NRC Docket Nos. 50-295 and 50-304

COMMONWEALTH EDISON COMPANY RESPONSES
TO IE BULLETIN NO. 79-13

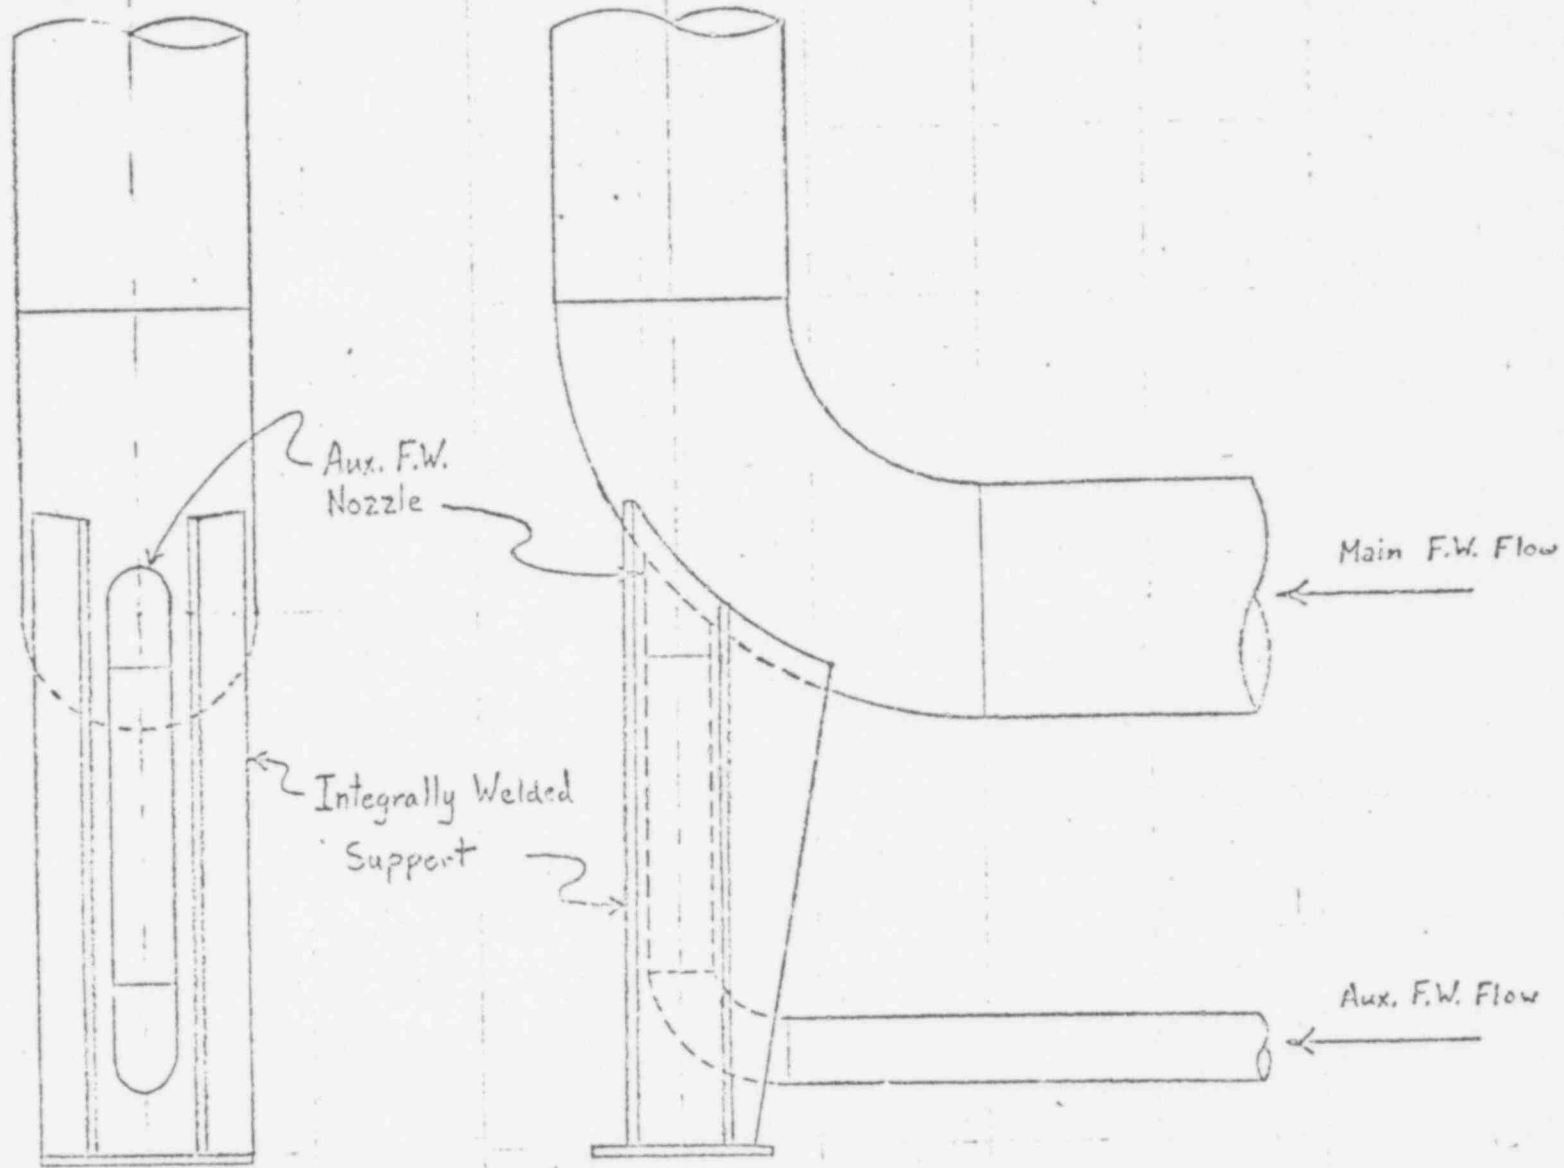
FIGURE 1

Commonwealth Edison requests relief from performing volumetric examinations of the welds connecting the auxiliary feedwater piping to the main feedwater line. The branch connection of the 3 inch auxiliary feedwater piping is located on the outside radius of a 90 degree elbow on the 16 inch main feedwater piping (see attached Figure 1). Arranged on both sides of the branch connection is a constant load pipe support of all welded construction. Access is not provided for either radiographic or ultrasonic inspections to be conducted. As an alternative, surface examinations will be performed.

Sketch of Typical Auxiliary F.W. Branch Connection
