INTERIM REPORT
ON THE
STPEGS RCB NO. 1 LIFT 8 CONTAINMENT VOIDS

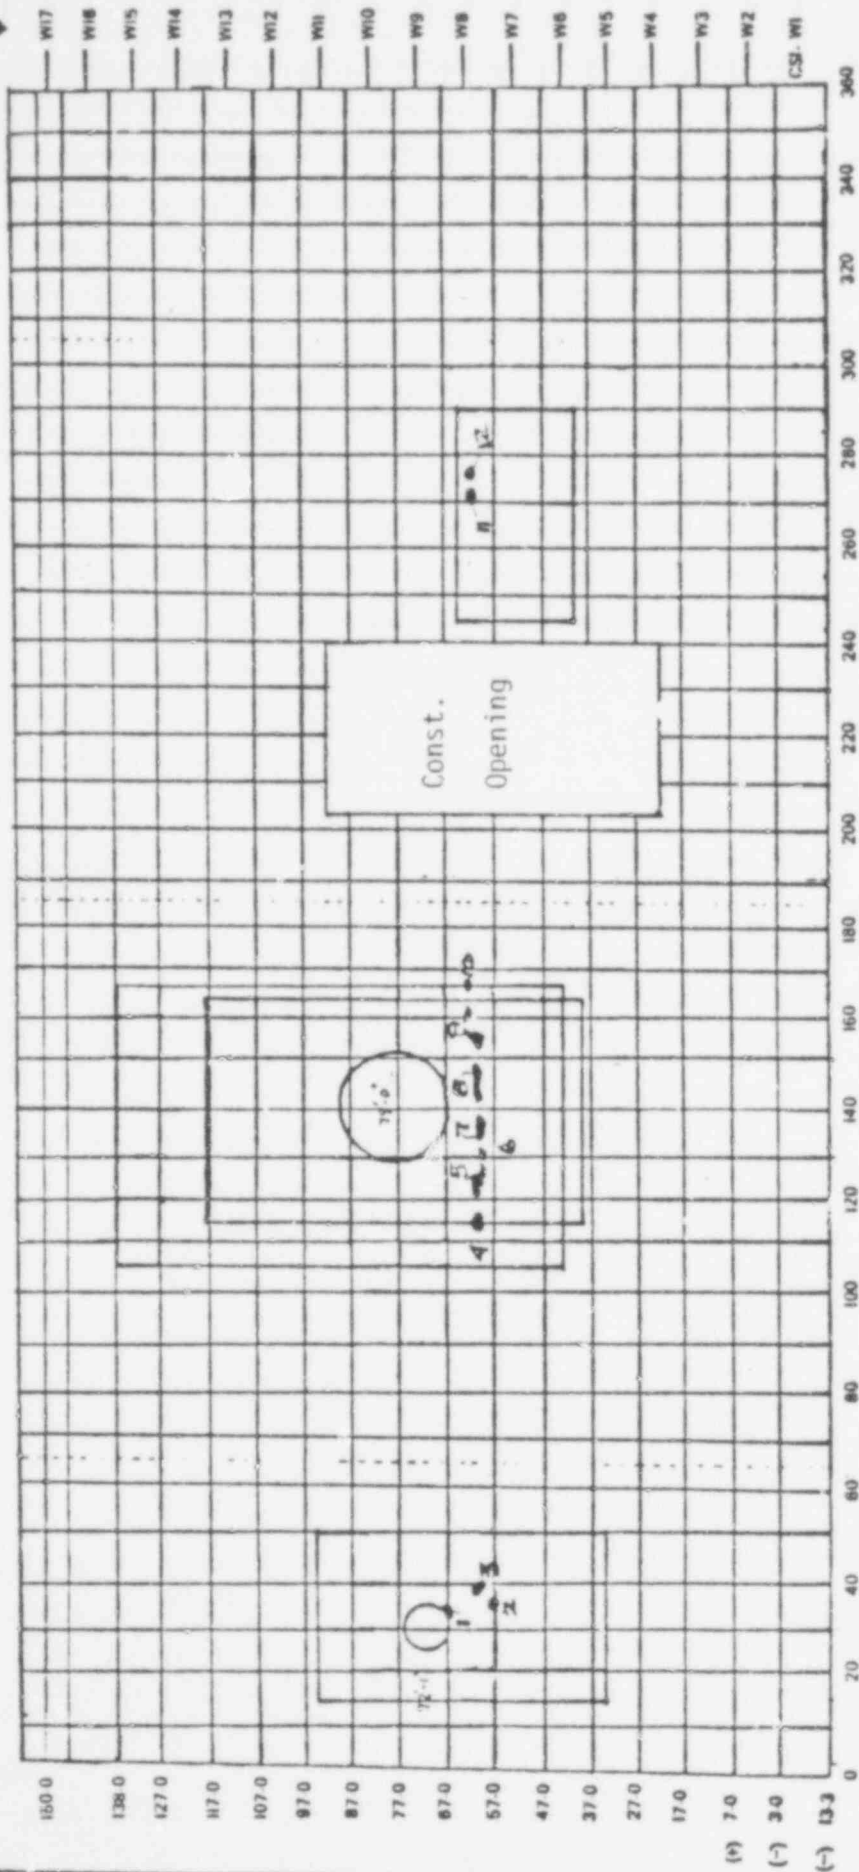
Figure 2

Initially, B&R Construction placed a 2' x 2' grid on the steel Containment liner from El. 57'0" to El. 67'0" for the full circumference of the Containment. The liner was then sounded for the purpose of detecting potential void areas, using procedures that were developed during the investigation on Lift 15. All of this activity was conducted under Quality Control surveillance. This procedure involves the tapping of the liner using a metal hammer and identifying areas of "non-contact" between the liner plate and the concrete based upon the sounds as detected by the human ear. The areas of "non-contact" were physically marked on the liner plate and this information was then transferred to drawings and transmitted for evaluation. Drawings of the liner were prepared showing all penetration and liner stiffening systems. Based upon these drawings, direction was provided to drill holes in the liner plate to determine if the "non-contact" areas were indeed voids. A total of 153 holes were drilled and investigated. As the result of this investigation, 12 areas were identified in which voids existed. The voids were then explored using probes and a fiber scope to determine the extent of "non-contact". These void areas are shown in Figure 2. The majority of the "non-contact" areas were attributed to temporary weldments attached

to the liner, normal concrete settlement/shrinkage, and liner movement. These findings were consistent with the conclusions obtained during the investigation of the Lift 15 deficiency.

LIFT 8 VOID REGIONS

7. 5" Deep (1.4 Sq. Ft.)
8. Varies From 3" to 5" Deep (5.4 Sq. Ft.)
9. Varies From 6" to 10" Deep (12.84 Sq. Ft.)
10. 9" Deep (.36 Sq. Ft.)
11. 3" Deep (.38 Sq. Ft.)
12. 3" Deep (.38 Sq. Ft.)

1. Sand Pocket (1 Sq. Ft.)
2. Small Sand Pocket (12 Sq. Ft.)
3. 7" Deep (.7 Sq. Ft.)
4. Varies From 3" to 8" Deep (5.86 Sq. Ft.)
5. Varies From 6" To 9" Deep (7.84 Sq. Ft.)
6. 10" Deep (12.8 Sq. Ft.)

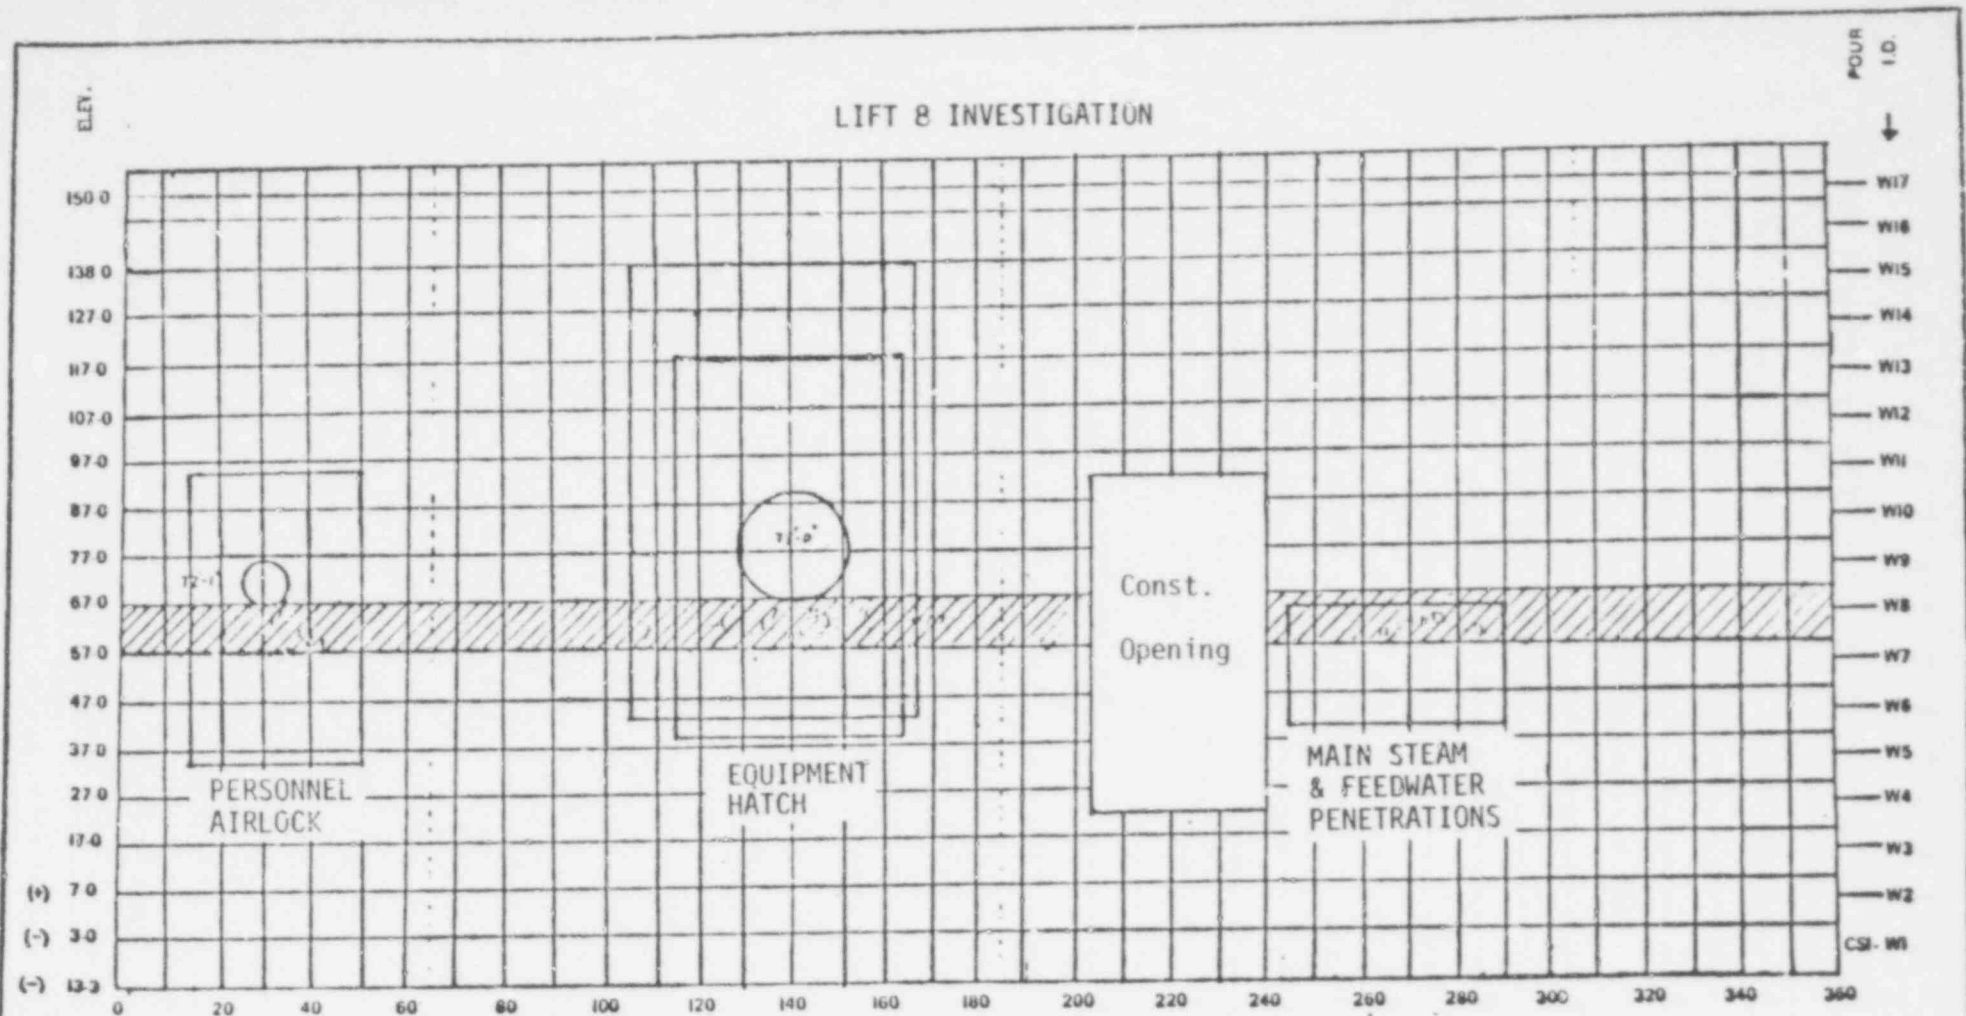
FIGURE 3.1

Based upon the information obtained during this investigation of the voids in Lift 8, it was concluded that other void areas could exist beneath penetrations and the 8" channel and plate stiffeners where additional reinforcing steel is located. Therefore, additional soundings will be made in three general penetration areas of high stress regions and congestion: 1) the equipment hatch, 2) personnel air lock, and 3) the main steam and feedwater lines. The current areas of investigation are shown in Figure 3.1 and 3.2. The logic diagram and plan for the completion of this activity is contained in Figure 3.3.
