UNITED STATES
NUCLEAR REGULATORY COMMISSION
OFFICE OF INSPECTION AND ENFORCEMENT
WASHINGTON, D.C. 20555

IE Bulletin No. 79-13
Date: June 25, 1979
Page 1 of 4

CRACKING IN FEEDWATER SYSTEM PIPING

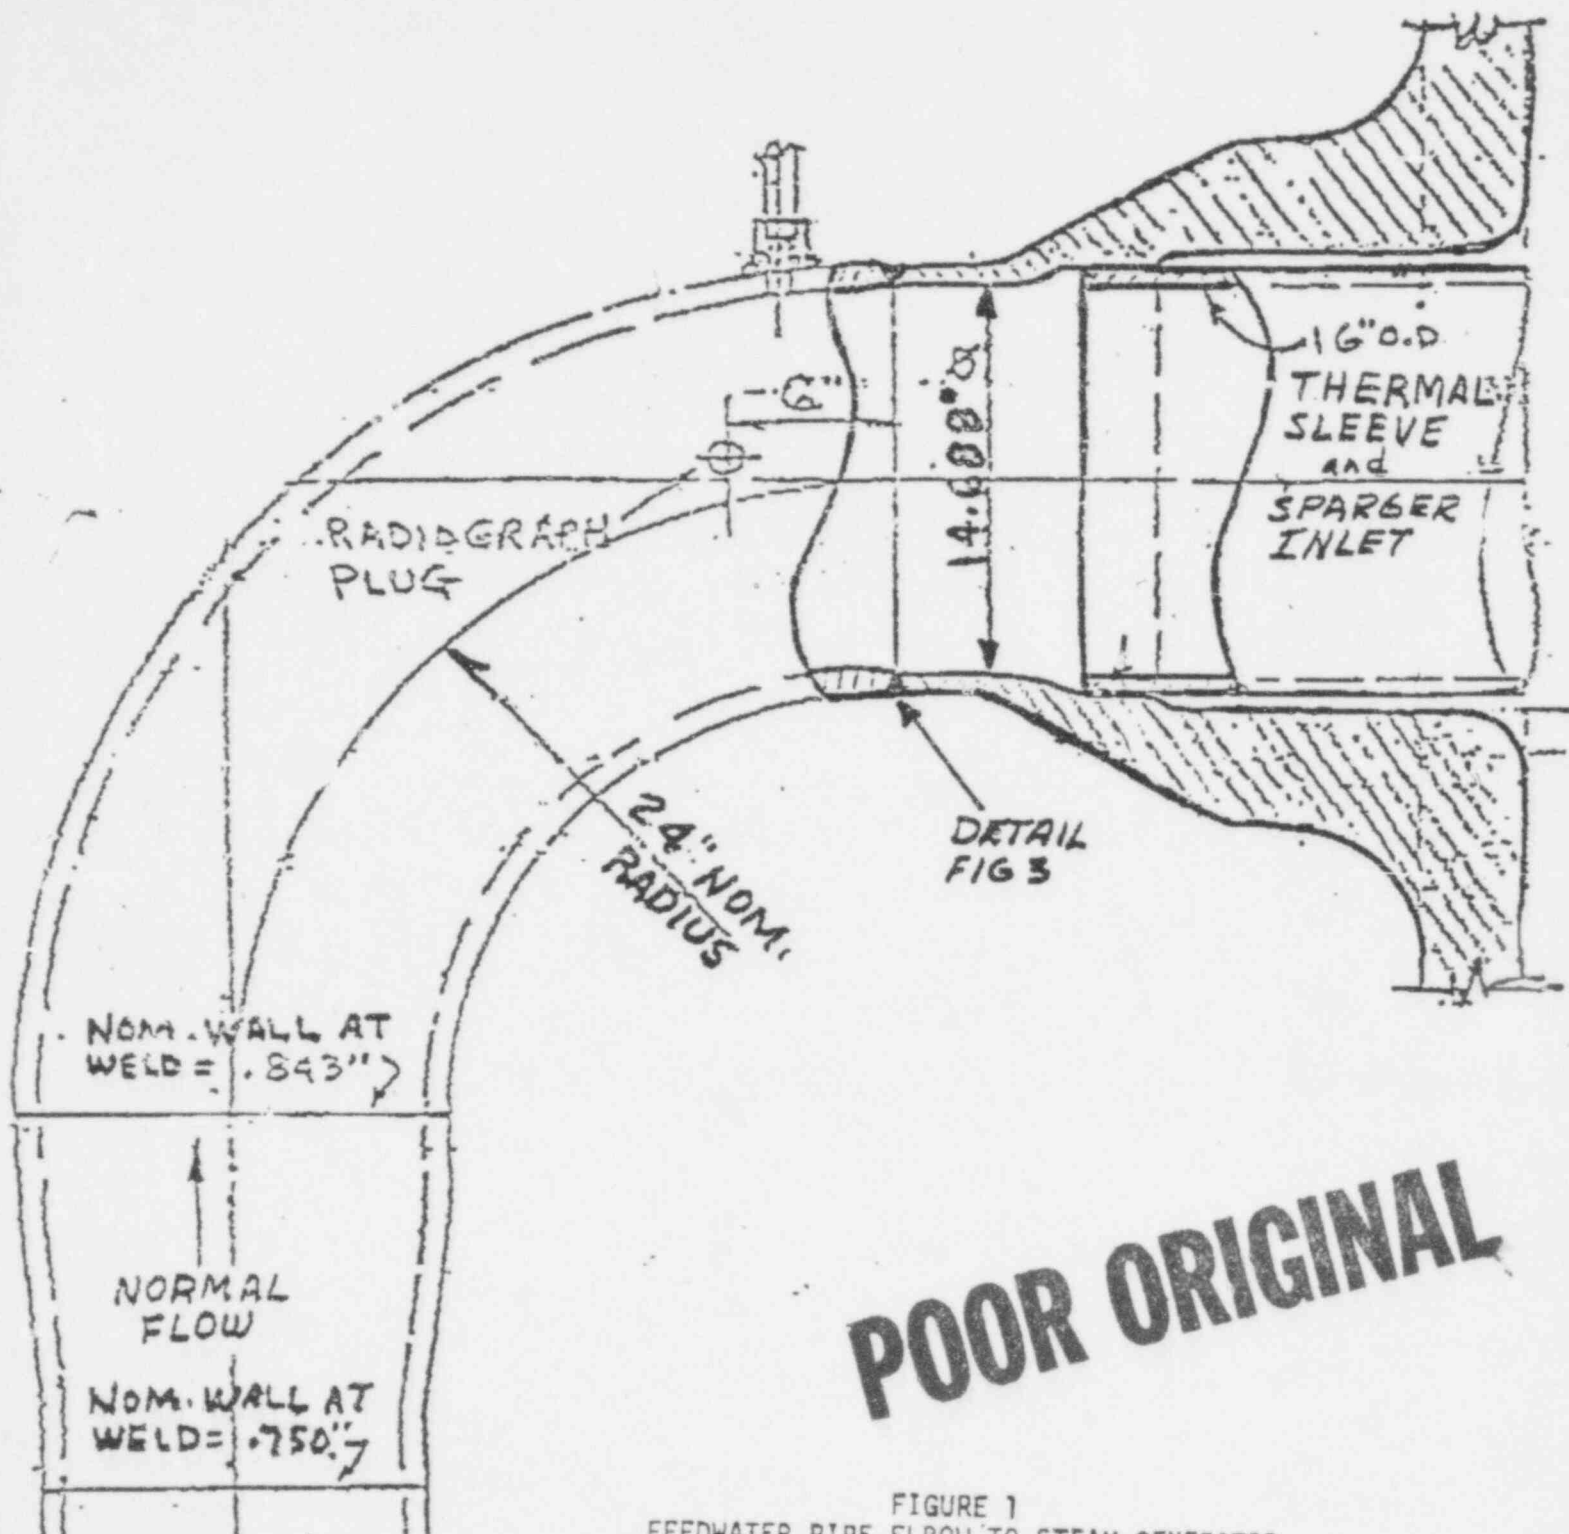
FIGURE 1
FEEDWATER PIPE ELBOW TO STEAM GENERATOR
NOZZLE INSTALLATION (DC COOK)

On May 20, 1979, Indiana and Michigan Power Company notified the NRC of cracking in two feedwater lines at their D. C. Cook Unit 2 facility. The cracking was discovered following a shutdown on May 19 to investigate leakage inside containment. Leaking circumferential cracks were identified in the 16-inch feedwater elbows adjacent to two steam generator nozzle elbow welds. Subsequent radiographic examination revealed crack indications in all eight steam generator feedwater lines at this location on both Units 1 and 2.

The feedwater nozzle-to-pipe configurations for D.C. Cook and for San Onofre are shown on the attached figures 1 and 2. A typical feedwater pipe-to-nozzle weld joint detail showing the principal crack locations for D.C. Cook and San Onofre are shown on the attached figure 3.

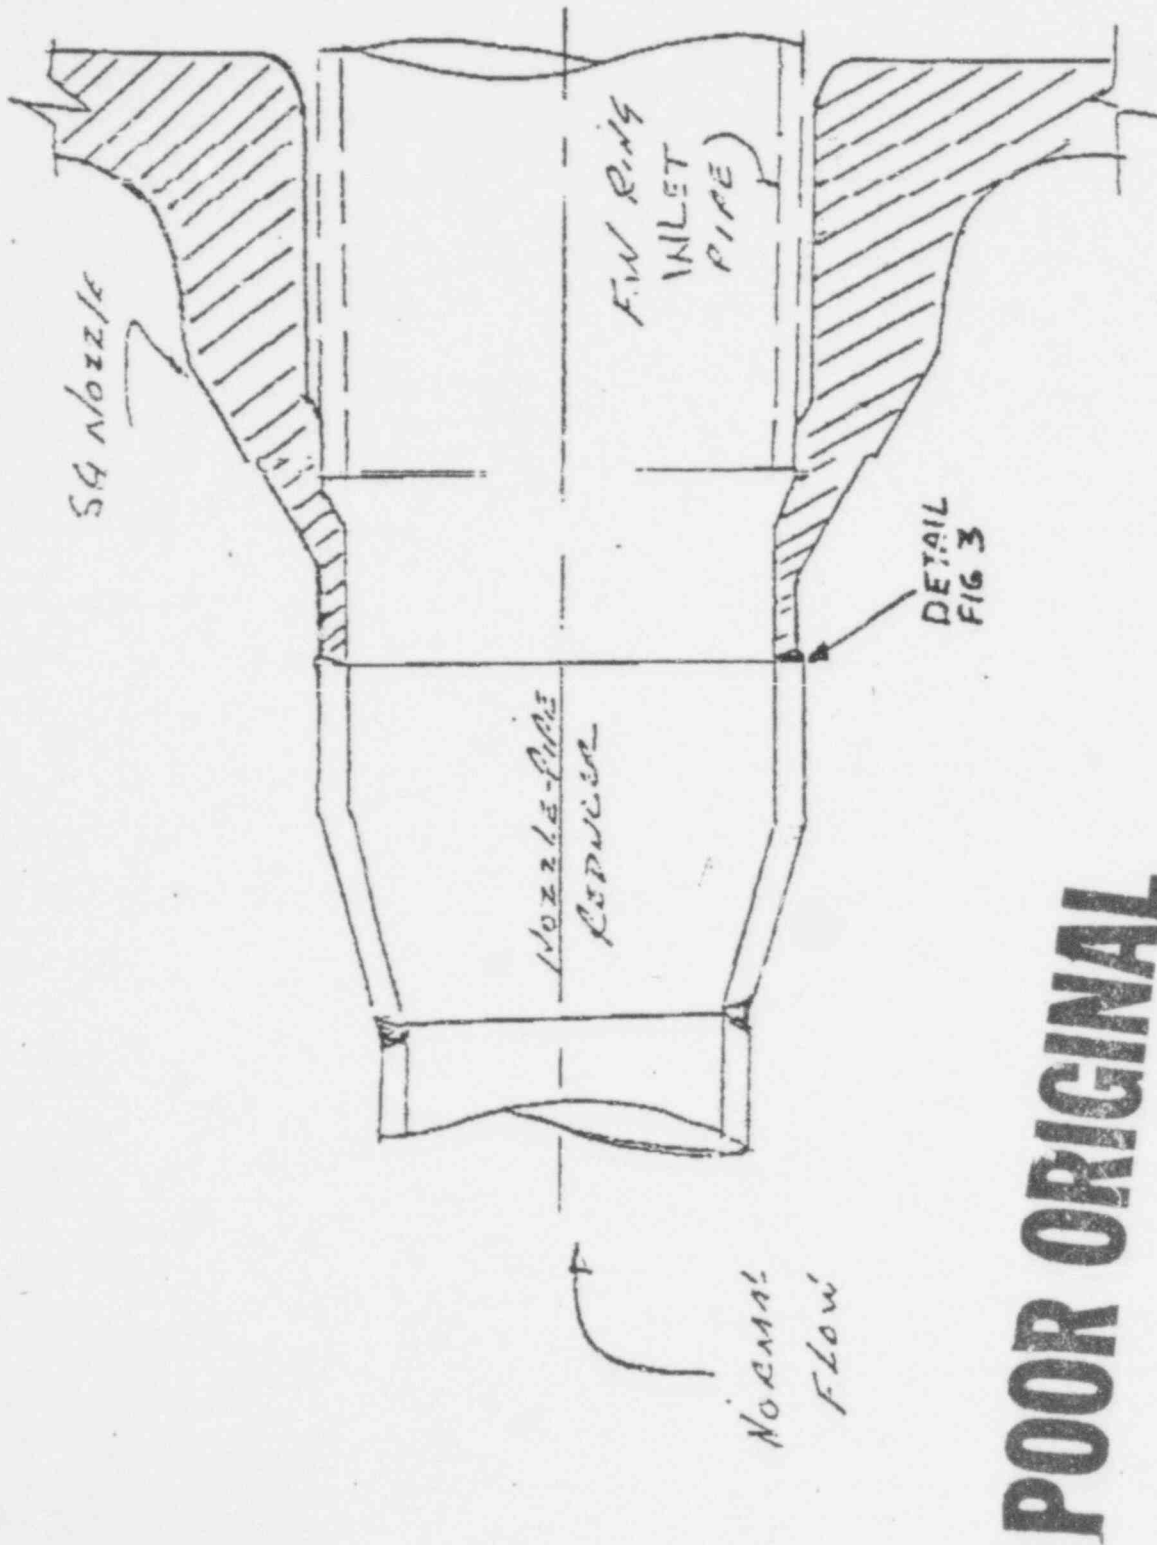
FIGURE 2
FEEDWATER PIPE REDUCER TO STORM GENERATOR
NOZZLE INSTALLATION (SAN INOFRE)

As a result of these actions, several other licensees with Westinghouse steam generators reported crack indications. Southern California Edison reported on June 5, 1979, that radiographic examination revealed indications of cracking in feedwater nozzle-to-piping welds on two of three steam generators of San Onofre Unit 1. On June 15, 1979, Carolina Power and Light reported that radiography showed crack indications in similar locations at their H. B. Robinson Unit 2. Duquesne Power and Light confirmed on June 18, 1979, that radiography has shown cracking in their Beaver Valley Unit 1 feedwater piping to vessel nozzle weld. Public Service Electric and Gas Company reported on June 20, 1979 that Salem Unit 1 also has crack indications. Wisconsin Public Service company decided on June 20, 1979 to cut out a feedwater nozzle-to-pipe weld which contained questionable indication, for metallurgical examination. As of June 22, 1979 and since May 15, 1979 seven other PWR facilities have inspected the feedwater nozzle-to-pipe welds without finding cracking indications.

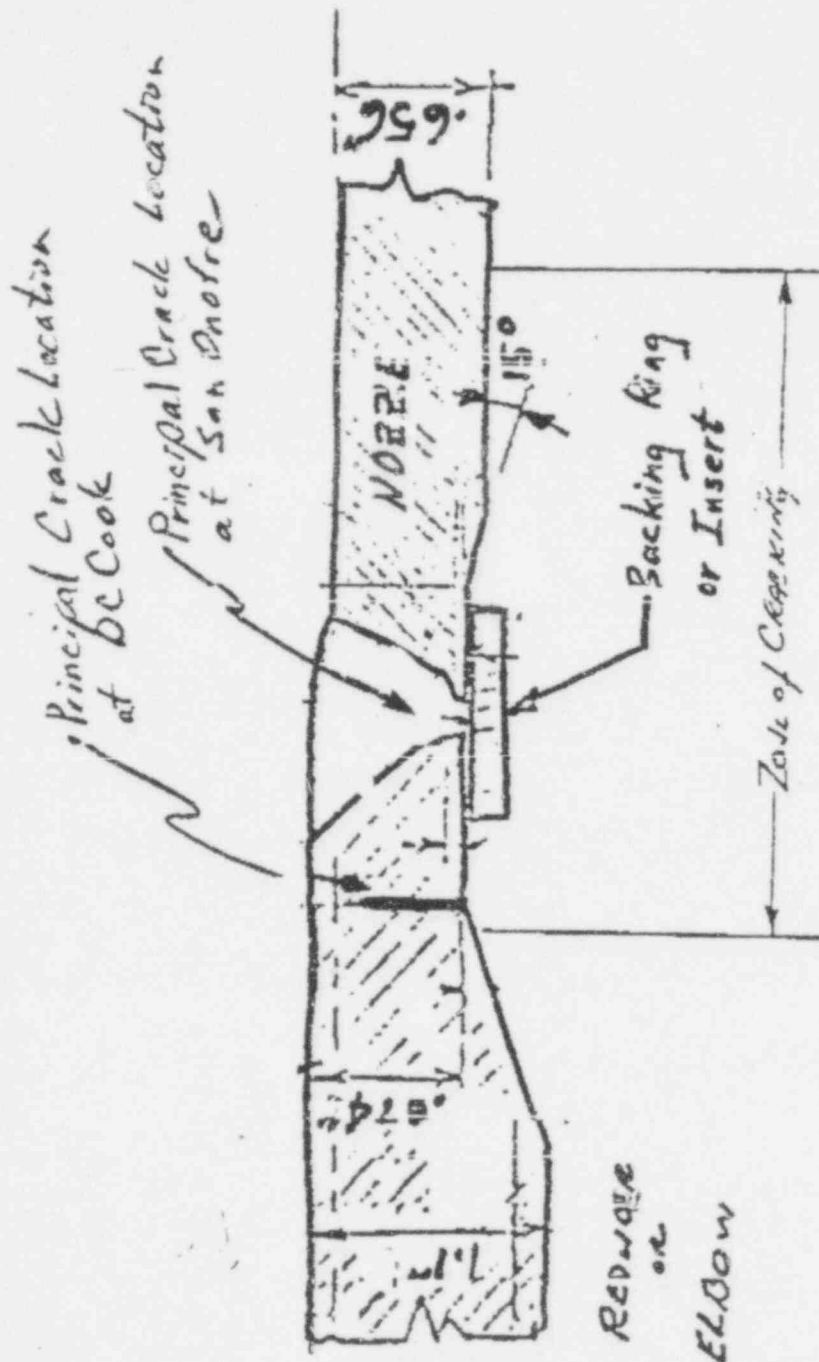
FIGURE 3
TYPICAL FEEDWATER PIPE TO NOZZLE
WELD JOINT DETAIL
(I C E)

Cracked weldments have been removed from the D. C. Cook Units 1 and 2 and San Onofre Unit 1 feedwater systems for extensive metallurgical investigation by Westinghouse. Based on preliminary analysis, Westinghouse stated the D. C. Cook failure may be "fatigue assisted by corrosion." The San Onofre cracking was stated to be characteristic of "stress assisted corrosion."

1. Facilities which have steam generators fabricated by Westinghouse or Combustion Engineering that have not conducted volumetric examination of feedwater nozzles since May 1979 shall complete the inspection program described below at the earliest practical time but no later than 90 days after the date of this Bulletin.
 - a. Perform radiographic examination, supplemented by ultrasonic examination as necessary to evaluate indications, of all feedwater nozzle-to-piping welds and of adjacent pipe and nozzle areas (a distance equal to at least two wall thicknesses). Evaluation shall be in accordance with ASME Section III, Subsection NC, Article NC-5000. Radiography shall be performed to the 2T penetrameter sensitivity level, in lieu of Table NC-5111-1, with systems void of water.
