UNITED STATES
NUCLEAR REGULATORY COMMISSION
REGION I
631 PARK AVENUE
KING OF PRUSSIA, PENNSYLVANIA 19406

UNITED STATES
NUCLEAR REGULATORY COMMISSION
OFFICE OF INSPECTION AND ENFORCEMENT
WASHINGTON, D.C. 20555

IE Bulletin No. 79-13
Date: June 25, 1979
Page 1 of 4

CRACKING IN FEEDWATER SYSTEM PIPING

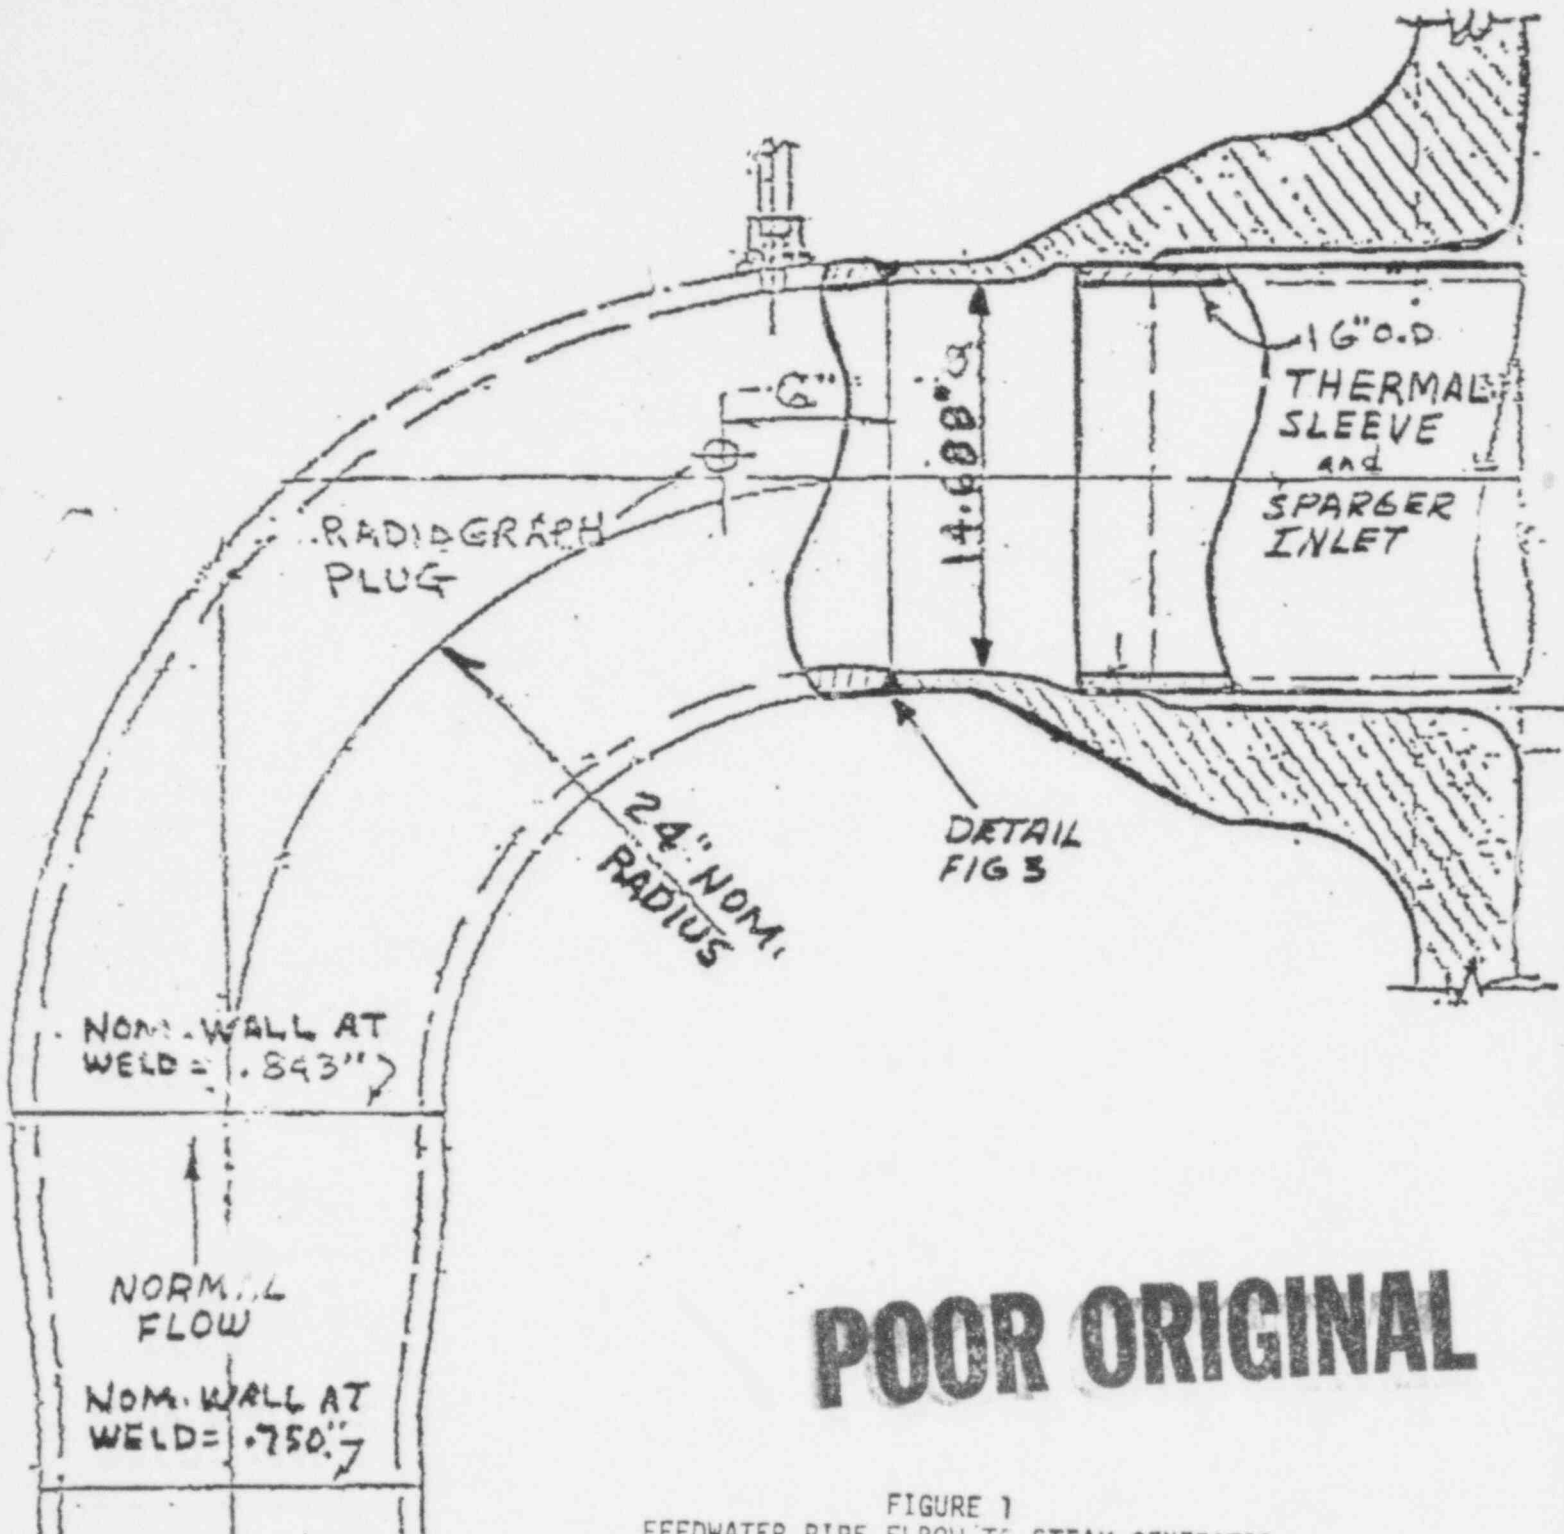
FIGURE 1
FEEDWATER PIPE ELBOW TO STEAM GENERATOR
NOZZLE INSTALLATION (DC COOK)

On May 20, 1979, Indiana and Michigan Power Company notified the NRC of cracking in two feedwater lines at their D. C. Cook Unit 2 facility. The cracking was discovered following a shutdown on May 19 to investigate leakage inside containment. Leaking circumferential cracks were identified in the 16-inch feedwater elbows adjacent to two steam generator nozzle elbow welds. Subsequent radiographic examination revealed crack indications in all eight steam generator feedwater lines at this location on both Units 1 and 2.

The feedwater nozzle-to-pipe configurations for D.C. Cook and for San Onofre are shown on the attached figures 1 and 2. A typical feedwater pipe-to-nozzle weld joint detail showing the principal crack locations for D.C. Cook and San Onofre are shown on the attached figure 3.

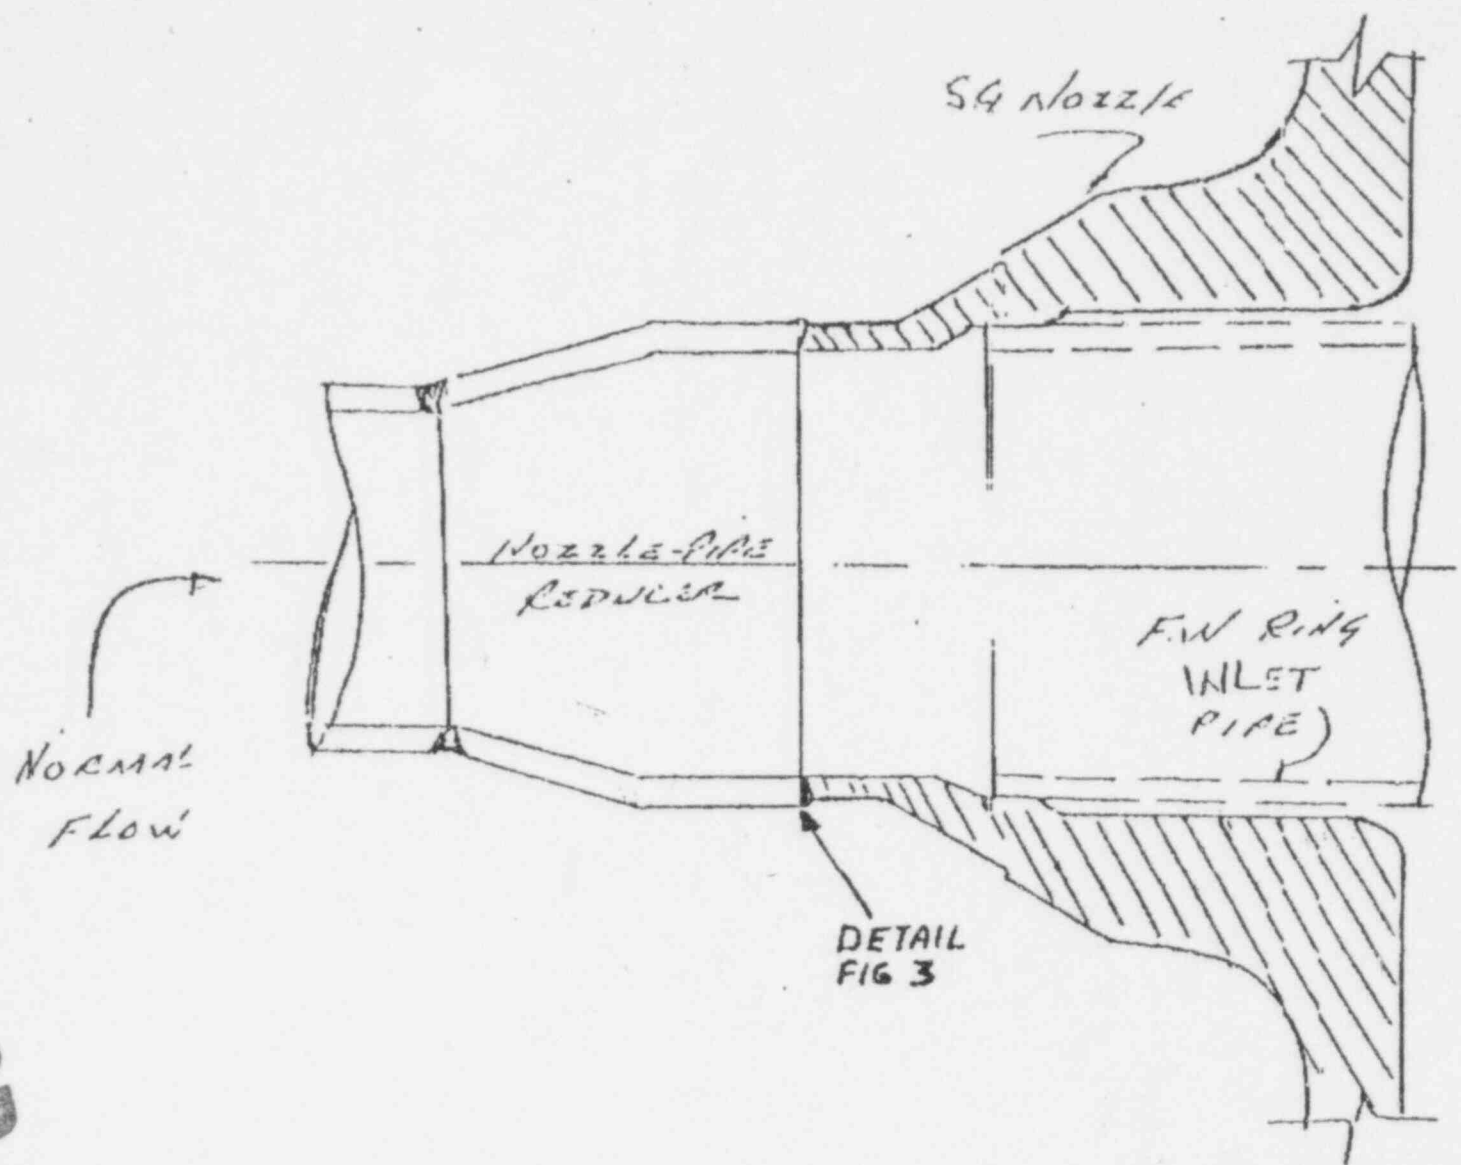
FIGURE 2
 FEEDWATER PIPE REDUCER TO STRM GENERATOR
 NOZZLE INSTALLATION (SAN INOFRE)

As a result of these actions, several other licensees with Westinghouse steam generators reported crack indications. Southern California Edison reported on June 5, 1979, that radiographic examination revealed indications of cracking in feedwater nozzle-to-piping welds on two of three steam generators of San Onofre Unit 1. On June 15, 1979, Carolina Power and Light reported that radiography showed crack indications in similar locations at their H. B. Robinson Unit 2. Duquesne Power and Light confirmed on June 18, 1979, that radiography has shown cracking in their Beaver Valley Unit 1 feedwater piping to vessel nozzle weld. Public Service Electric and Gas Company reported on June 20, 1979 that Salem Unit 1 also has crack indications. Wisconsin Public Service company decided on June 20, 1979 to cut out a feedwater nozzle-to-pipe weld which contained questionable indication, for metallurgical examination. As of June 22, 1979 and since May 15, 1979 seven other PWR facilities have inspected the feedwater nozzle-to-pipe welds without finding cracking indications.

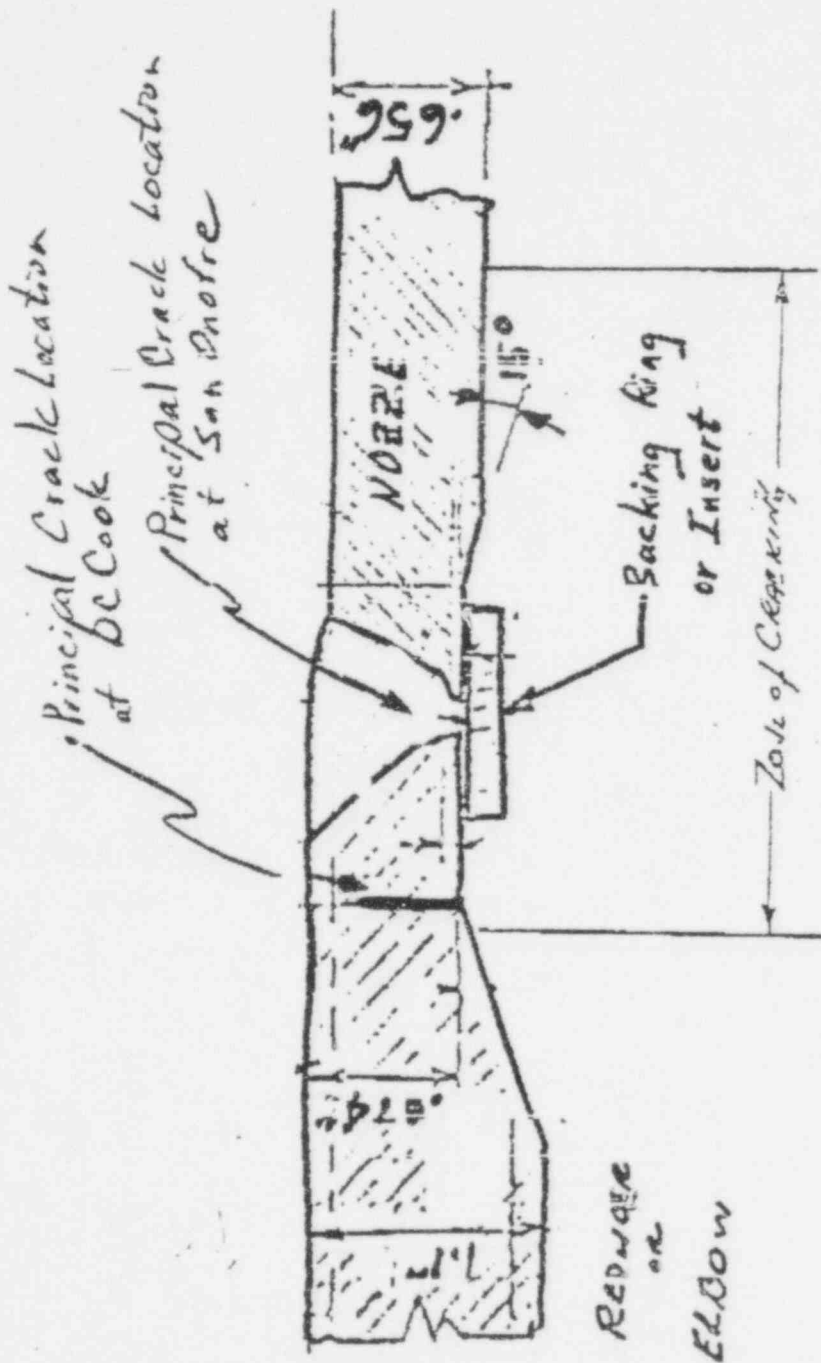
FIGURE 3
TYPICAL FEEDWATER PIPE TO NOZZLE
WELD JOINT DETAIL
(I C E)

Cracked weldments have been removed from the D. C. Cook Units 1 and 2 and San Onofre Unit 1 feedwater systems for extensive metallurgical investigation by Westinghouse. Based on preliminary analysis, Westinghouse stated the D. C. Cook failure may be "fatigue assisted by corrosion." The San Onofre cracking was stated to be characteristic of "stress assisted corrosion."
