UNITED STATES
NUCLEAR REGULATORY COMMISSION
OFFICE OF INSPECTION AND ENFORCEMENT
WASHINGTON, D.C. 20555

IE Bulletin No. 79-13
Date: June 25, 1979
Page 1 of 4

CRACKING IN FEEDWATER SYSTEM PIPING

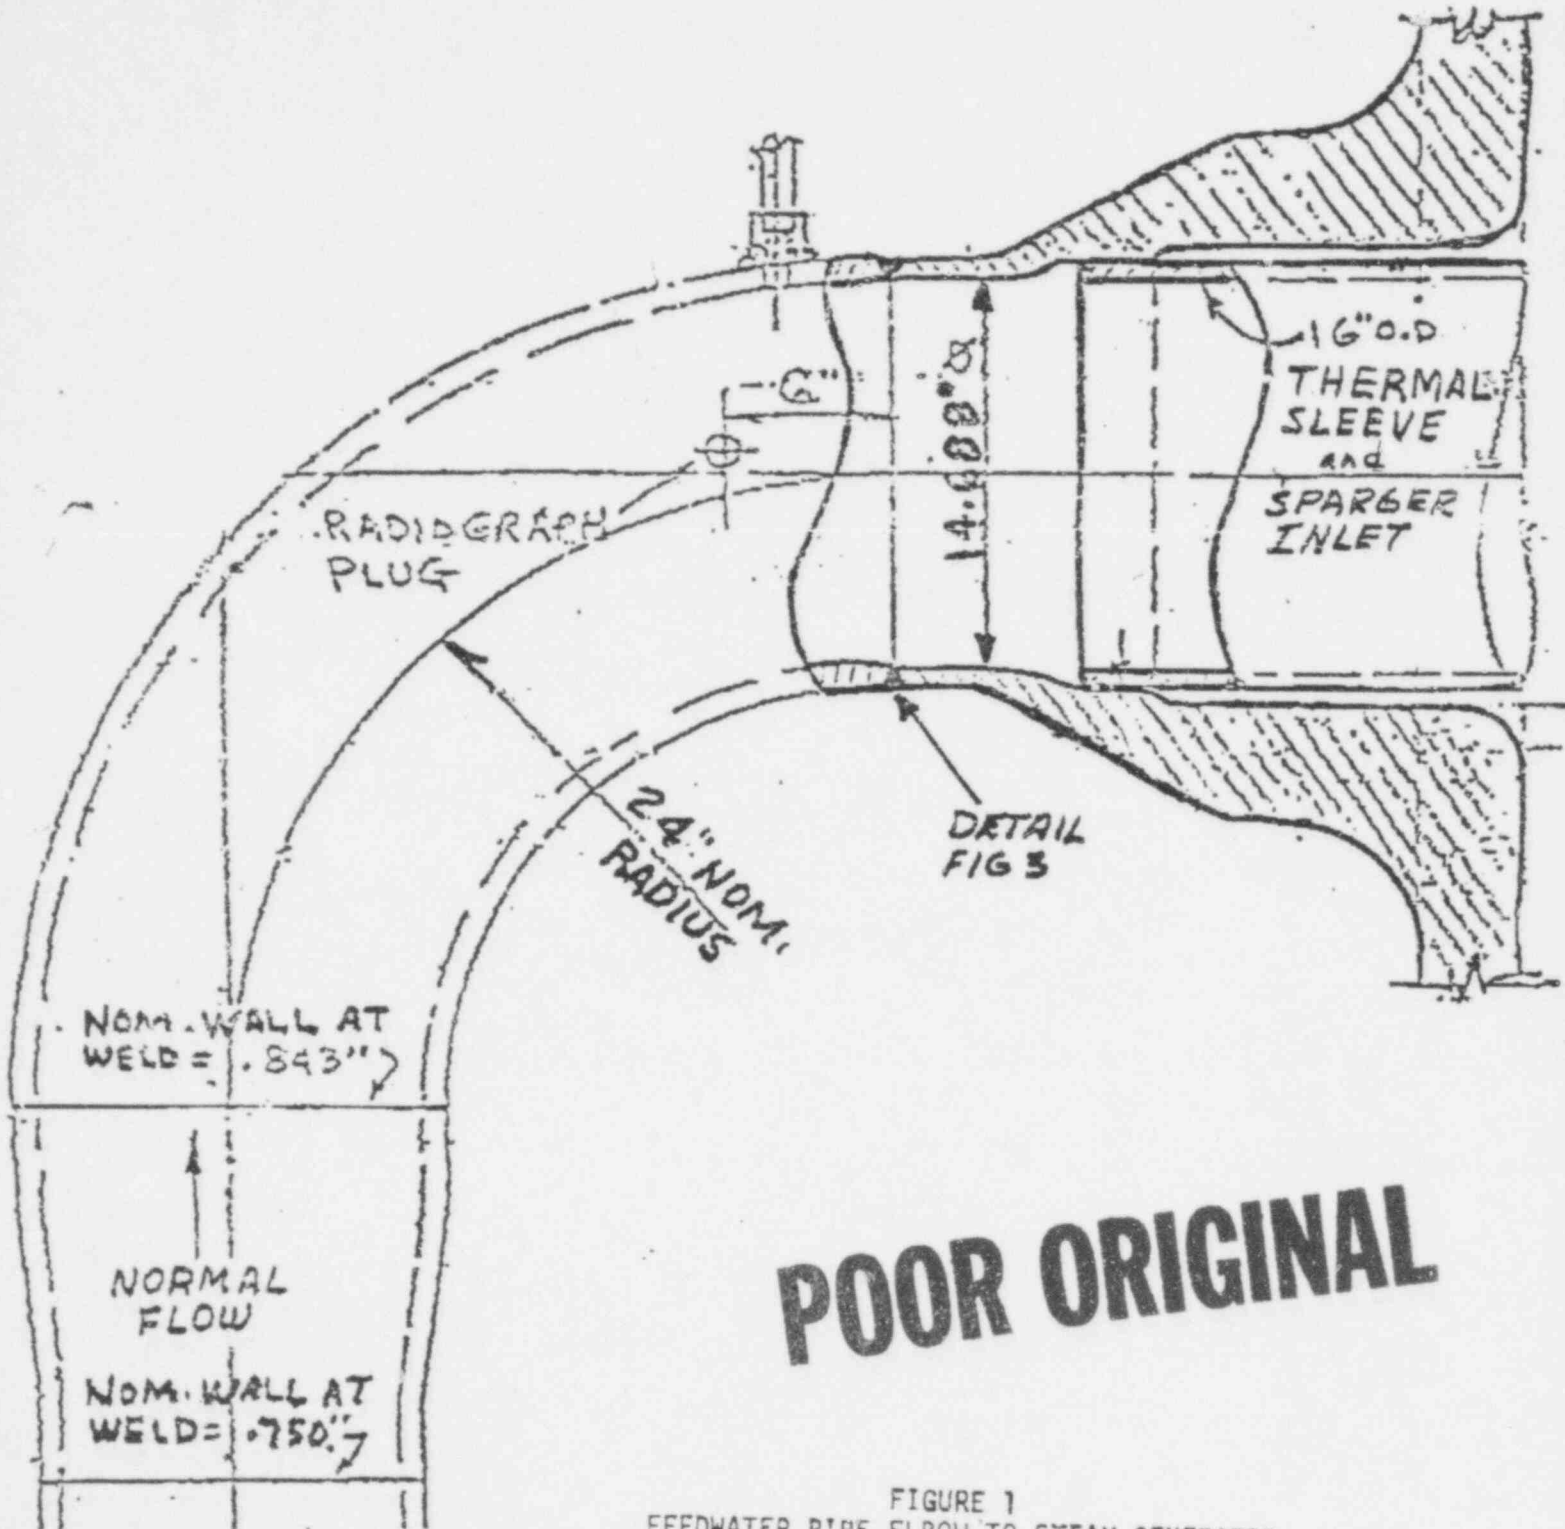
FIGURE 1
FEEDWATER PIPE ELBOW TO STEAM GENERATOR
NOZZLE INSTALLATION (DC COOK)

On May 20, 1979, Indiana and Michigan Power Company notified the NRC of cracking in two feedwater lines at their D. C. Cook Unit 2 facility. The cracking was discovered following a shutdown on May 19 to investigate leakage inside containment. Leaking circumferential cracks were identified in the 16-inch feedwater elbows adjacent to two steam generator nozzle elbow welds. Subsequent radiographic examination revealed crack indications in all eight steam generator feedwater lines at this location on both Units 1 and 2.

The feedwater nozzle-to-pipe configurations for D.C. Cook and for San Onofre are shown on the attached figures 1 and 2. A typical feedwater pipe-to-nozzle weld joint detail showing the principal crack locations for D.C. Cook and San Onofre are shown on the attached figure 3.

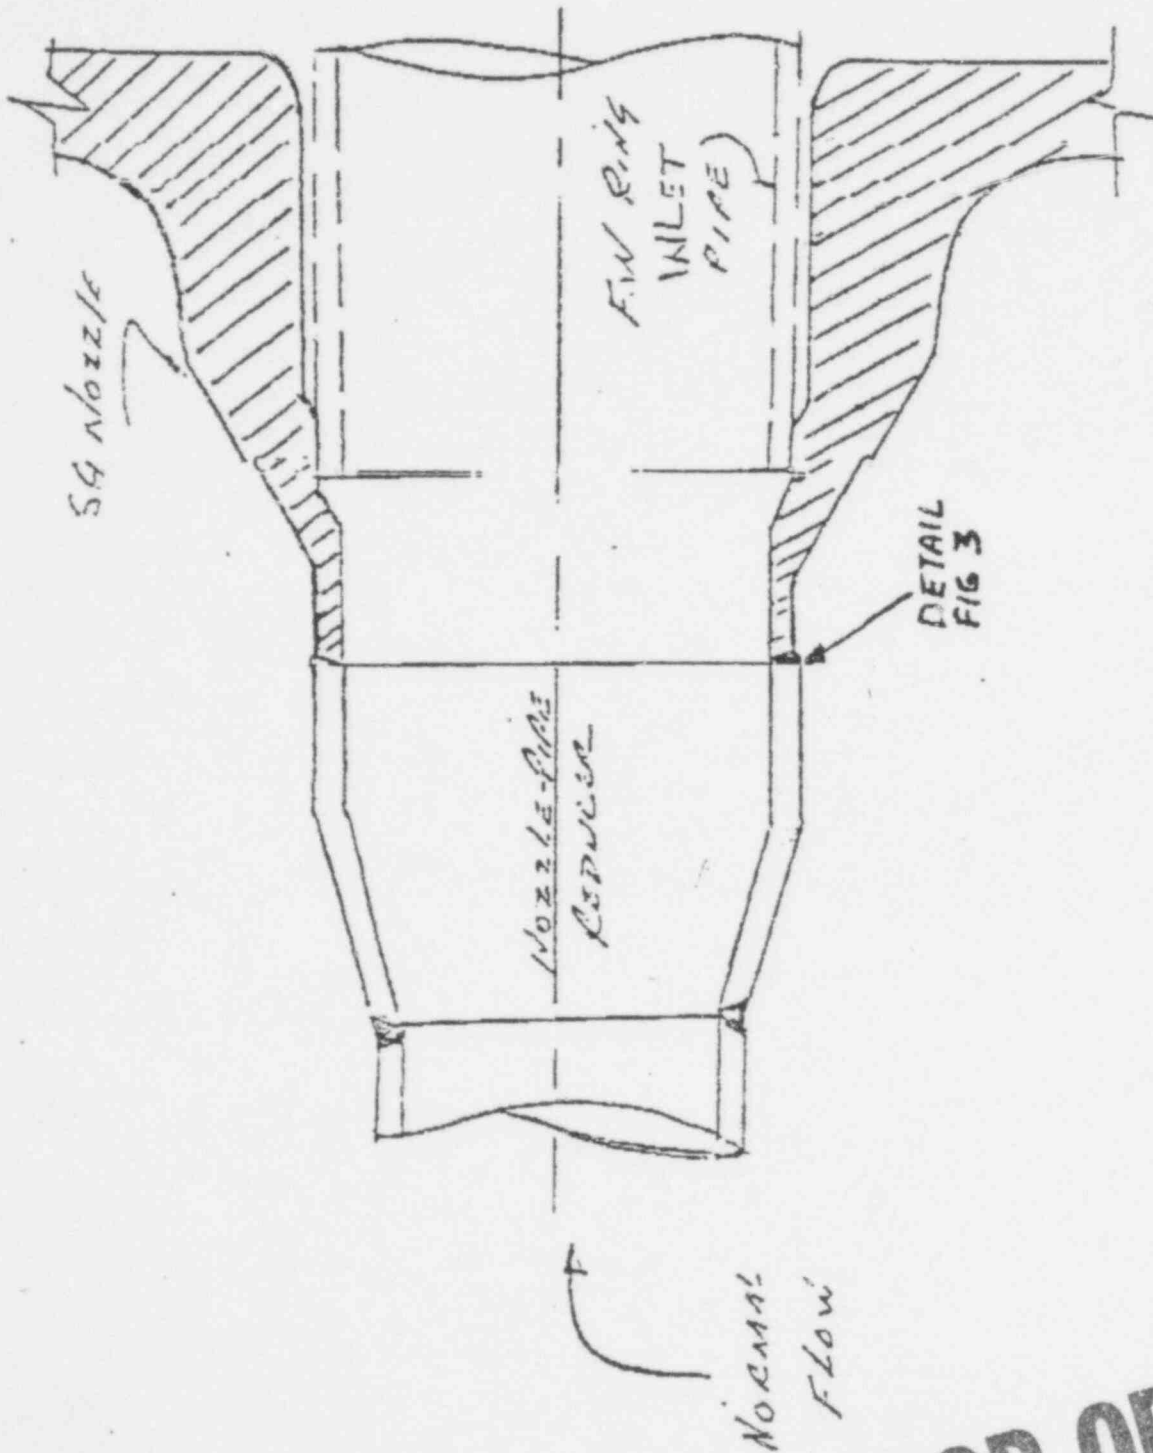
FIGURE 2
FEEDWATER PIPE REDUCER TO STORM GENERATOR
NOZZLE INSTALLATION (SAN INOFRE)

As a result of these actions, several other licensees with Westinghouse steam generators reported crack indications. Southern California Edison reported on June 5, 1979, that radiographic examination revealed indications of cracking in feedwater nozzle-to-piping welds on two of three steam generators of San Onofre Unit 1. On June 15, 1979, Carolina Power and Light reported that radiography showed crack indications in similar locations at their H. B. Robinson Unit 2. Duquesne Power and Light confirmed on June 18, 1979, that radiography has shown cracking in their Beaver Valley Unit 1 feedwater piping to vessel nozzle weld. Public Service Electric and Gas Company reported on June 20, 1979 that Salem Unit 1 also has crack indications. Wisconsin Public Service company decided on June 20, 1979 to cut out a feedwater nozzle-to-pipe weld which contained questionable indication, for metallurgical examination. As of June 22, 1979 and since May 15, 1979 seven other PWR facilities have inspected the feedwater nozzle-to-pipe welds without finding cracking indications.

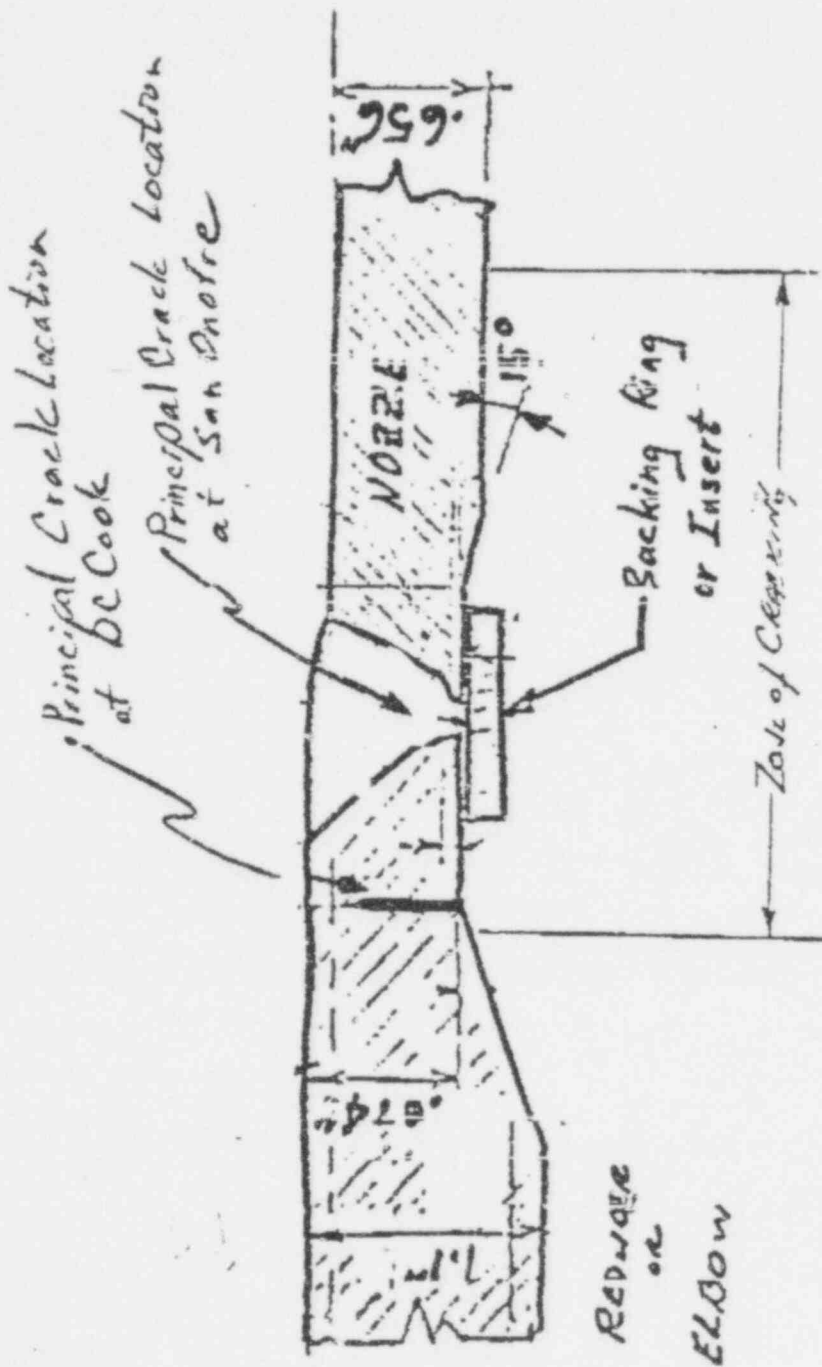
FIGURE 3
TYPICAL FEEDWATER PIPE TO NOZZLE
WELD JOINT DETAIL
(ICE)

Cracked weldments have been removed from the D. C. Cook Units 1 and 2 and San Onofre Unit 1 feedwater systems for extensive metallurgical investigation by Westinghouse. Based on preliminary analysis, Westinghouse stated the D. C. Cook failure may be "fatigue assisted by corrosion." The San Onofre cracking was stated to be characteristic of "stress assisted corrosion."
