Docket No. 50-336

IE Bulletin No. 79-13
Date: June 25, 1979
Page 1 of 4

CRACKING IN FEEDWATER SYSTEM PIPING

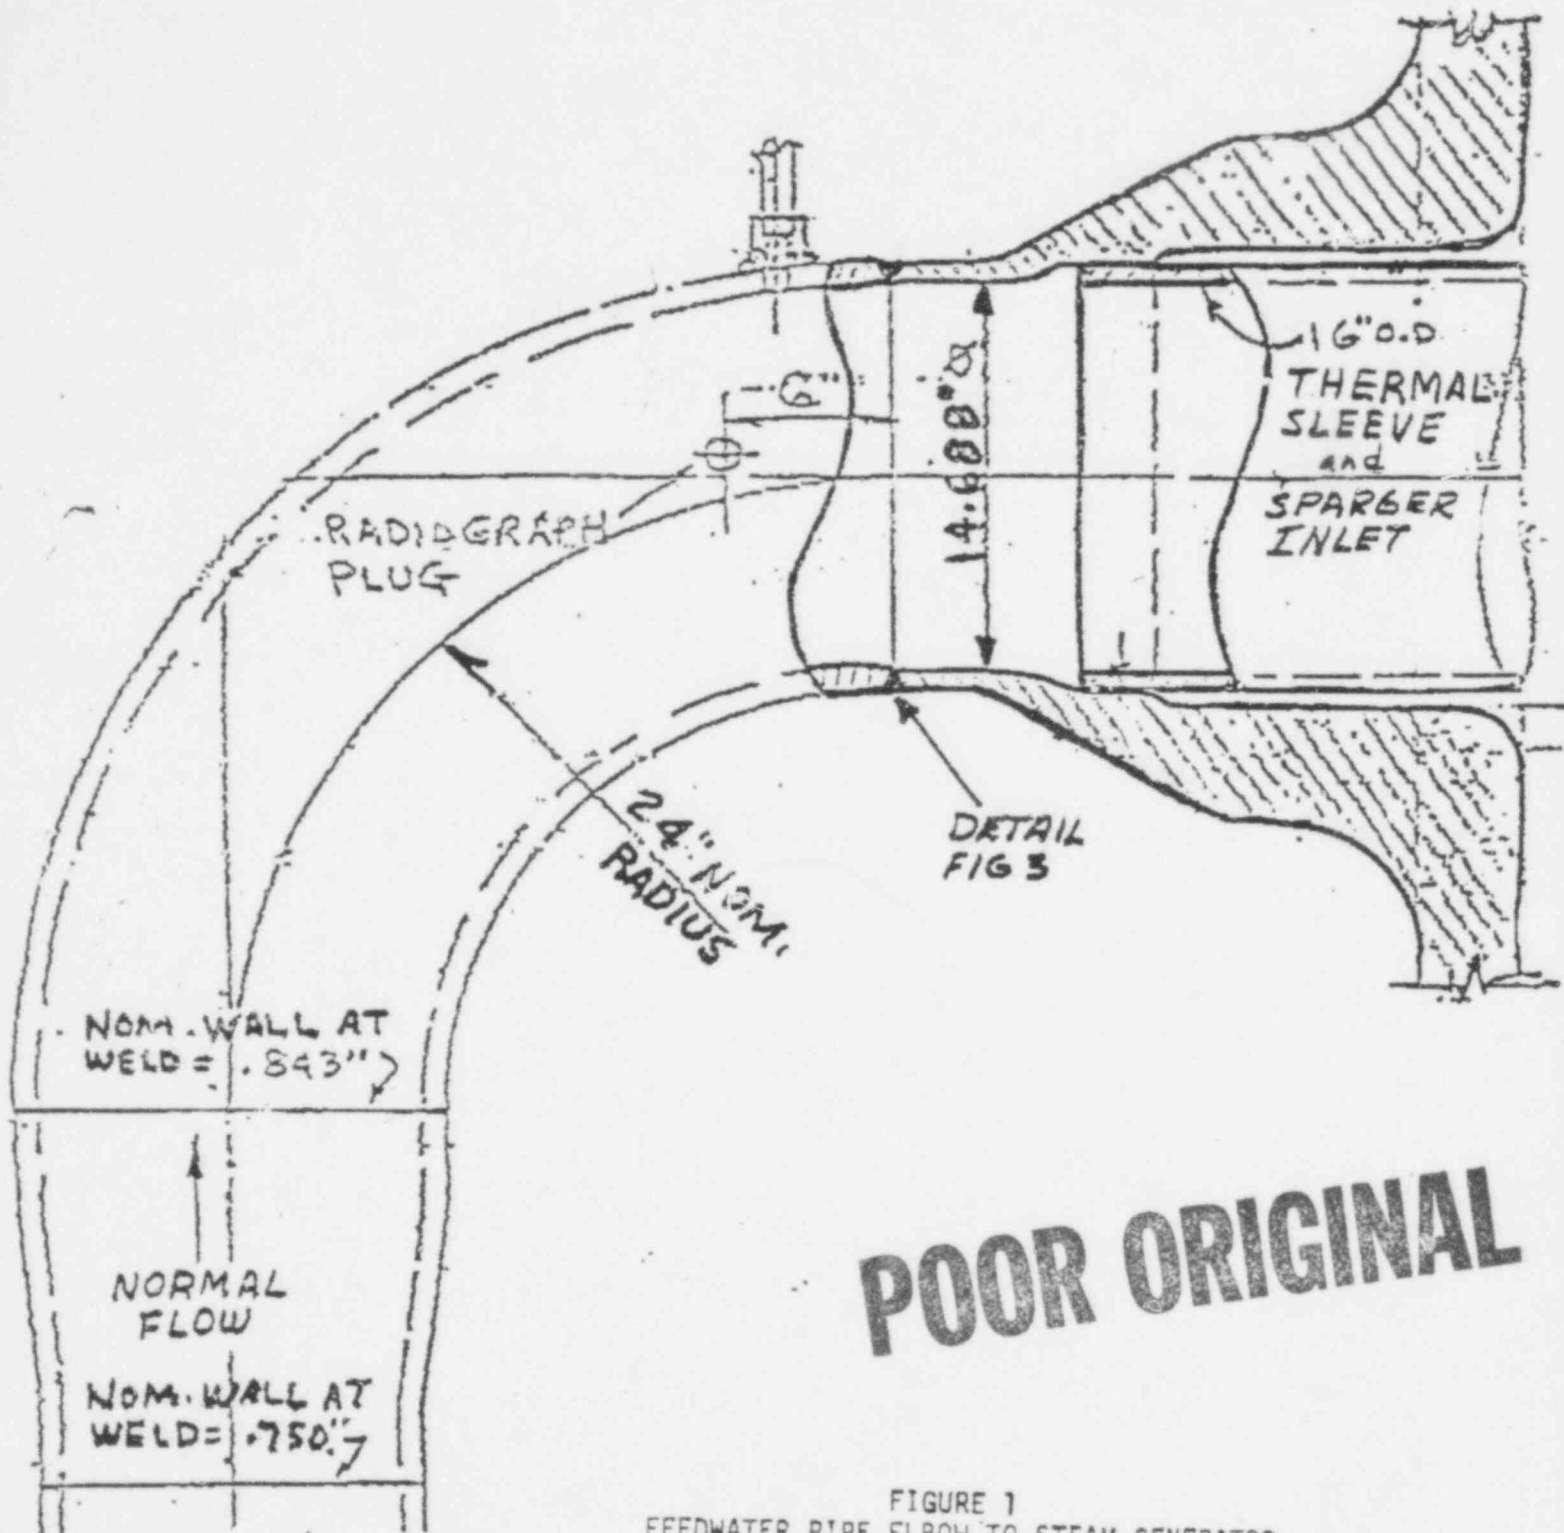
FIGURE 1
FEEDWATER PIPE ELBOW TO STEAM GENERATOR
NOZZLE INSTALLATION (DC COOK)

On May 20, 1979, Indiana and Michigan Power Company notified the NRC of cracking in two feedwater lines at their D. C. Cook Unit 2 facility. The cracking was discovered following a shutdown on May 19 to investigate leakage and containment. Leaking circumferential cracks were identified in the two feedwater elbows adjacent to two steam generator nozzle elbow welds. Subsequent radiographic examination revealed crack indications in all eight steam generator feedwater lines at this location on both Units 1 and 2.

Cracked weldments have been removed from the D. C. Cook Units 1 and 2 and San Onofre Unit 1 feedwater systems for extensive metallurgical investigation by Westinghouse. Based on preliminary analysis, Westinghouse stated the D. C. Cook failure may be "fatigue assisted by corrosion." The San Onofre cracking was stated to be characteristic of "stress assisted corrosion."

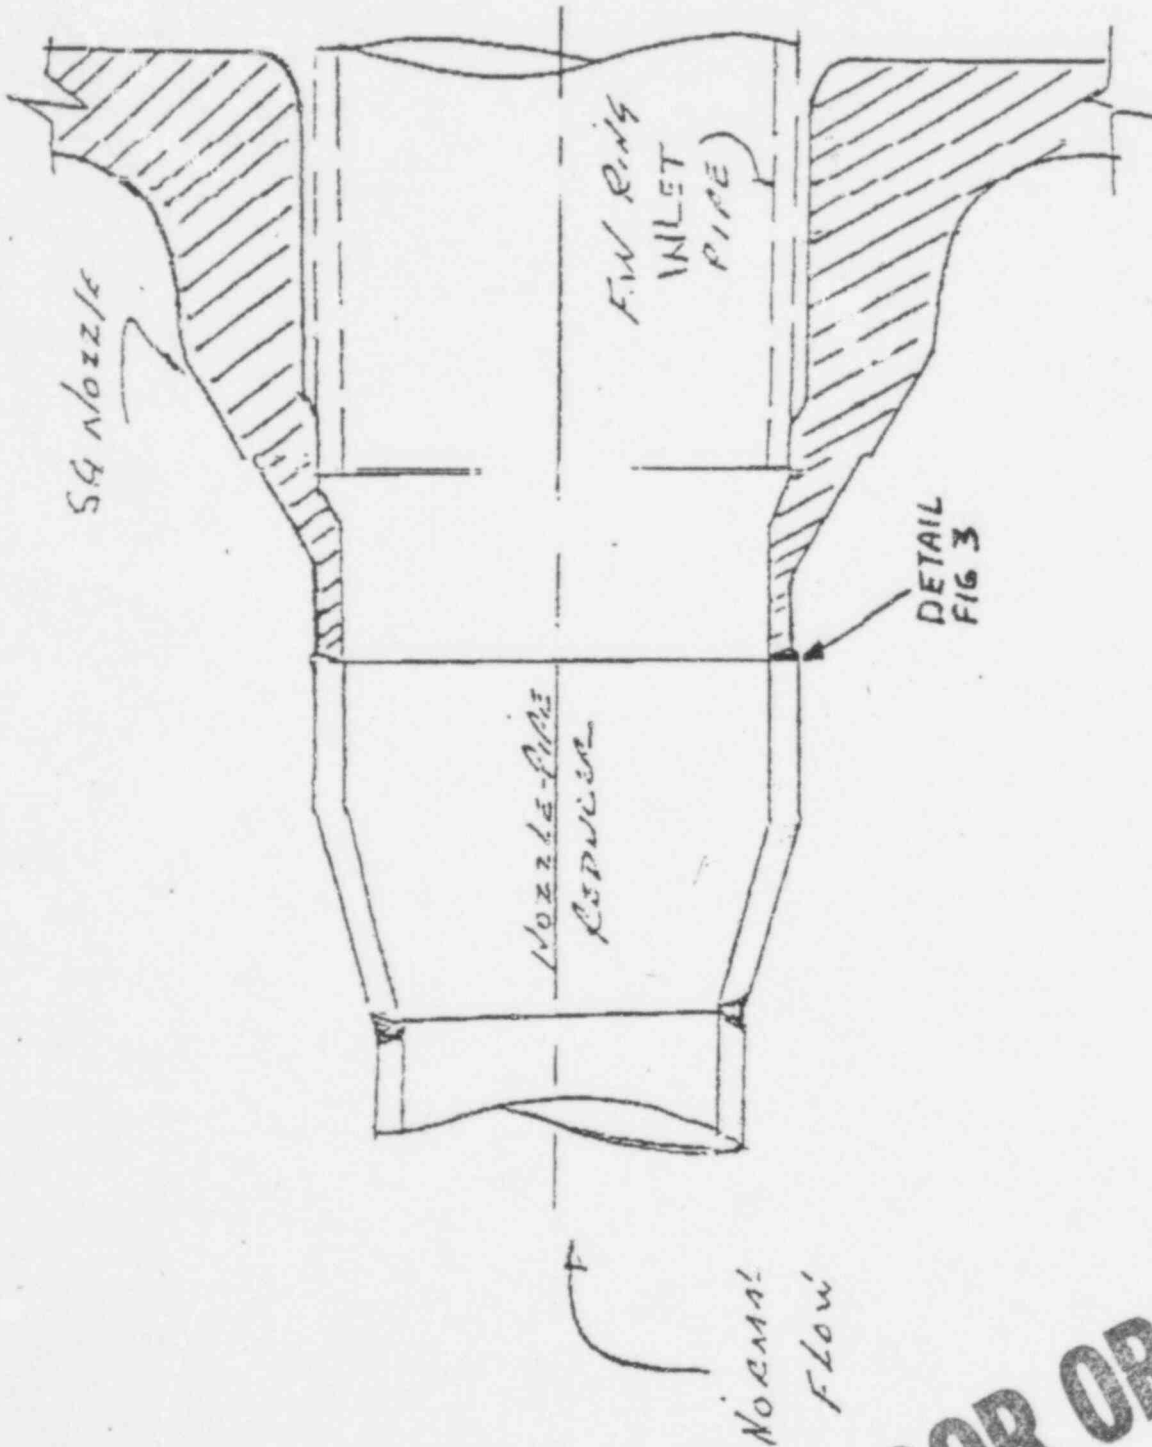
FIGURE 2
FEEDWATER PIPE REDUCER TO STEAM GENERATOR
NOZZLE INSTALLATION (SAN INOFRE)

As a result of these actions, several other licensees with Westinghouse steam generators reported crack indications. Southern California Edison reported on June 5, 1979, that radiographic examination revealed indications of cracking in feedwater nozzle-to-piping welds on two of three steam generators of San Onofre Unit 1. On June 15, 1979, Carolina Power and Light reported that radiography showed crack indications in similar locations at their H. B. Robinson Unit 2. Duquesne Power and Light confirmed on June 18, 1979, that radiography has shown cracking in their Beaver Valley Unit 1 feedwater piping to vessel nozzle weld. Public Service Electric and Gas Company reported on June 20, 1979 that Salem Unit 1 also has crack indications. Wisconsin Public Service company decided on June 20, 1979 to cut out a feedwater nozzle-to-pipe weld which contained questionable indication, for metallurgical examination. As of June 22, 1979 and since May 15, 1979 seven other PWR facilities have inspected the feedwater nozzle-to-pipe welds without finding cracking indications.

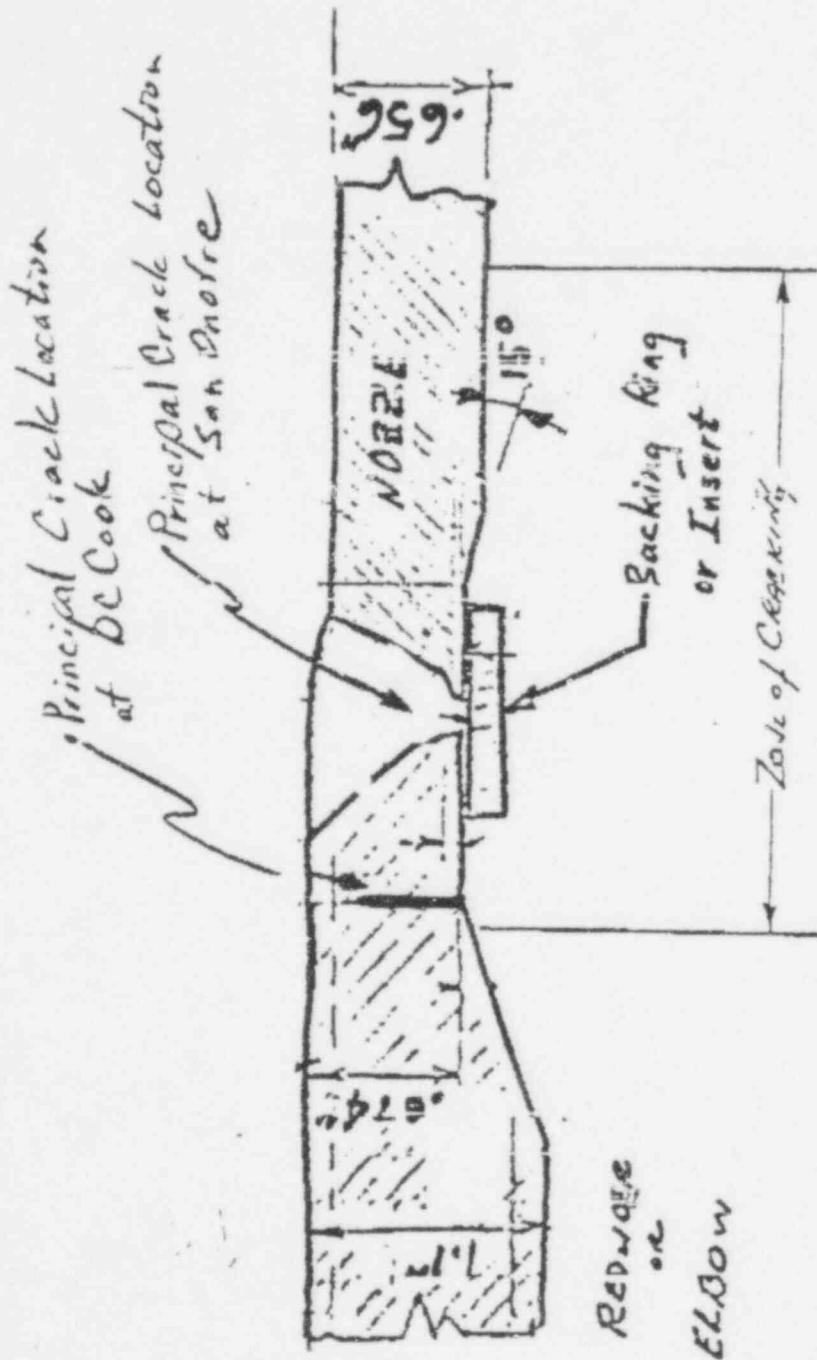
FIGURE 3
TYPICAL FEEDWATER PIPE TO NOZZLE
WELD JOINT DETAIL
(ICE)

The feedwater nozzle-to-pipe configurations for D.C. Cook and for San Onofre are shown on the attached figures 1 and 2. A typical feedwater pipe-to-nozzle weld joint detail showing the principal crack locations for D.C. Cook and San Onofre are shown on the attached figure 3.
