U. S. ATOMIC ENERGY COMMISSION
DIVISION OF COMPLIANCE

CO-Inspection Report No. 50-146/71-03

Subject: Saxton Nuclear Experimental Corporation

Dates of Inspection: December 27 - 29, 1971

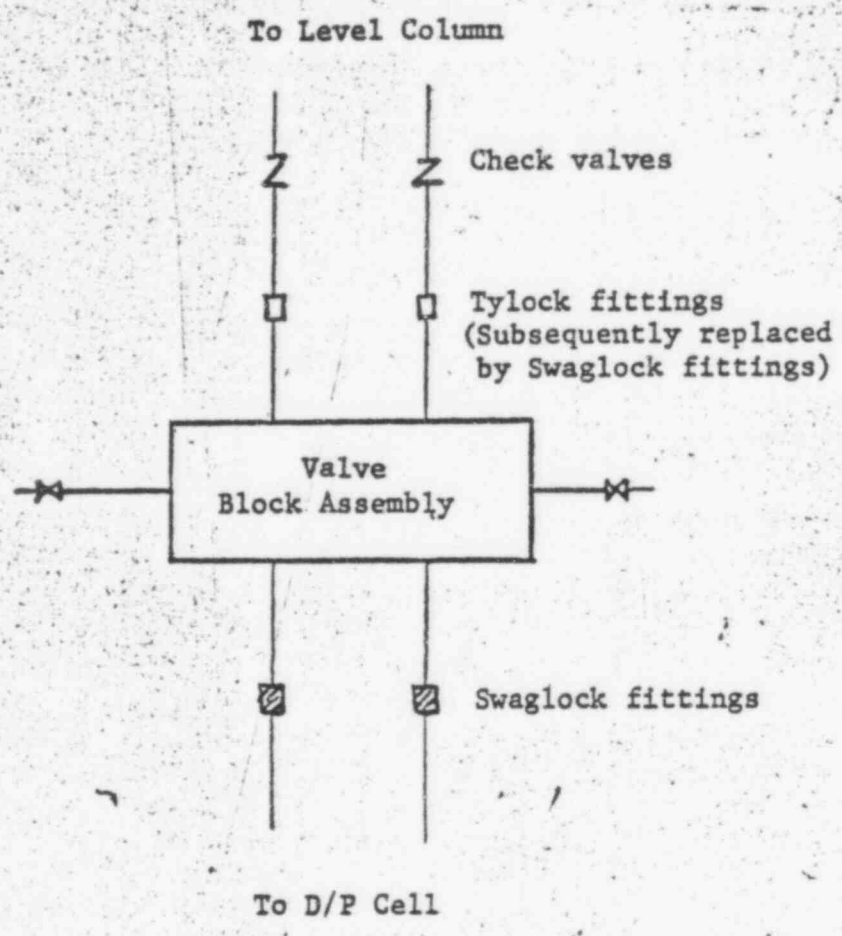
Separation of both 3/8 inch sensing lines to the pressurizer level indicator D/P cell occurred during primary system heatup at 2000 psig and 636° F in the pressurizer. Excess flow check valves functioned as designed and there was no primary leakage. (See Section E.1. of this report.)

In discussions with Messrs. Swift and Pekar it was learned that the pressurizer channel (LIC-2), which provides signals for continuous level indication, "On" - "Off" high and low level alarms, low-level heater shut-off, and low-level scram, indicated an increase in level from 50% to 100% during primary system heatup (2000 psig and 636° F in pressurizer). The plant was cooled down and investigation revealed that the Tylock fittings in both 3/8 inch stainless steel tubing lines connecting the pressurizer level column to a D/P cell had separated which caused the level indication on LIC-2 to increase to 100%. There was no primary system leakage as a result of this occurrence because the excess flow check valve (Chemiquip Type 50 FM 100) located upstream of the Tylock fitting in both lines, functioned as designed. The separation occurred above the stainless steel

valve block assembly, which is mounted in the D/P cell cabinet. The arrangement is shown in Figure 1 attached. Prior to system heatup the D/P cell had been removed for calibration by uncoupling the D/P cell from the valve block assembly at the Swaglock fittings. Corrective action taken by the licensee consisted of installing a new valve block assembly, replacing the Tylock fittings with Swaglock fittings, recalibrating the D/P cell, and performing a hot functional primary system pressure (leak) test at 2285 psig and 512° F.

D/P CELL CABINET ARRANGEMENT

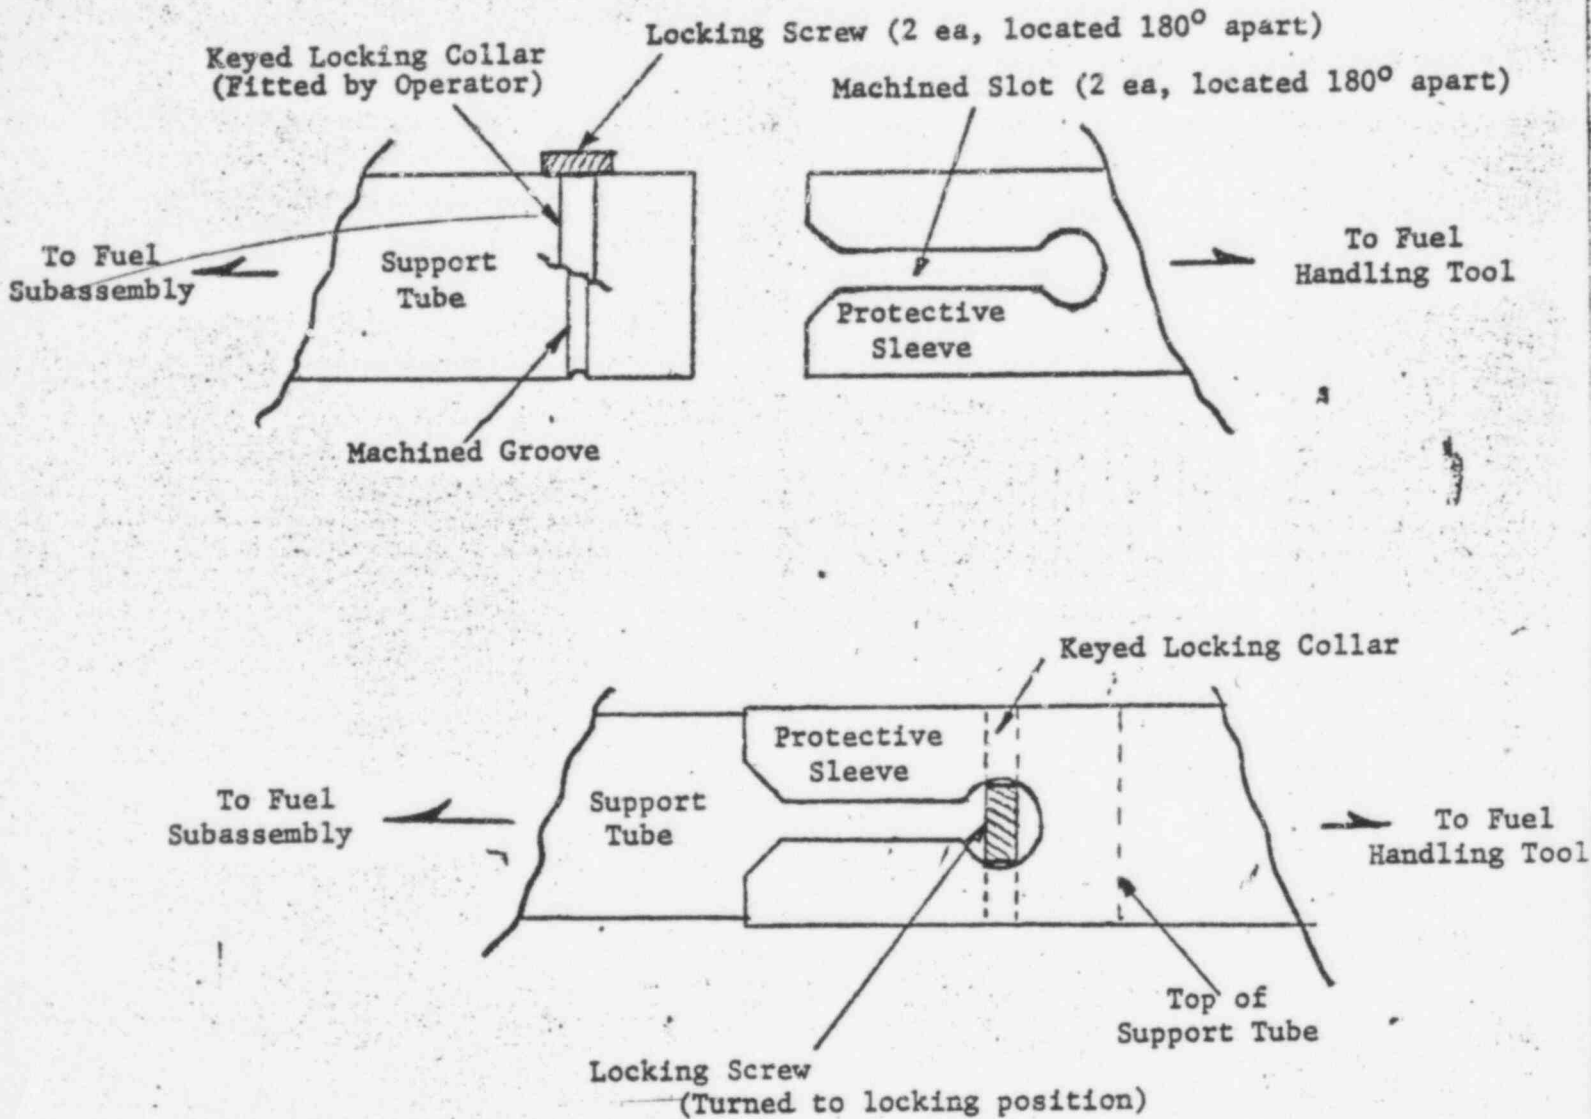
Fuel subassembly 504-4-25 was dropped a distance of approximately 12 inches while being loaded into the spent fuel storage rack following its inspection. Buckling damage to the subassembly can occurred which precluded its reloading into the core. (See Section O of this report.)

Licensee correspondence with DRL** and subsequent discussions with Messrs. Swift, Goodman, and Potts revealed that after inspection by the Westinghouse Mobile Fuel Evaluation Team, fuel subassembly 504-4-25 was dropped approximately 12 inches while being loaded into the spent fuel storage rack. Examination by the licensee revealed that the fuel pins were not damaged, but the 0.019 inch thick perforated stainless steel can showed buckling damage about 4 - 5 inches from the top and 3 - 4 inches from the bottom of the can. It was decided by the licensee that this subassembly would not be reloaded into the core. (See previously referenced letter). The subassembly fell when the support tube separated from the protective sleeve during normal handling. It was determined by the inspectors that this occurrence could have happened at any time during the handling period due to an apparent failure in the locking device and that this irradiated subassembly could have been dropped a distance of up to 14 feet.

An illustration of the mechanical fitup for lifting a fuel subassembly is given in Figure 2. The locking action occurs when the locking screws are turned 90 degrees by an operator after the protective sleeve is lowered into position over the guide tube. The fitup occurs prior to raising the water level above the top of the reactor pressure vessel head in preparation for fuel handling. Mr. Swift stated that a large force is required to turn the locking screws but in this case the operator noted that less force than normal was required during the fitup. Mr. Swift indicated that both screws apparently rotated during subsequent fuel handling, and that the fuel handling was considerably more than normal due to the inspection of the fuel pins. A review of the draft On-Site Safety Committee minutes for the August 20, 1970 meeting indicated that this occurrence was not reviewed by the committee. This matter was discussed at the exit interview.

FITUP FOR LIFTING FUEL SUBASSEMBLY
