Subject of this Document: "Nickel Contaminated Titanium Weld Wire Study"

LOFT TECHNICAL REPORT LTR 141-93

JULY 18, 1979

NICKEL CONTAMINATED TITANIUM  
WELD WIRE STUDY

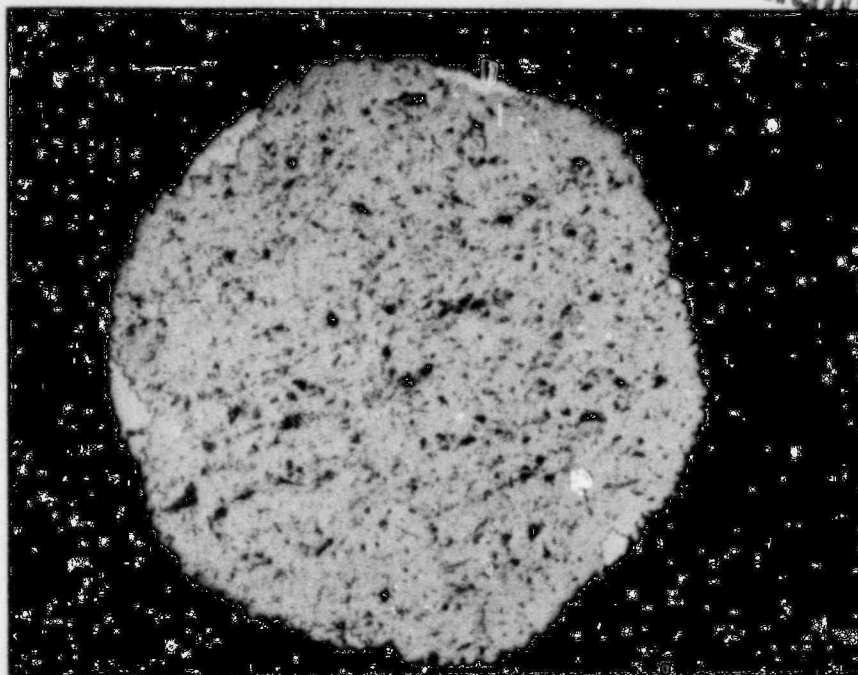
Optical photomicrograph at random transverse cross-section of nickel contaminated. 0.015 in diameter titanium weld wire.

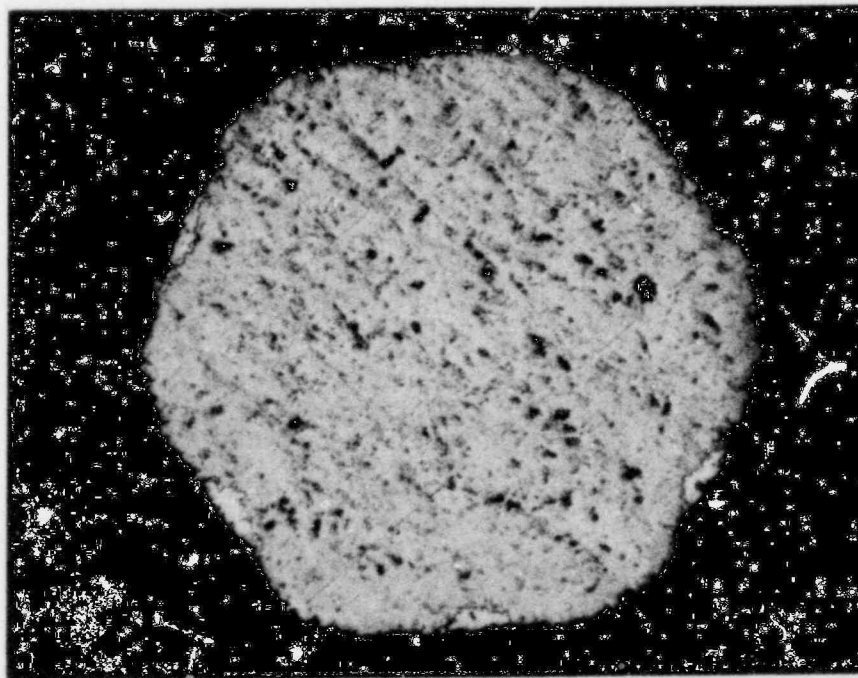
Optical photomicrograph at random transverse cross-section of nickel contaminated 0.015 in diameter titanium weld wire

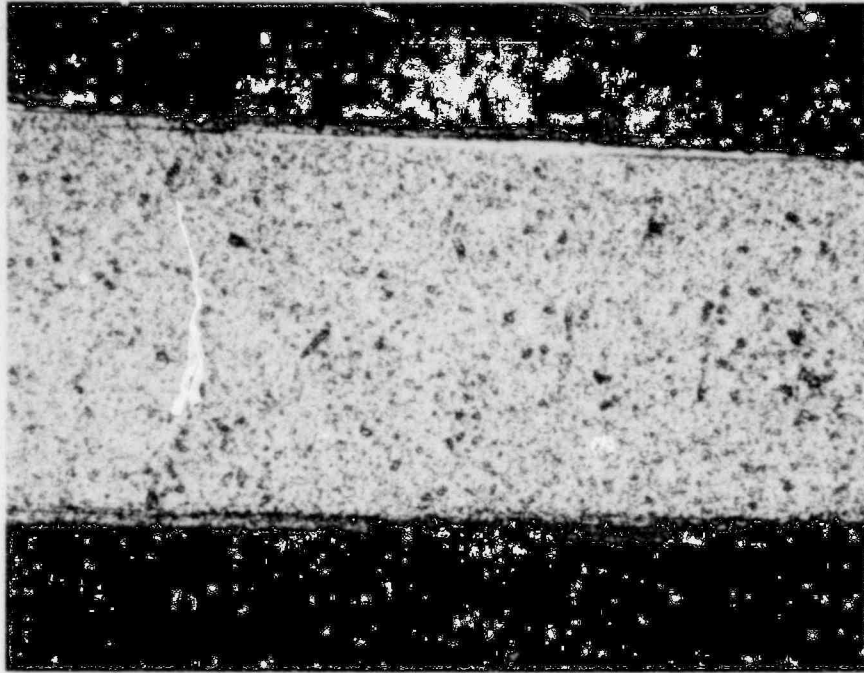
Wire #4 Longitudinal optical photomicrograph. Approximately 200X of nickel contaminated titanium weld wire.

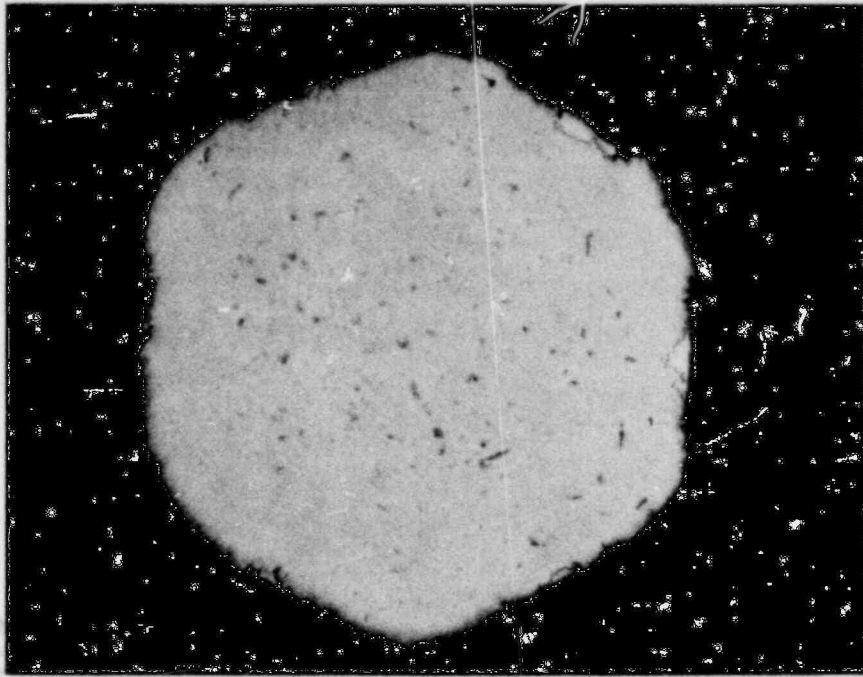
Optical photomicrograph section at location A, approximately 200X

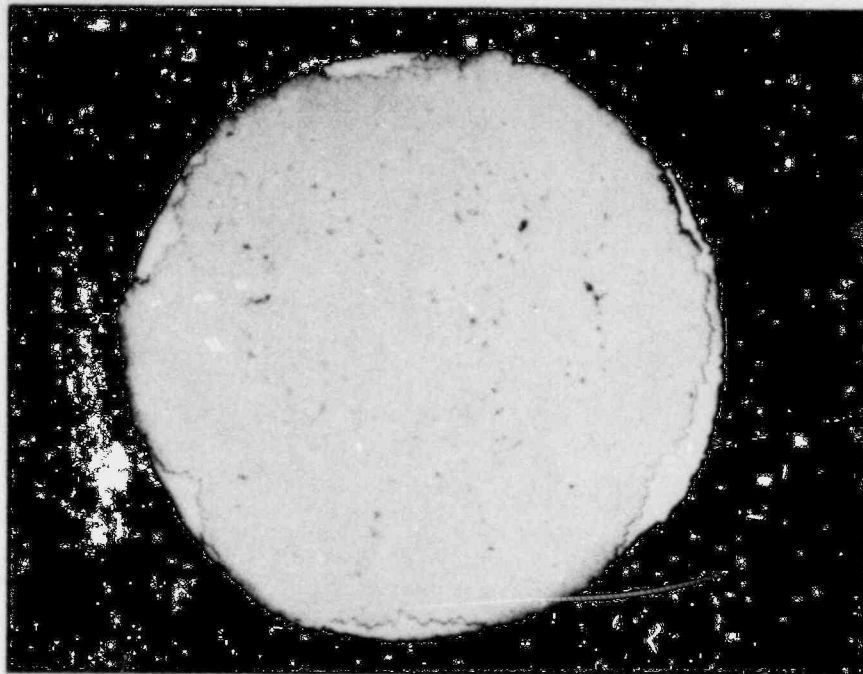
Optical photomicrograph section at location C. Approximately 200X

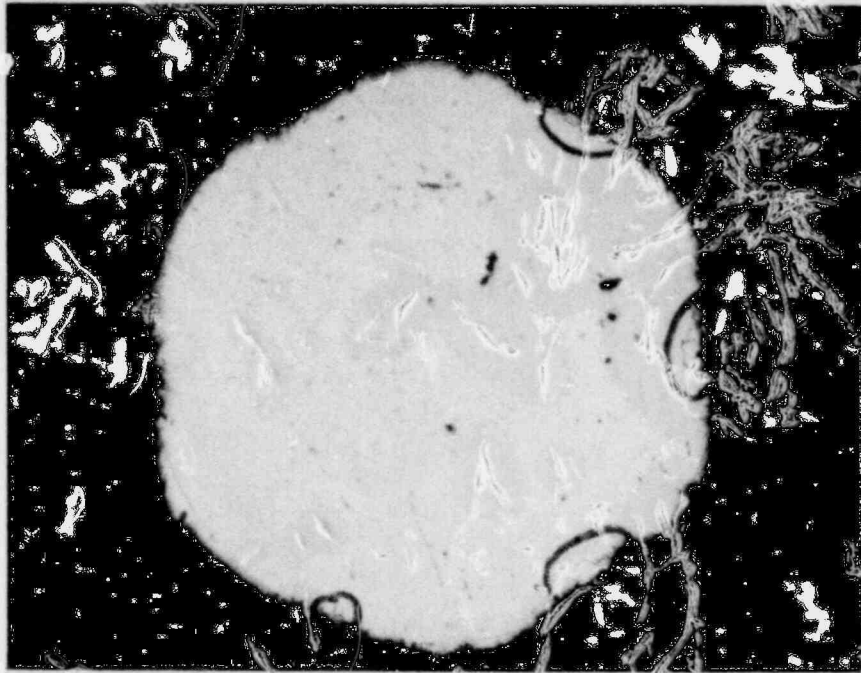
Optical photomicrograph section at location G. Approximately 200X

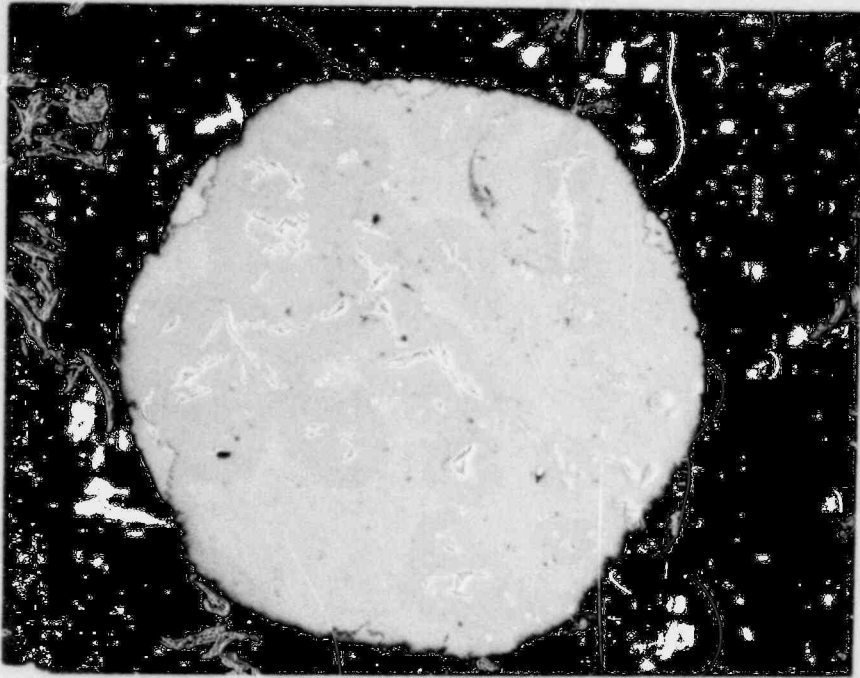
Optical photomicrograph section at location J. Approximately 200X

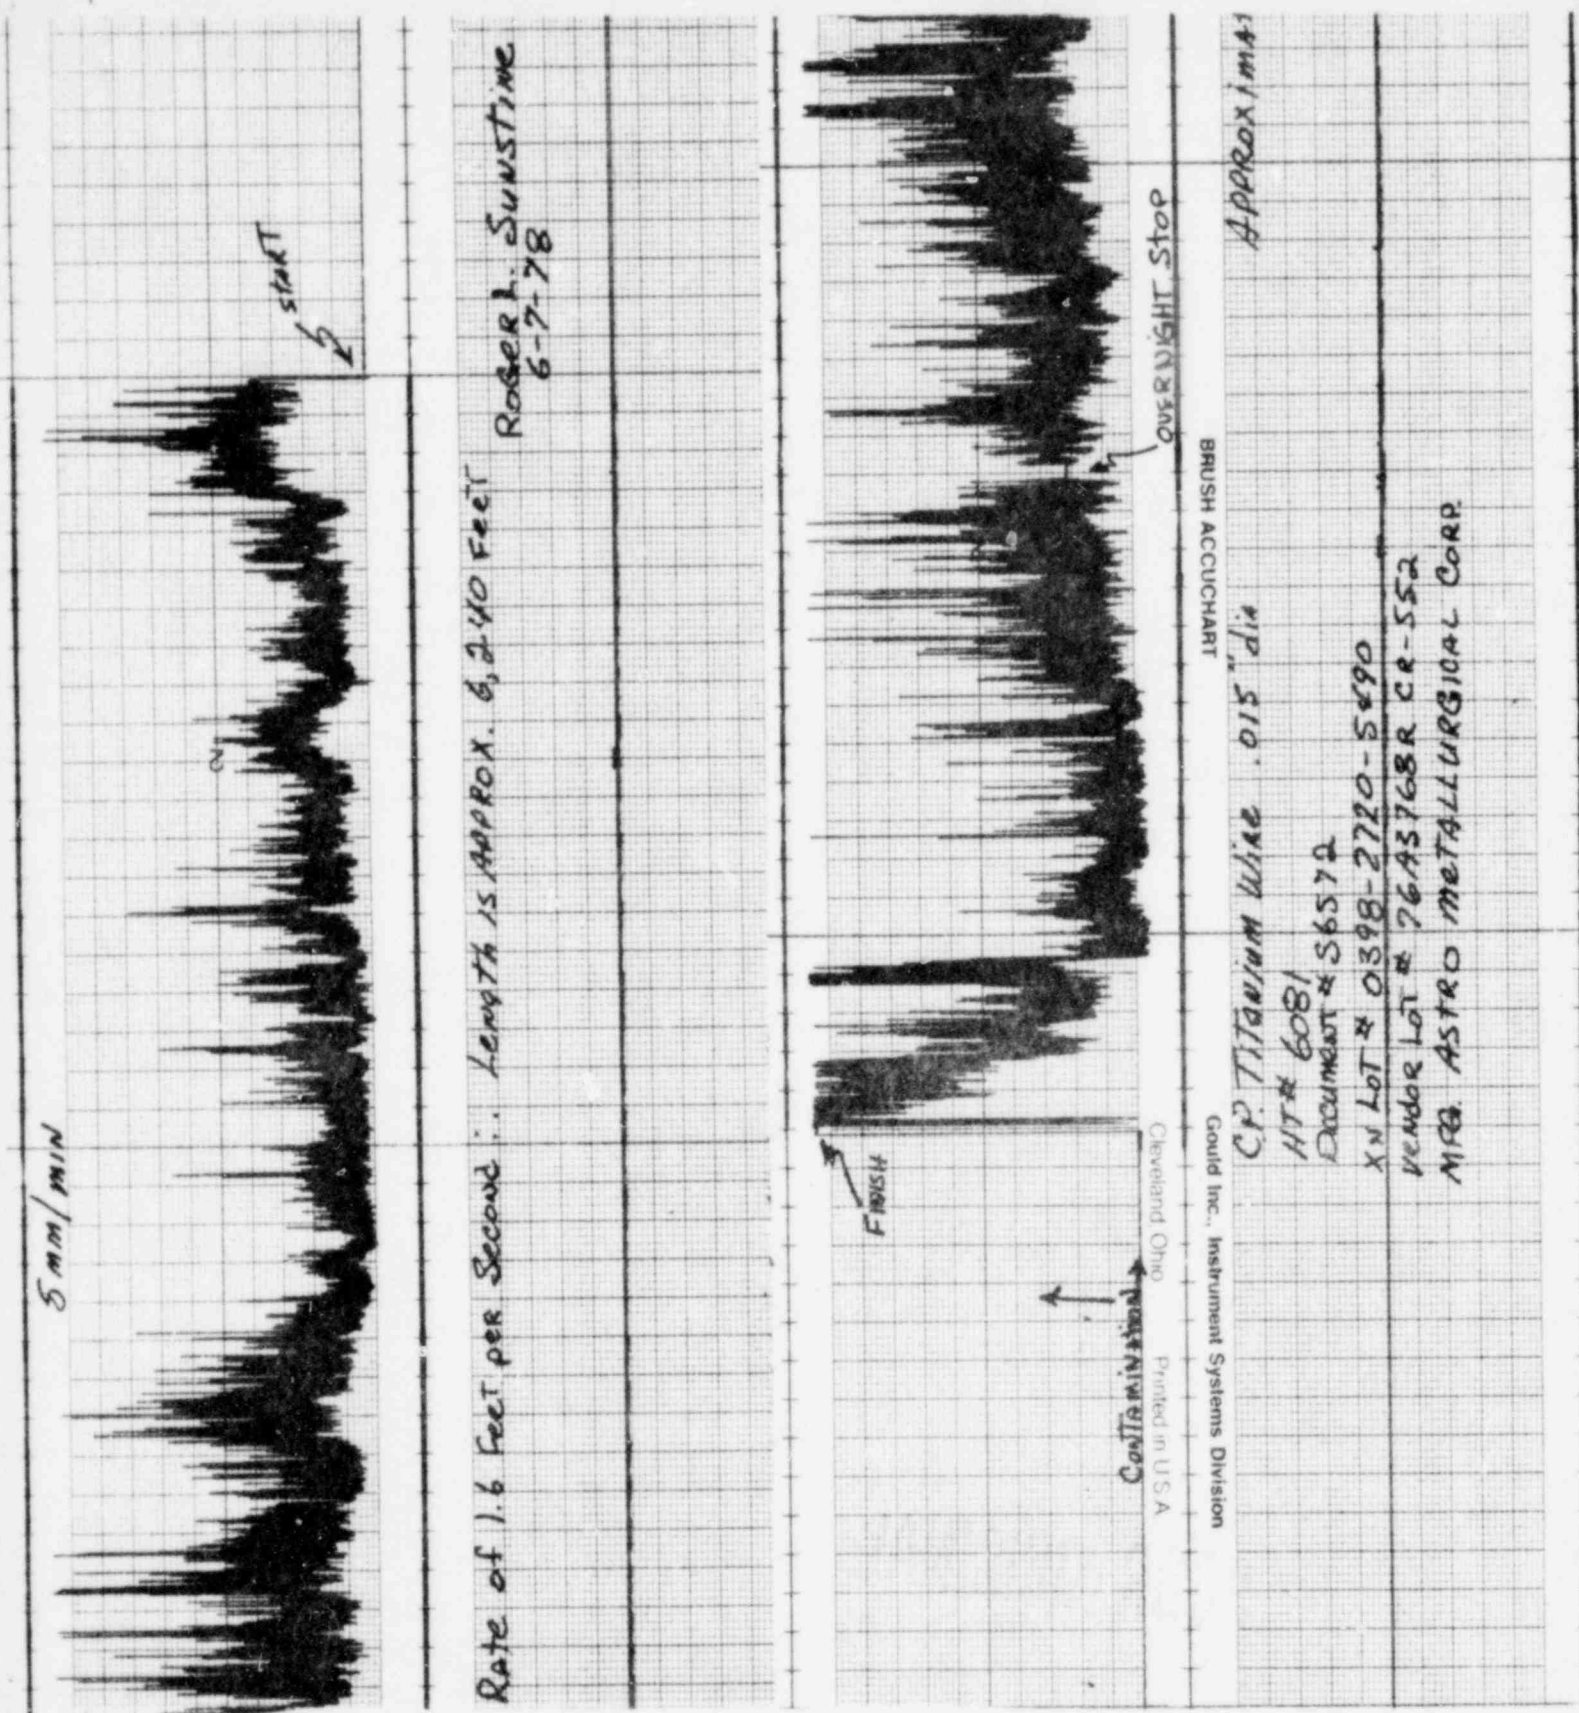
Figure 1. Inspection trace records of Astro-Metallurgical Corp. Titanium weld wire lot number 76A3768R.

Inspection was conducted on 1902 meters of 0.381 mm (0.015 inch) diameter -CP titanium weld wire supplied by Astro Metallurgical Corp. (vendor lot number 76A3768R, CR-552 Heat Treat number 6081 under contract number S6572). The entire lot was rejected due to nickel contamination. This rejection overrides previously accepted material where only end point samples were visually inspected. The inspection equipment trace record is included in Appendix B of this report.
