NUREG-0090  
Vol. 2, No. 1

# REPORT TO CONGRESS ON ABNORMAL OCCURRENCES

January - March 1979

Office of Management and Program Analysis  
U. S. Nuclear Regulatory Commission

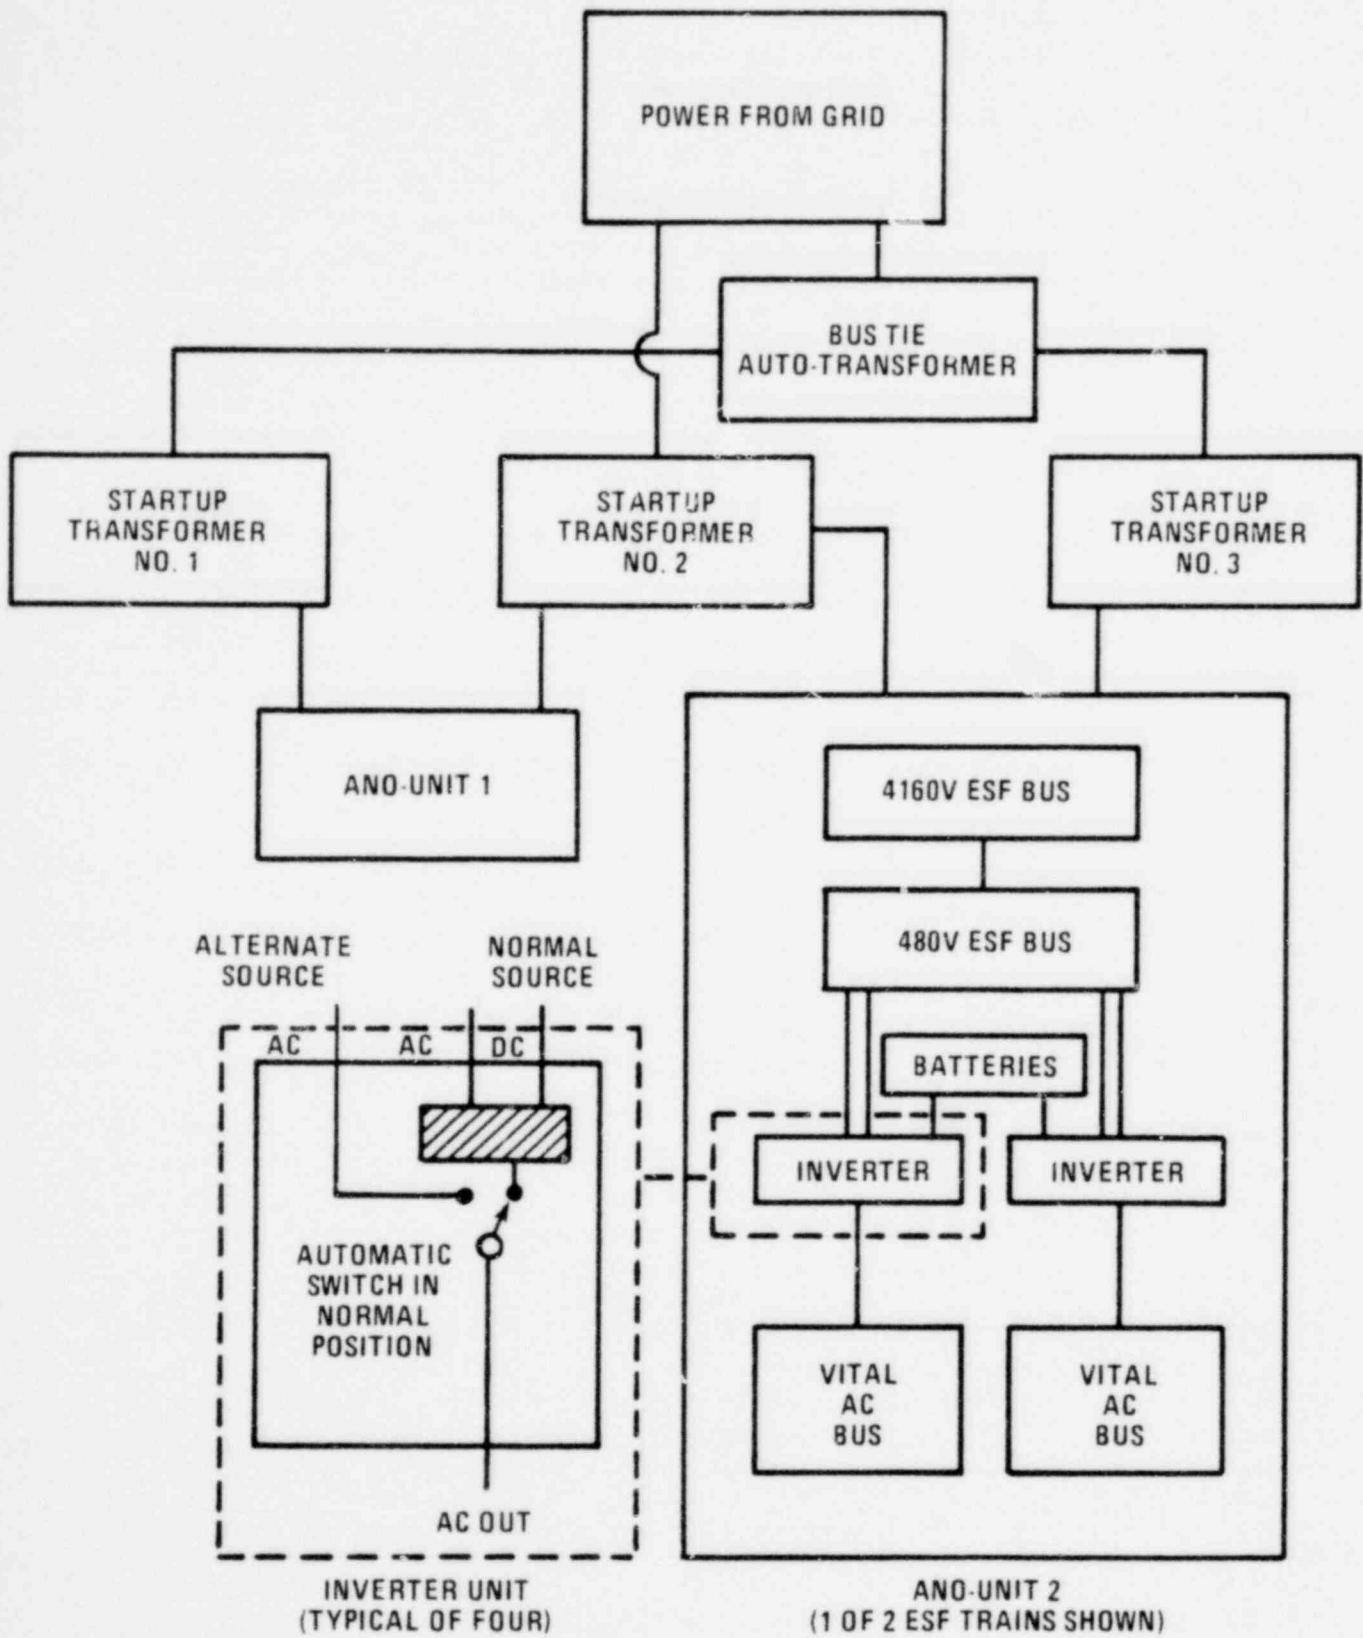
Figure 1. Simplified Block Diagram - Electric Distribution

- (1) The offsite power supply for ANO Unit 1 Engineered Safety Feature loads was deficient in that degraded voltage could have resulted in the unavailability of ESF equipment, if it were to be needed.
- (2) The design of the ANO site electrical system that provides offsite power to Units 1 and 2 did not fully meet the Commission's Regulations, 10 CFR 50, Appendix A, General Design Criterion 17, because in certain circumstances a failure of one of the two offsite power circuits would also result in a failure of the other such circuit.
- (3) Deficiencies existed in the operation of the Unit 2 inverters that convert battery power to AC power for certain safety-related equipment.

and Unit 2 operation<sup>3</sup> a loss of the Bus Tie Auto-Transformer, which was caused in this case by personnel error, would automatically lead to the overloading of Startup Transformer No. 2.

Cause or Causes - The immediate causes of the undesirable event at Arkansas Nuclear One were: (1) loss of the Bus Tie Auto-Transformer which resulted in degraded power operation through Startup Transformer No. 2, and (2) multiple Unit 2 inverter failures.

The loss of the Bus Tie Auto-Transformer was caused by inappropriate setpoints for its protective relays. The operation and maintenance of this piece of equipment is assigned to an AP&L organization outside of Arkansas Nuclear One. No one within AP&L remembered the necessity to reset the relays for operation of two units at the site. The Bus Tie Auto-Transformer failure had not been adequately reviewed prior to this event in that the overloading of the shared Startup Transformer No. 2 had not been identified during the design and review process.

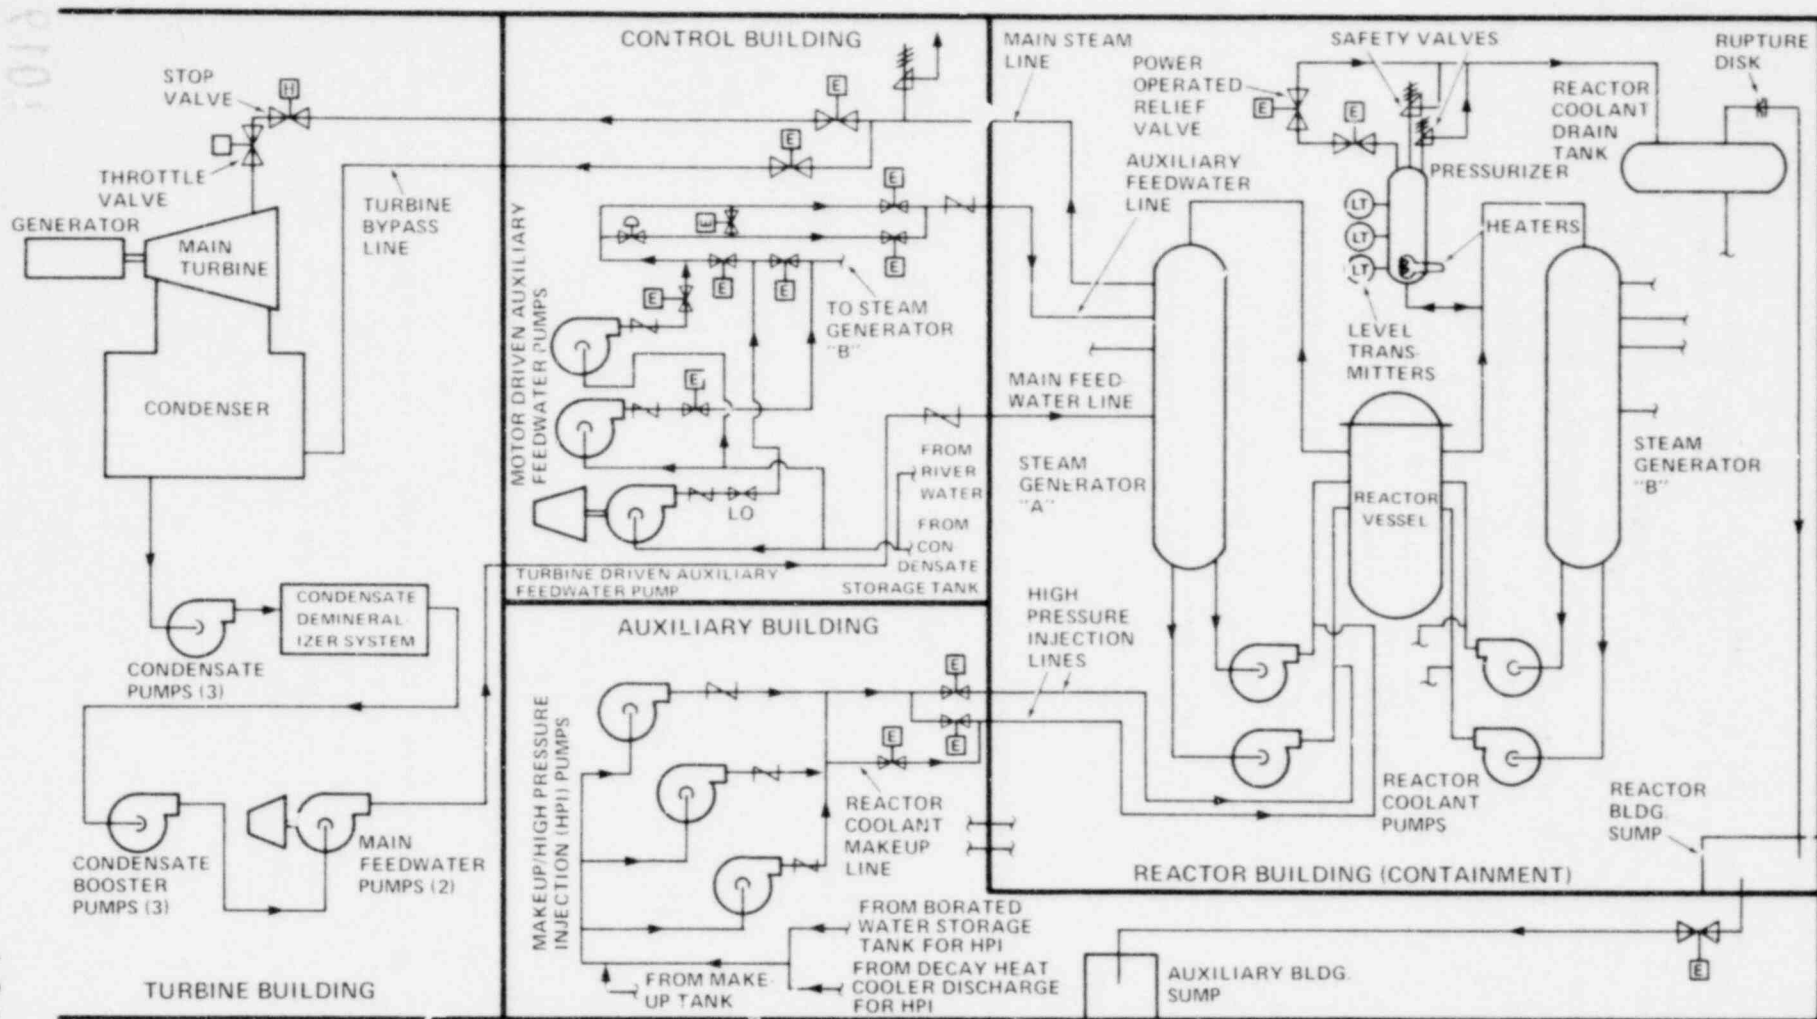
Figure 2. Simplified RCS/Steam/Feed Systems

At about 4:00 a.m. on March 28, 1979, the secondary (non-nuclear) cooling system of the Three Mile Island facility suffered a malfunction. The function and flow pattern for this system were discussed previously (see Figure 2). The malfunction was a loss of a condensate pump in the feedwater return system, apparently due to moisture in the control air of a valve.

The malfunction in the condensate system caused the feedwater pumps to turn off (trip), which in turn caused the turbine-generator to turn off and stop generating electricity. Since the steam generators were not removing heat due to the stoppage of feedwater flow, the heat generated in the reactor caused system pressure to increase and the pressurizer relief valve opened to reduce reactor pressure. The reactor turned off by the rapid insertion of the plant's control rods (scrammed) as designed and the nuclear chain reaction stopped leaving behind principally residual, or decay heat. These events all occurred within the first 30 seconds following the initial event.

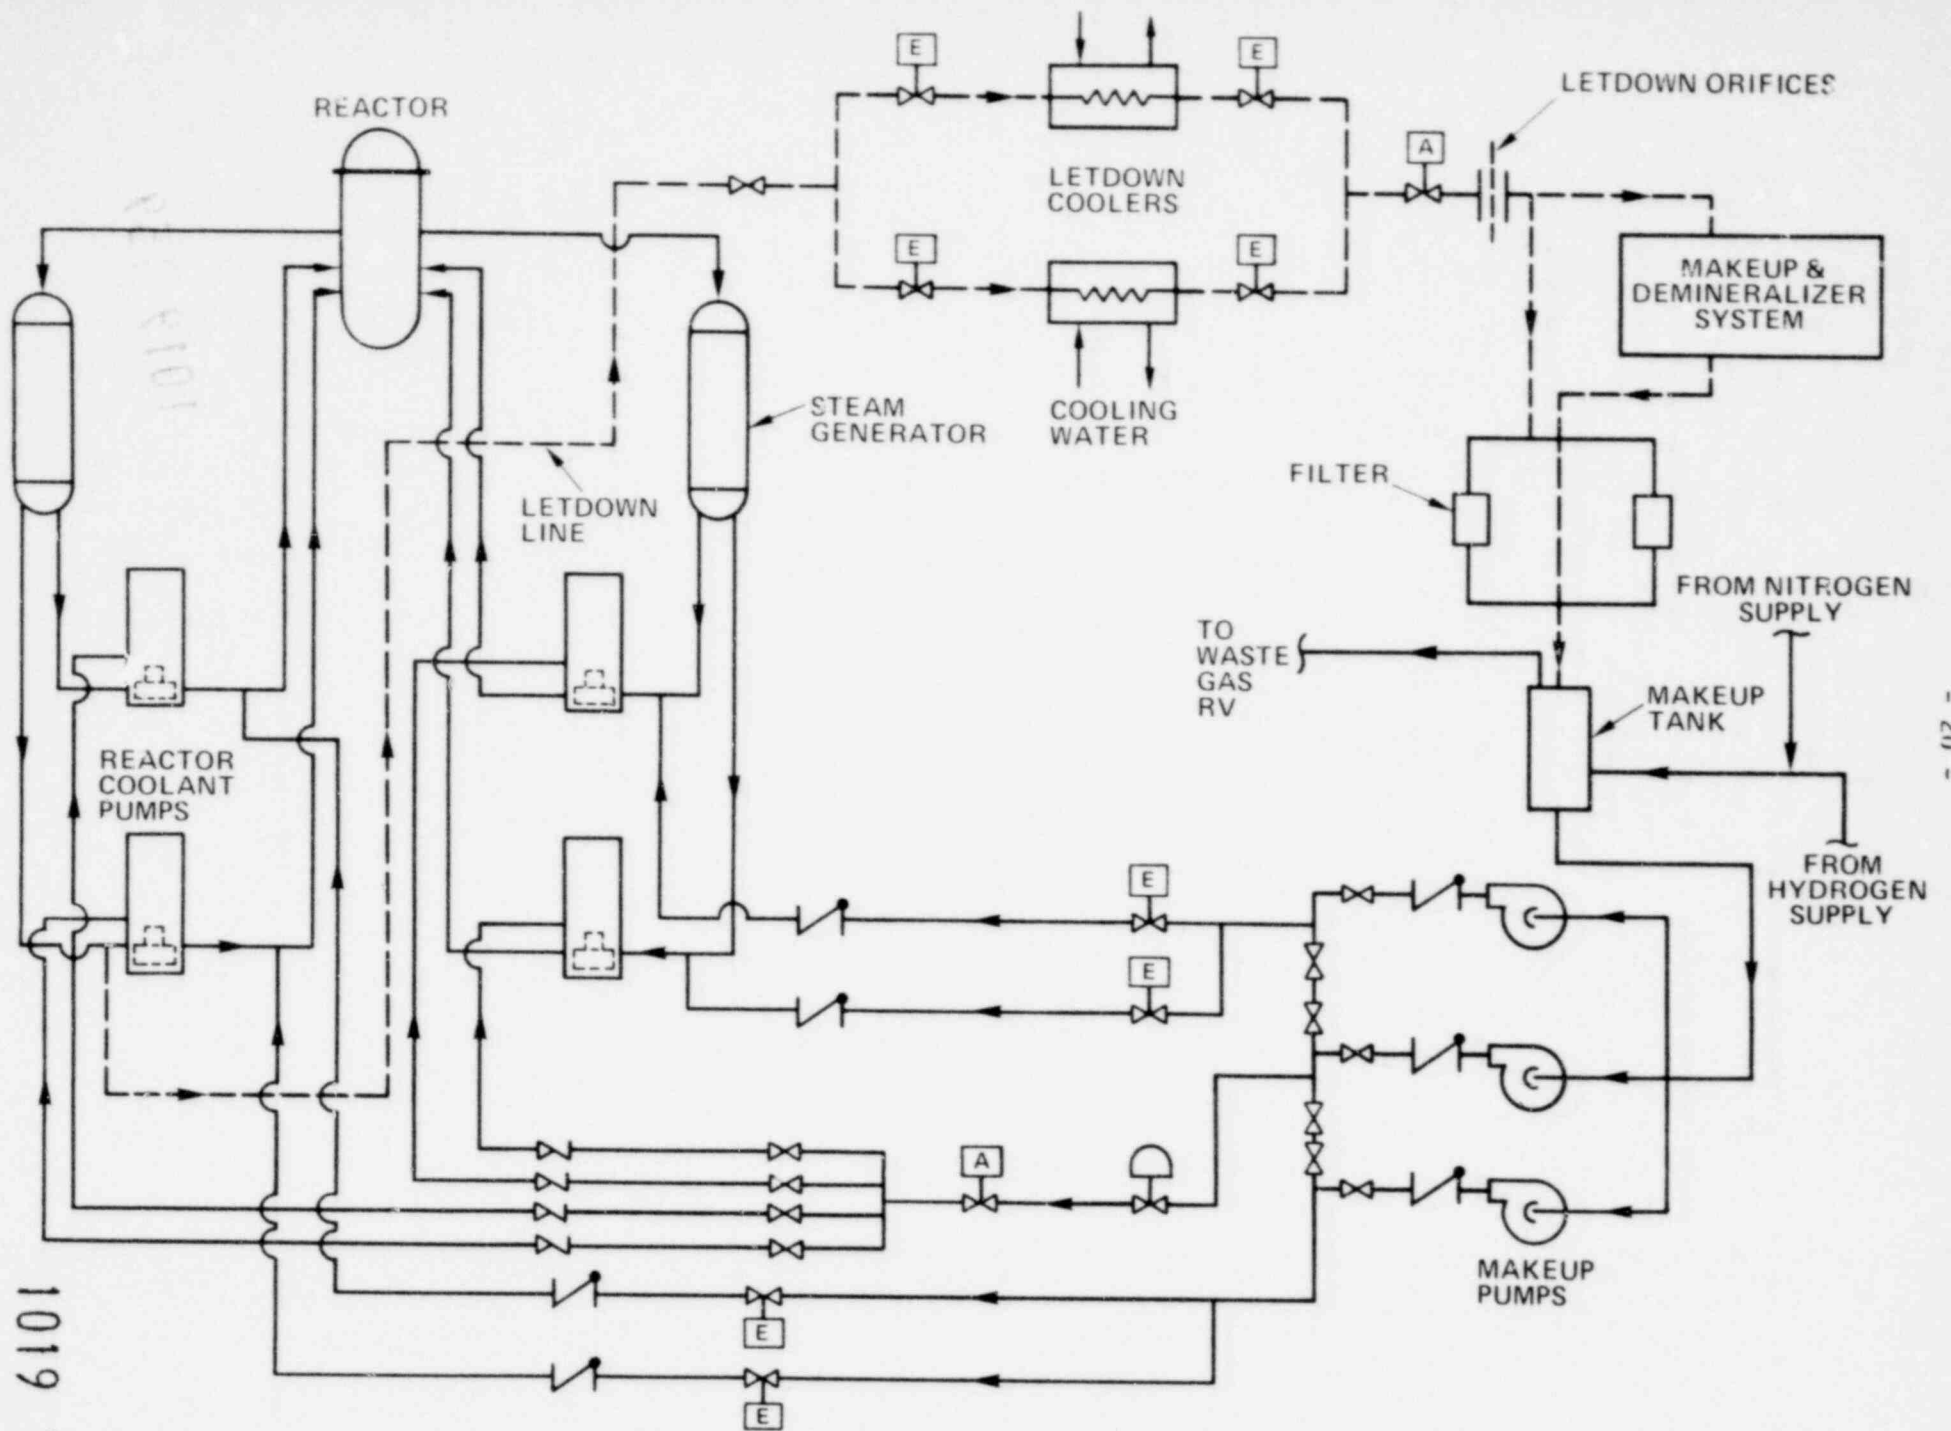
FIGURE 4. SIMPLIFIED MAKEUP & PURIFICATION SYSTEM

Following fuel damage, the concentration of radioactivity in the reactor coolant increased by several orders of magnitude. A flow of this highly contaminated reactor coolant was maintained from the primary coolant system through the letdown system and return to the primary coolant system via the makeup system for several days following the accident. This flow was required to ensure adequate cooling of the reactor coolant pump bearings. Gases evolving from the reactor coolant in the makeup and letdown system were collected in the waste gas system. Small leaks in these systems were of little radiological significance during normal operation. However, following the accident, these leaks caused very high radiation levels inside the auxiliary and fuel handling buildings and resulted in much higher than normal environmental releases via the ventilation exhausts from these buildings. This flow was the principal pathway by which radioactivity passed from the damaged reactor core to the auxiliary building, fuel handling building and to the environment.

the coolant is sprayed into the pressurizer. The spray condenses some of the steam lowering the pressure and increasing the surface area of the coolant in the pressurizer which releases some hydrogen and other non-condensable gases. These gases collect at the top of the pressurizer and are vented to the pressurizer relief tank. Apparently because the rupture disc on the relief tank had ruptured, the pressurizer was being vented into containment periodically. Degassing can also take place in the letdown flow, which is one of the functions of the makeup, purification and chemical addition systems. The letdown flow first passes through the letdown coolers where it is cooled and reduced in pressure (see dotted lines of Fig. 4). The pressure is further reduced by passing through the letdown orifices. This reduction in pressure releases hydrogen and other gases. The flow can then either go directly through the filters or through the demineralizer system and into the makeup tank. The makeup tank contains a layer of hydrogen. The hydrogen blanket is established by raising the tank water level and purging with nitrogen gas. The hydrogen introduced in the makeup tank is dissolved in the coolant by combining with any free oxygen while the fission gases present are removed by continuous venting of the makeup tank to the waste gas processing system. The pressurizer was vented to the containment periodically. Subsequently, a hydrogen recombiner was made operational to reduce the hydrogen concentration in the containment building atmosphere. A hydrogen recombiner is part of the gas waste processing system. The contaminated hydrogen gas in the makeup tank mixes with the nitrogen present and is pumped to the recombiner where oxygen is added to reduce the hydrogen content by oxidizing it to water vapor. Thus, the period of immediate crisis passed and the reactor cooldown process could proceed without the hydrogen bubble posing any safety problems.
